लोक निर्माण विभाग, ओडिशा सरकार के अंतर्गत, पुलों की आधुनिक परीक्षण प्रक्रियाओं का उपयोग करते हुए ओडिशा राज्य के रोड नेटवर्क के मेजर और माईनर ब्रिजो के स्थिति का आकलन और उपचारात्मक उपायों के लिए सुझाव

अंतिम रिपोर्ट

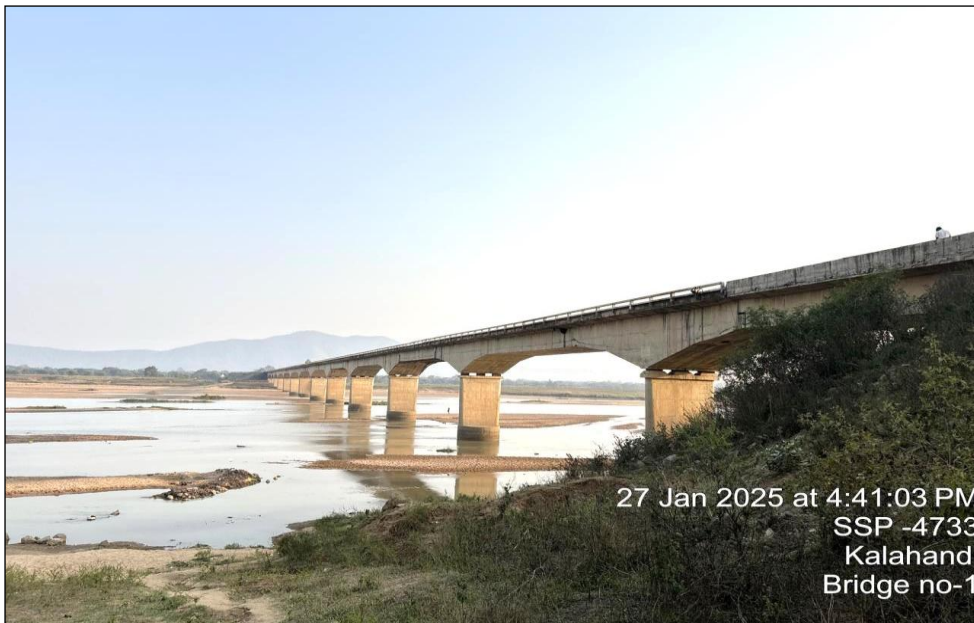
Suggestions for Repair, Rehabilitation, Retrofitting Measures and BOQ For the H.L. Tel River Bridge at Ch. 27+500 of Bhawanipatna-Kharier Road under Kalahandi Division

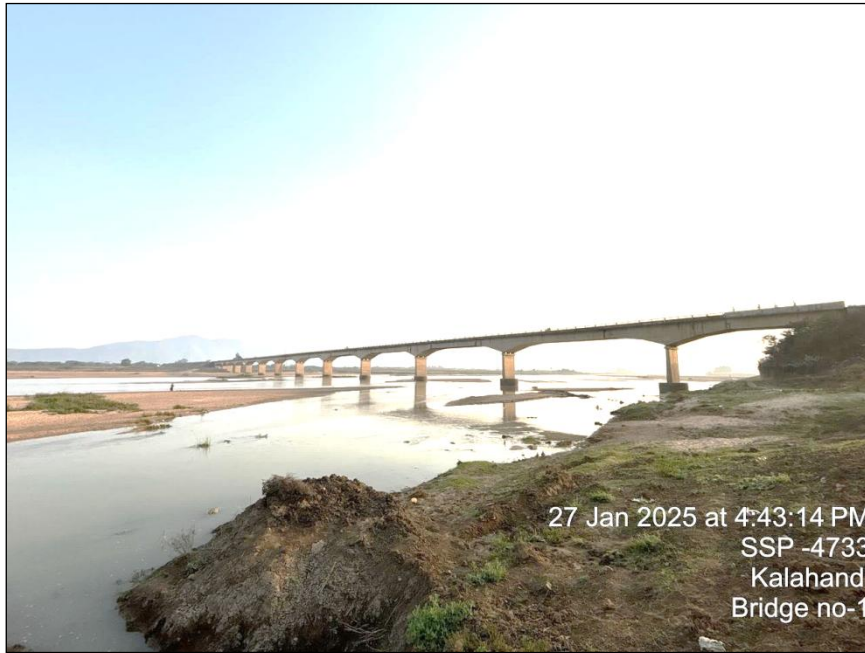
Photo 1: A D/S view of H.L Bridge at 27/500 Km on Bhawanipatna - Khariar Road in the Kalahandi Division.

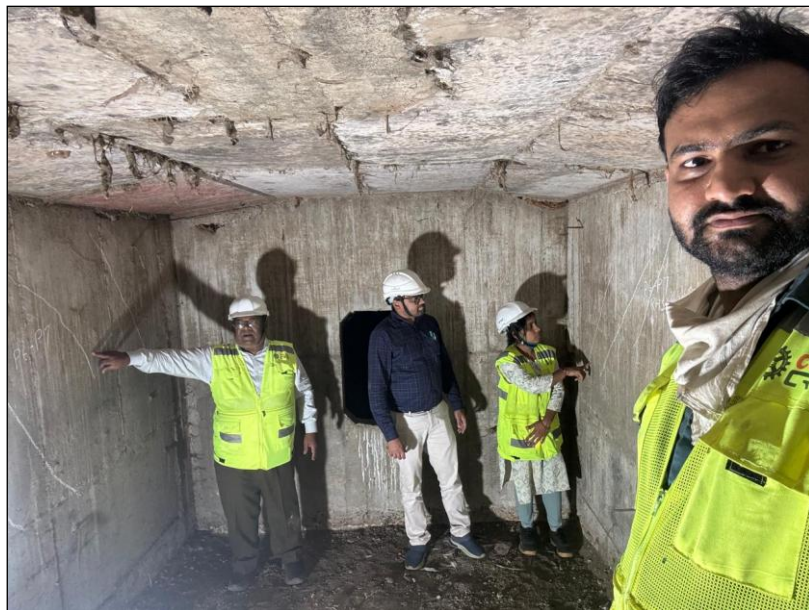
Photo 4: A view of Inspection of Crack in box Girder in span P6-P7 of H.L Bridge at 27/500 Km on Bhawanipatna – Khariar Road in the Kalahandi Division

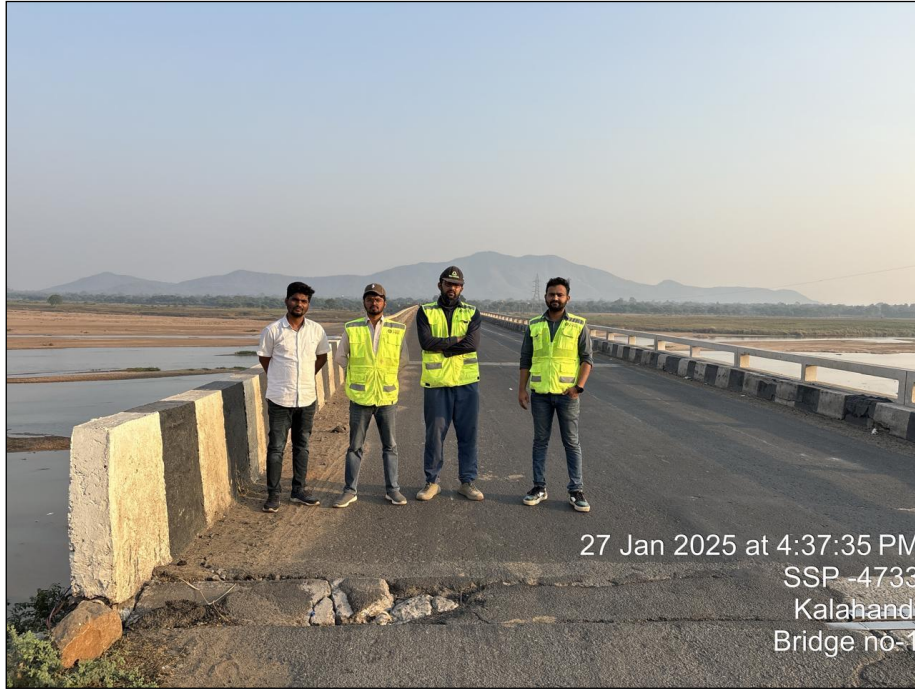
Photo 5: A view of team Member on Carriageway of H.L Bridge at 27/500 Km on Bhawanipatna – Khariar Road in the Kalahandi Division.

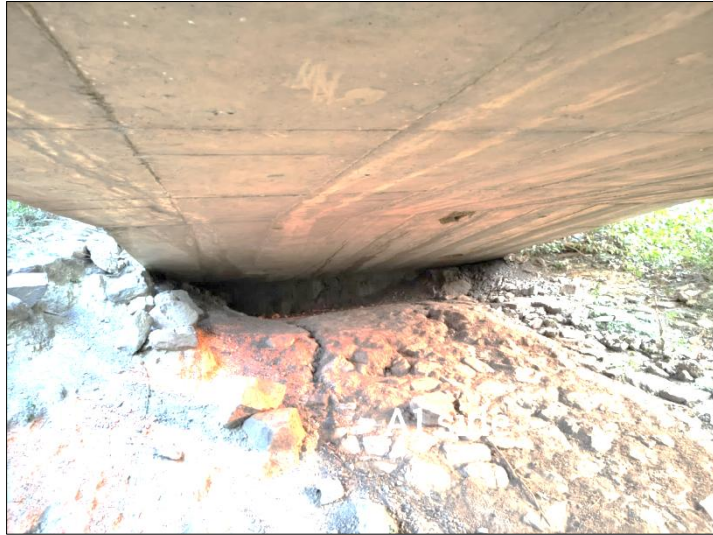
Photo 6: A view of Cantilever end towards A1 Side of the H.L Tel Bridge at 27/500 Km on Bhawanipatna–Khariar Road in the Kalahandi Division .

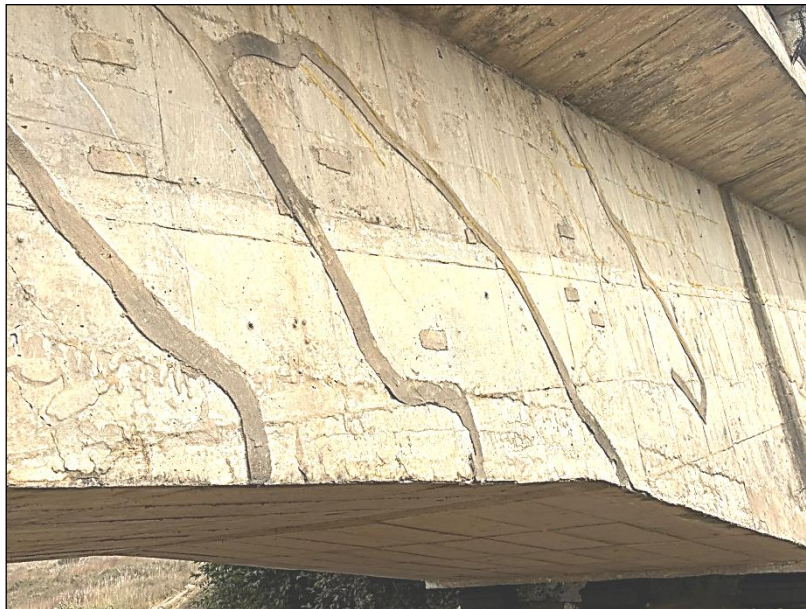
(span 12-A2 as per OWD)

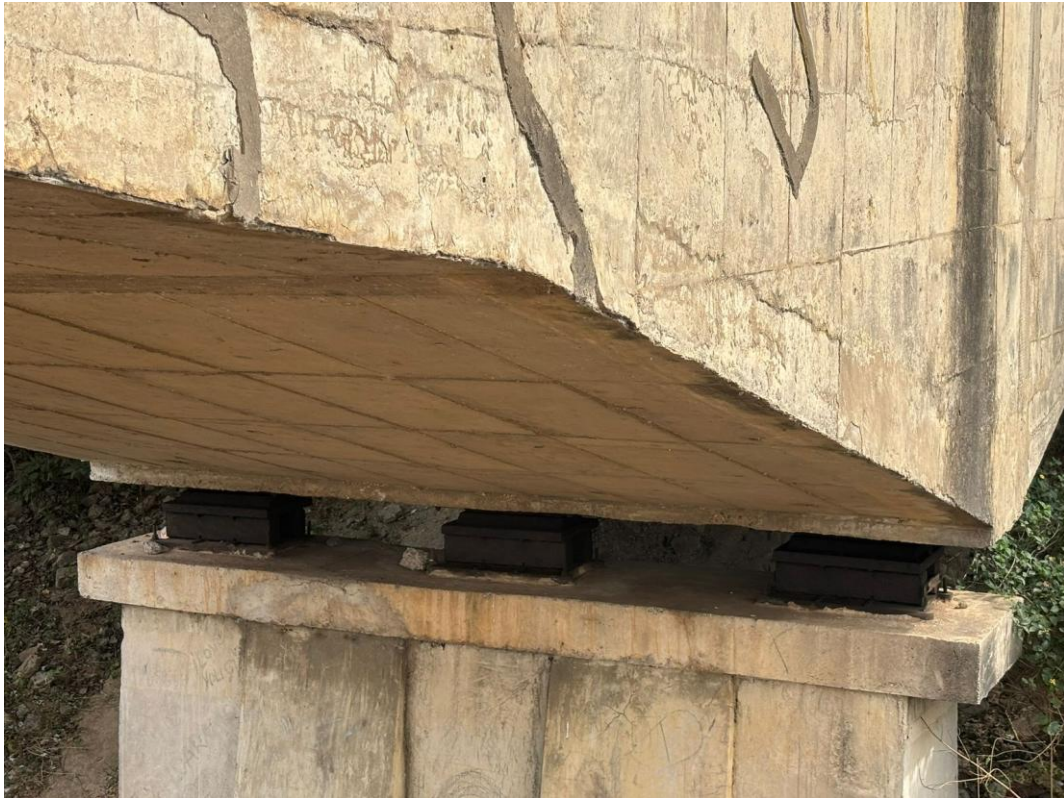
Photo 9(b): A view of Rocker-cum-cut Roller bearings at Abutment A-1 of the H.L Tel Bridge at 27/500 Km on Bhawanipatna–Khariar Road in the Kalahandi Division

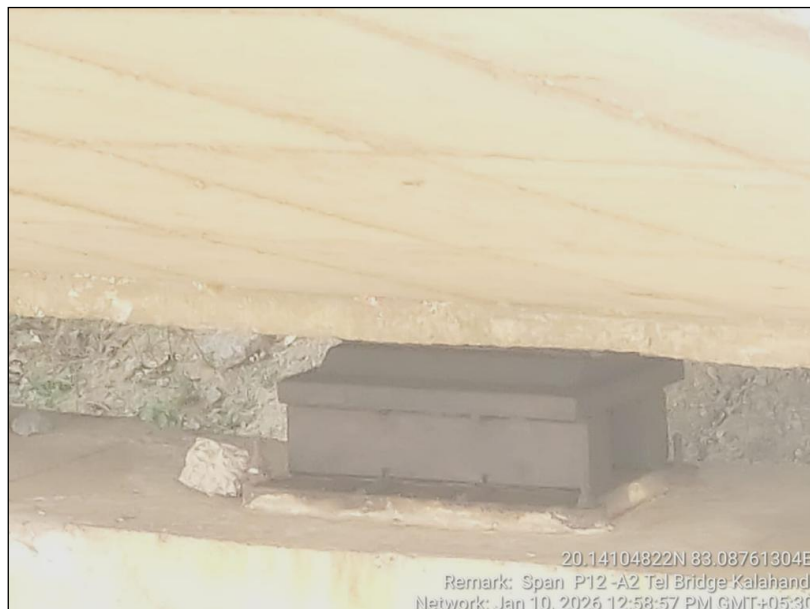
Photo 9(c): A view of Missing Tie plates in the Rocker-cum-cut Roller bearings at Abutment A-1 in the Tel Bridge of the Kalahandi Section.

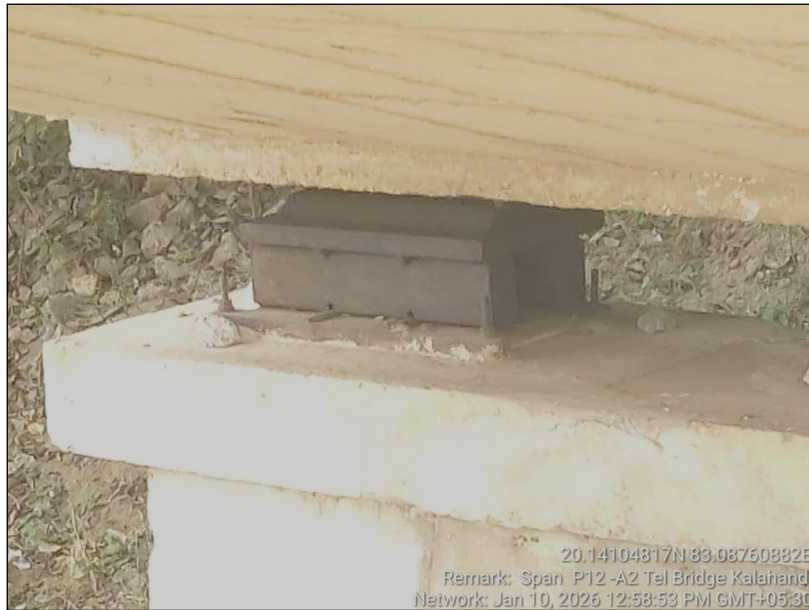
Photo 9(d): A typical view of Missing Tie plates in the Rocker-cum-cut Roller bearings at Abutment A-1 in the Tel Bridge of the Kalahandi Section.

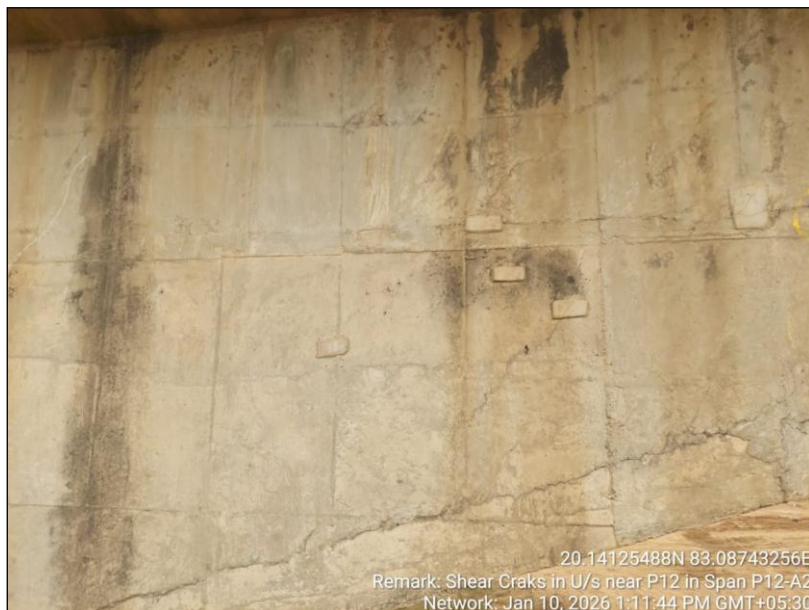
(span P12-A2 as per OWD)

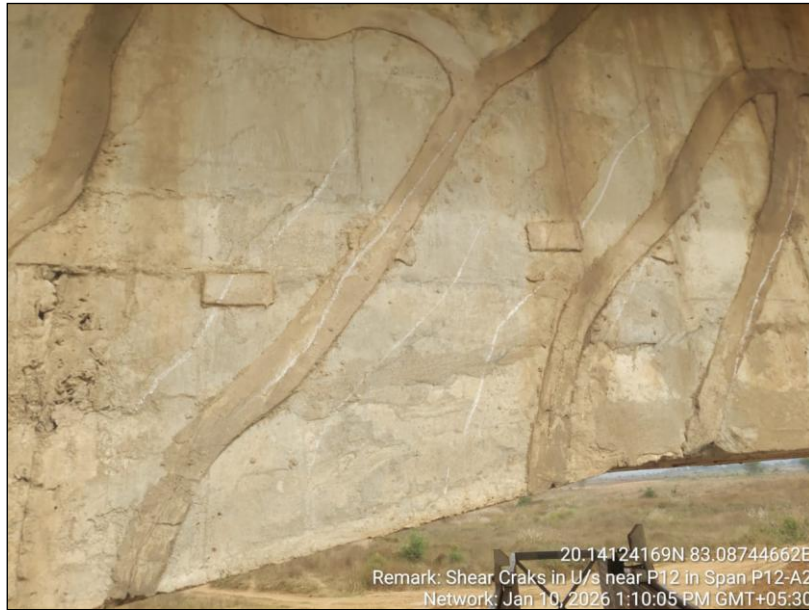
(span P12-A2 as per OWD)

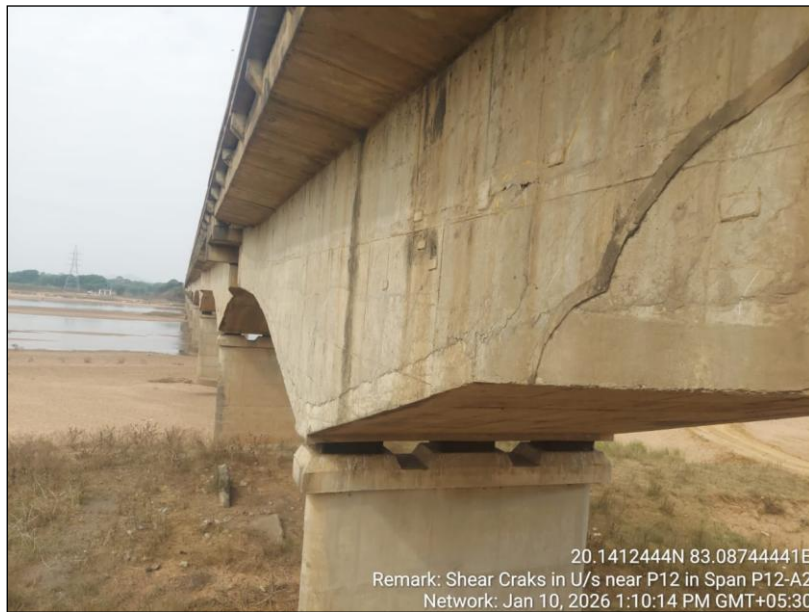
(span P12-A2 as per OWD)

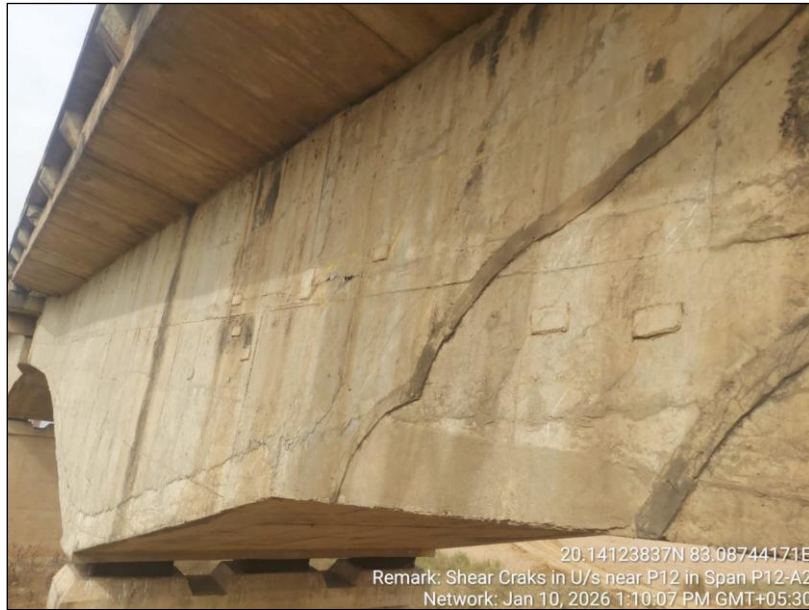
Photo 10(d): A view of Shear Cracks in U/S near Pier P-1 in the span P1-A1 of Tel Bridge of the Kalahandi Section.

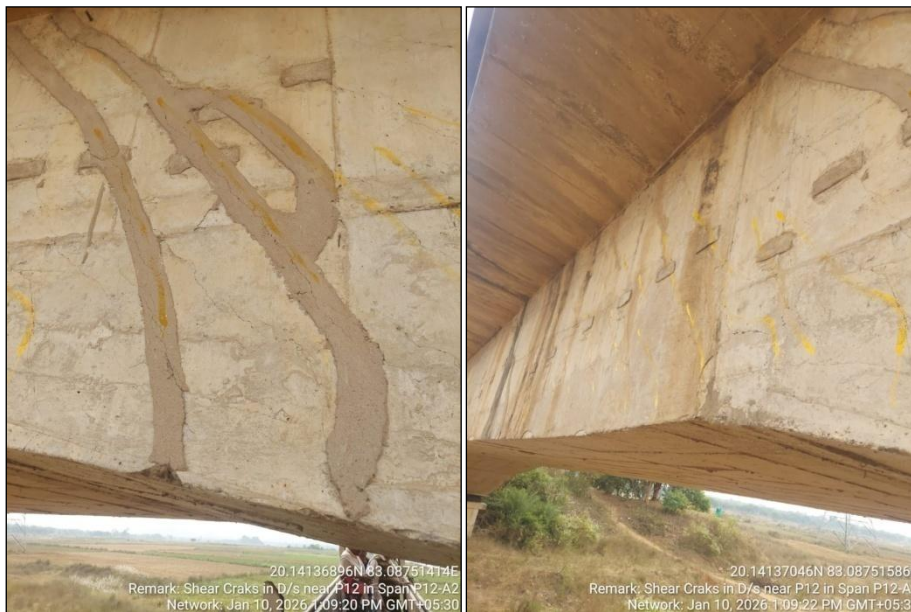
Photo 10(d): A view of Cracks in U/S in the span P1-A1 of Tel Bridge of the Kalahandi Section.

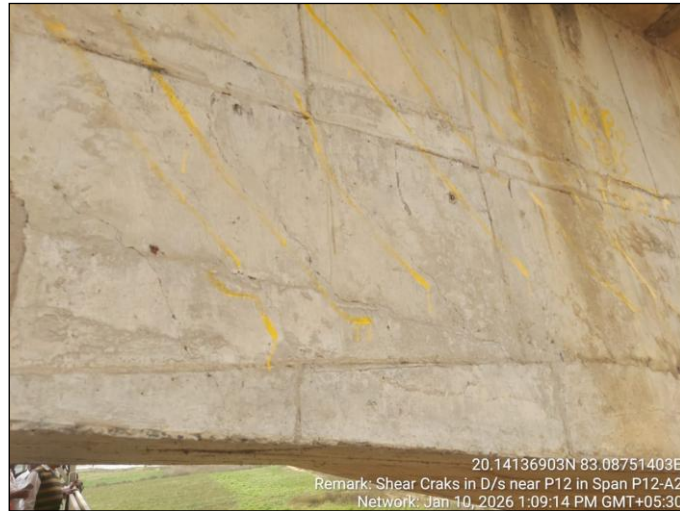
Photo 10(e): A view of cracks on U/S in the span P1-A1 of Tel Bridge of the Kalahandi Section.

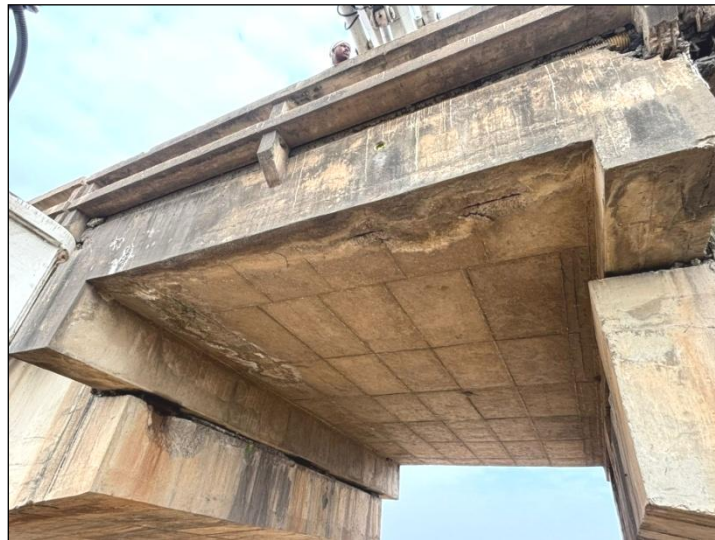
(span P11-P12 as per OWD)

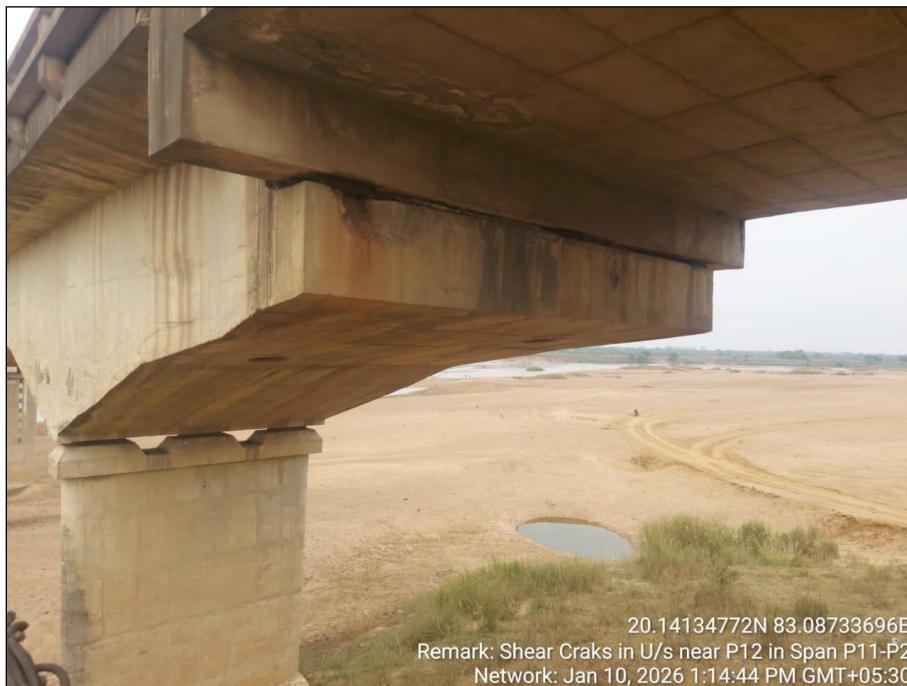
(span P11-P12 as per OWD)

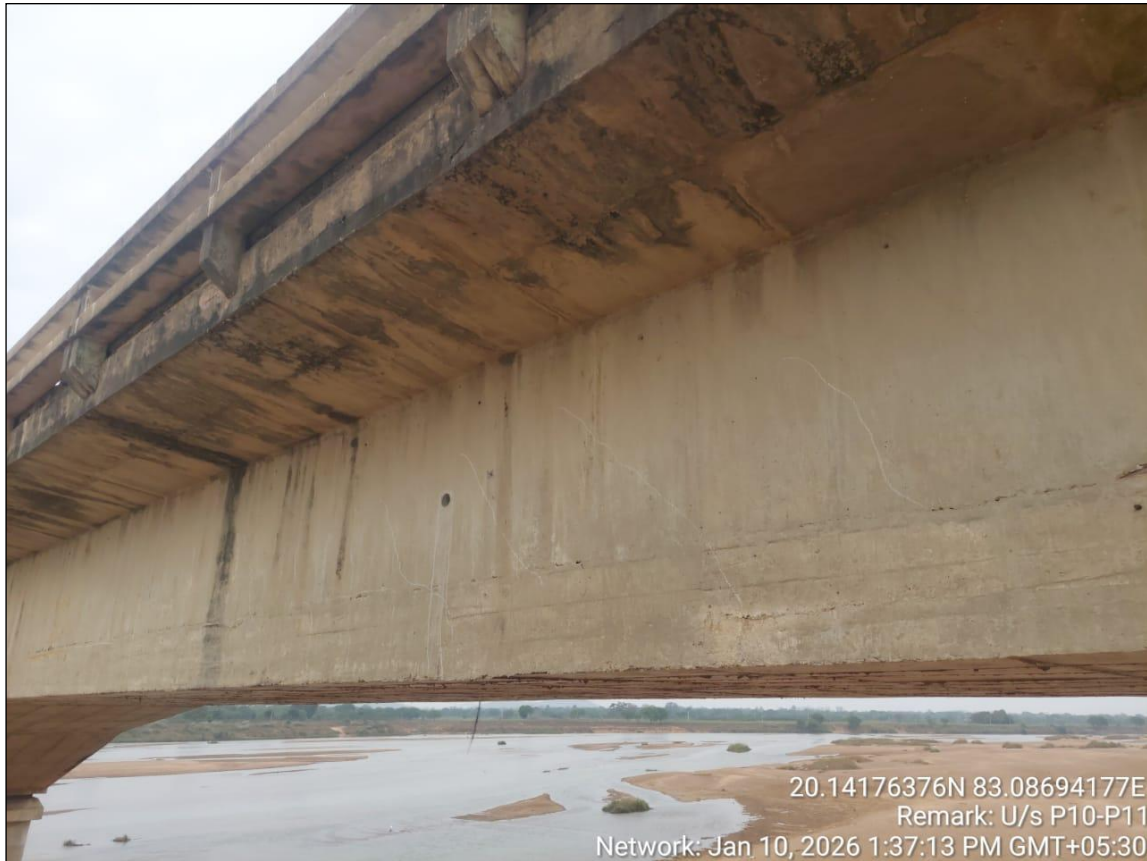
Photo 13: A view of cracks on the Web(u/s) in the span P2-P3 of the HL Tel Bridge at 27/500 Km on Bhawanipatna–Khariar Road in the Kalahandi Division

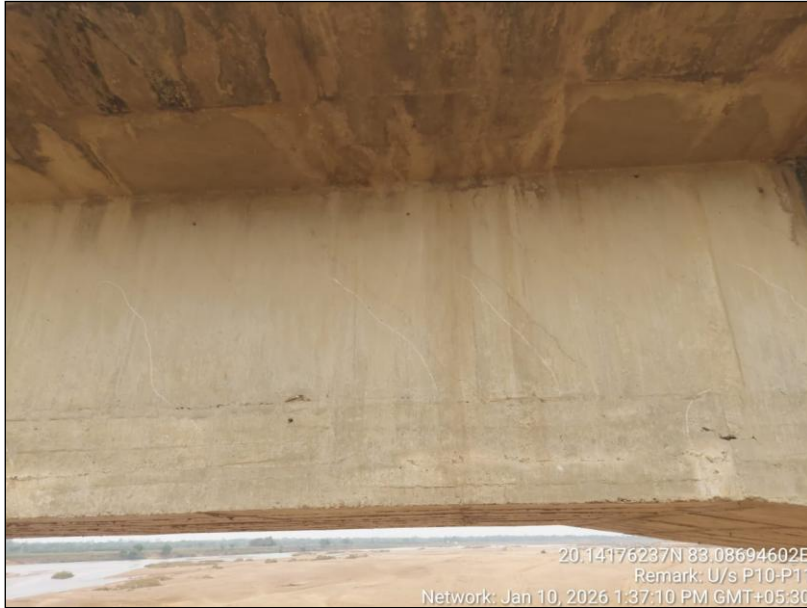
Photo 14(a): A view of cracks on the Web (u/s) in the span P2-P3 of the HL Tel Bridge at 27/500 Km on Bhawanipatna–Khariar Road in the Kalahandi Division.

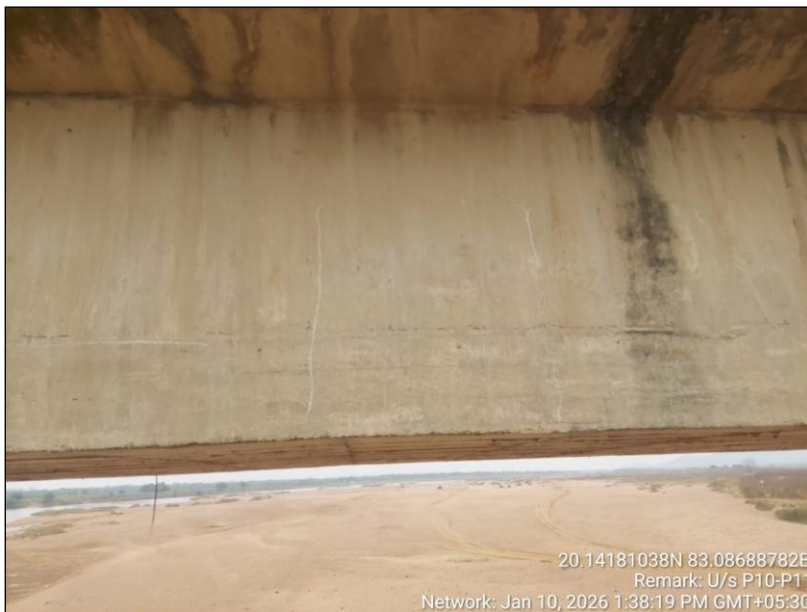
Photo 14(b): A view of cracks on the web (u/s) in the Span P2-P3 of H.L Bridge at 27/500 Km on Bhawanipatna–Khariar Road in the Kalahandi Division.

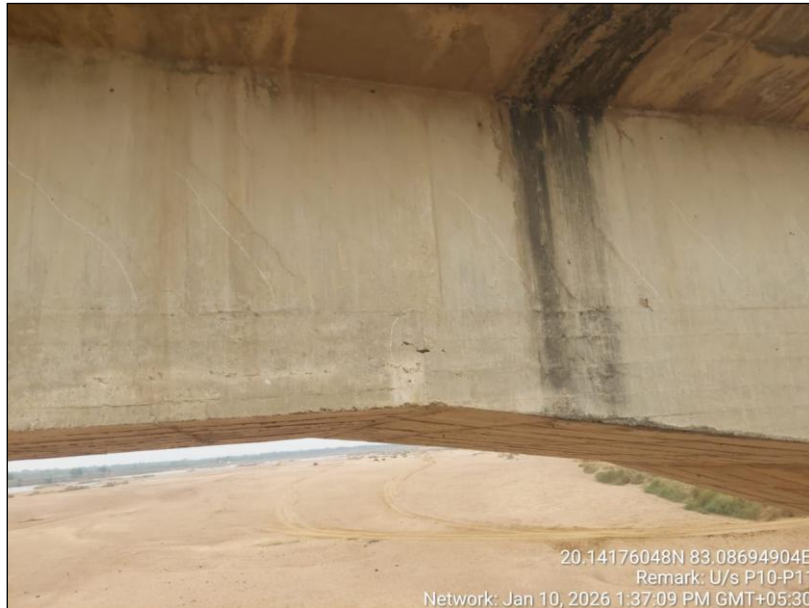
Photo 14(c): A view of cracks on web in the Span P2-P3 of H.L Bridge at 27/500 Km on Bhawanipatna–Khariar Road in the Kalahandi Division

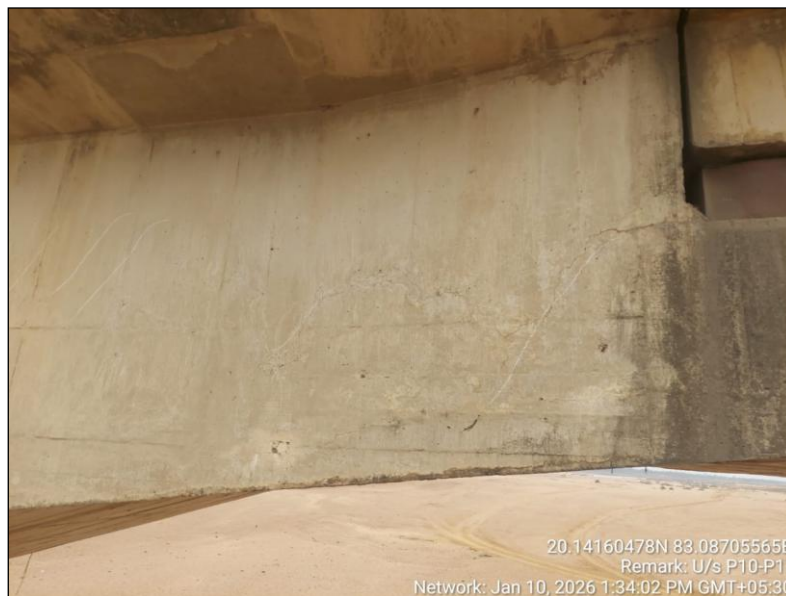
Photo 15: A view of cracks on web near articulation in the Span P2-P3 of H.L Bridge at 27/500 Km on Bhawanipatna–Khariar Road in the Kalahandi Division

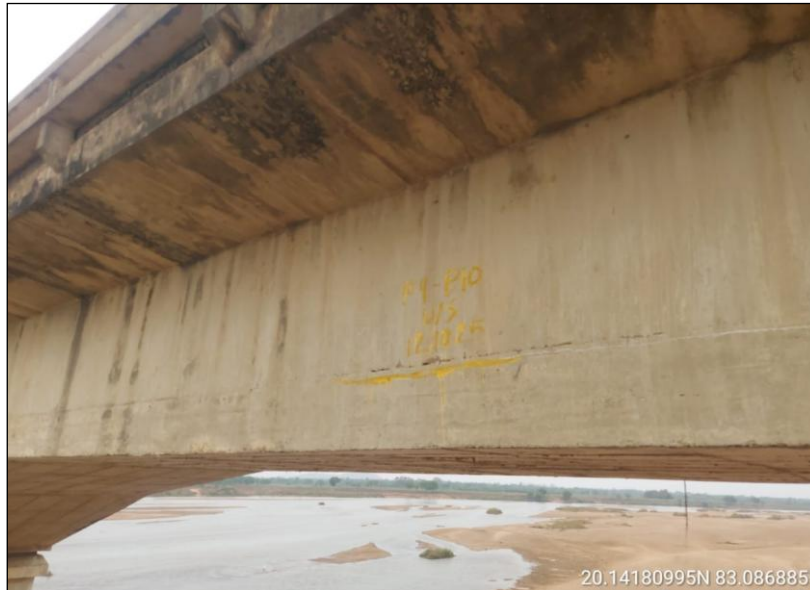
Photo 16: A view of the Web (u/s) in the Span P3-P4 of H.L Bridge at 27/500 Km on Bhawanipatna–Khariar Road in the Kalahandi Division.

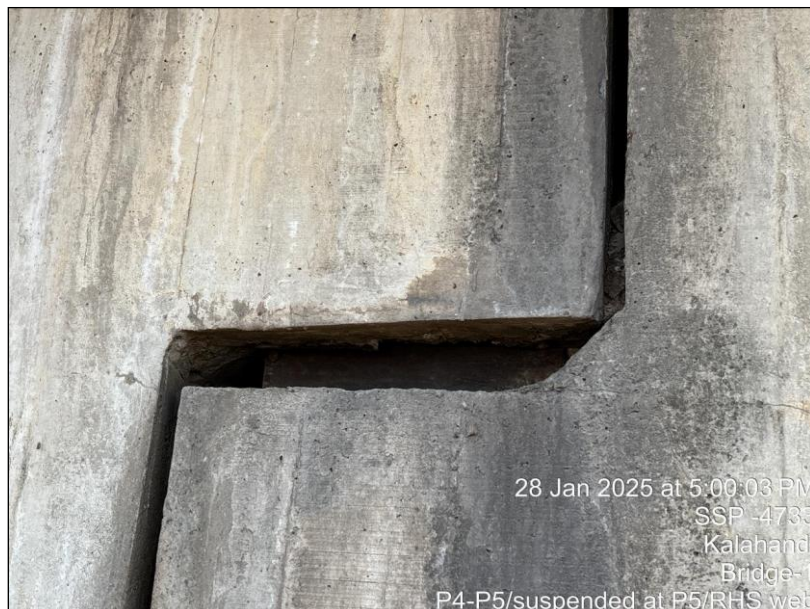
Photo 17: A view of Rocker bearing in suspended Span P4-P5 of H.L Bridge at 27/500 Km on Bhawanipatna–Khariar Road in the Kalahandi Division

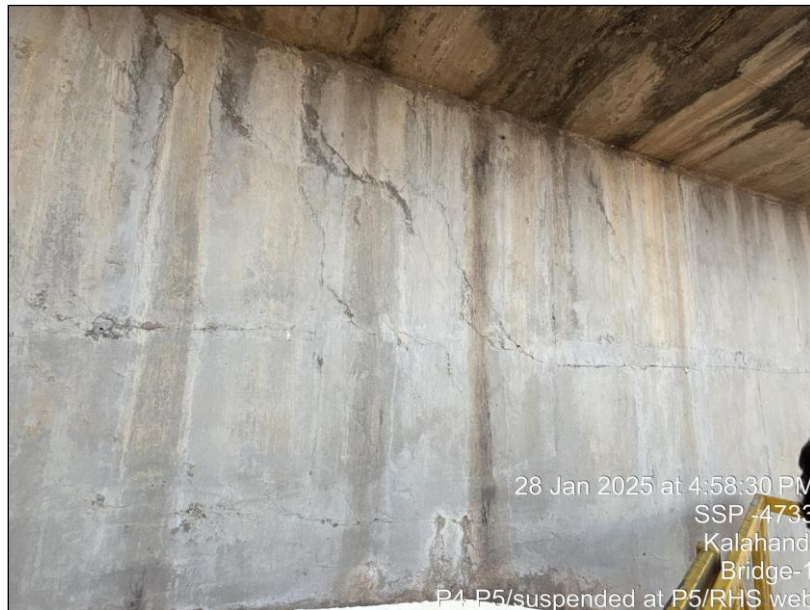
Photo 18: A view of Cracks on RHS Web near Pier P-5 in the Span P4-P5 of H.L Bridge at 27/500 Km on Bhawanipatna – Khariar Road in the Kalahandi Division.

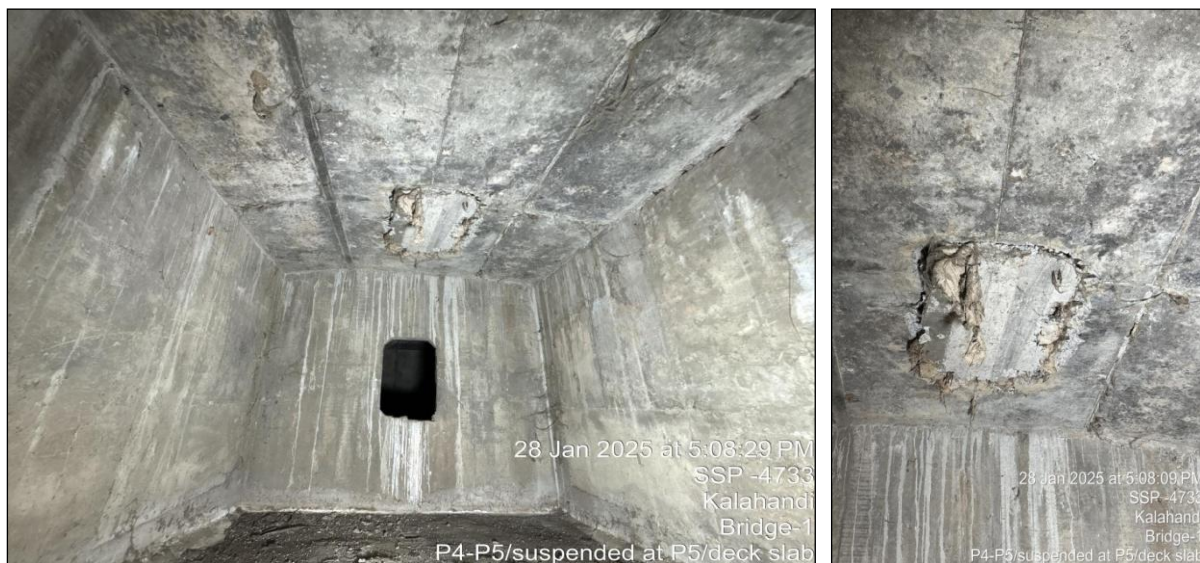
Photo 19: A view of repaired shear punching on the deck slab near pier P-5 in the Span P4-P5 of H.L Bridge at 27/500 Km on Bhawanipatna – Khariar Road in the Kalahandi Division.

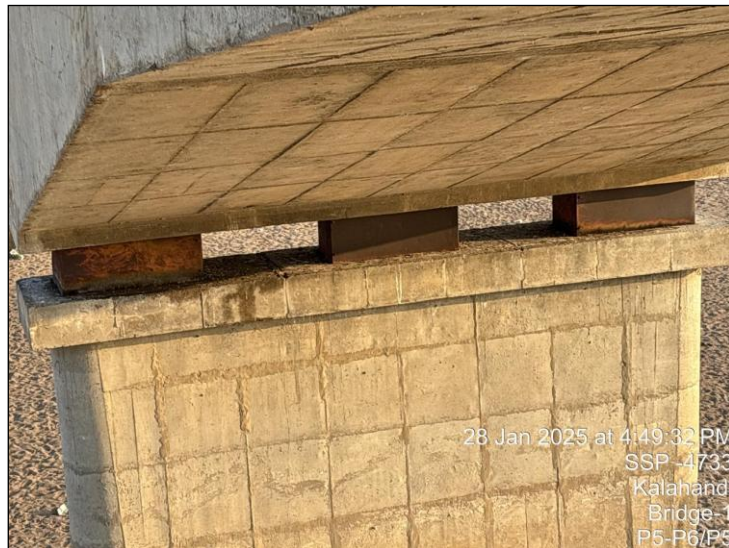
Photo 20: A view of Cut-Roller-cum-Rocker bearing on Pier P-5 in the Span P5-P6 of H.L Bridge at 27/500 Km on Bhawanipatna – Khariar Road in the Kalahandi Division

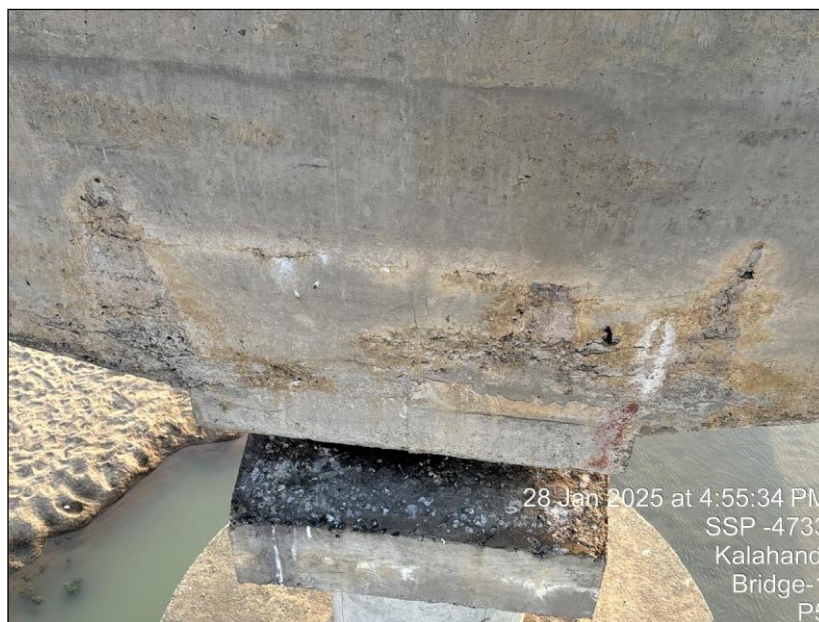
Photo 21: A view of cracks and honeycombing on Pier head at Pier P-5 in the Span P5-P6 of H.L Bridge at 27/500 Km on Bhawanipatna – Khariar Road in the Kalahandi Division

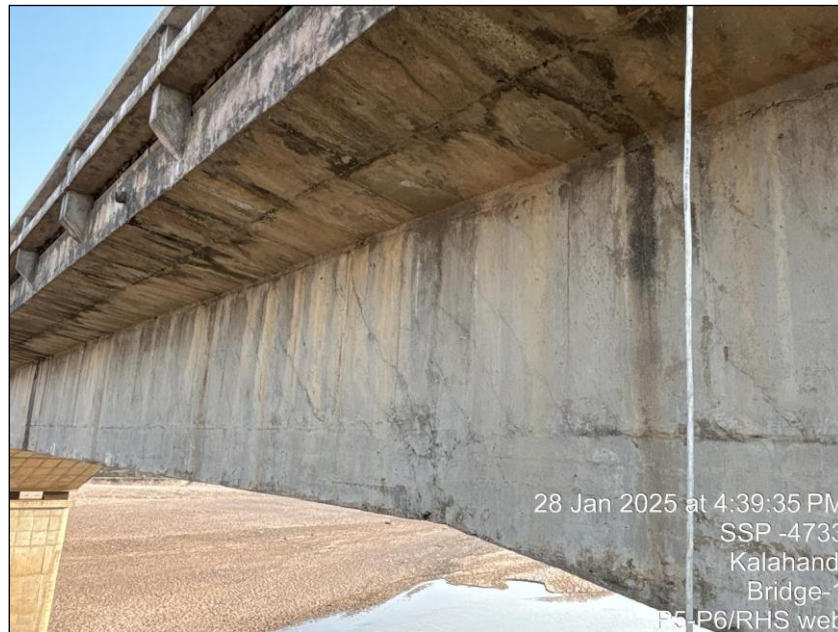
Photo 22: A view of cracks on RHS Web in the span P-5-P6 of H.L Bridge at 27/500 Km on Bhawanipatna – Khariar Road in the Kalahandi Division.

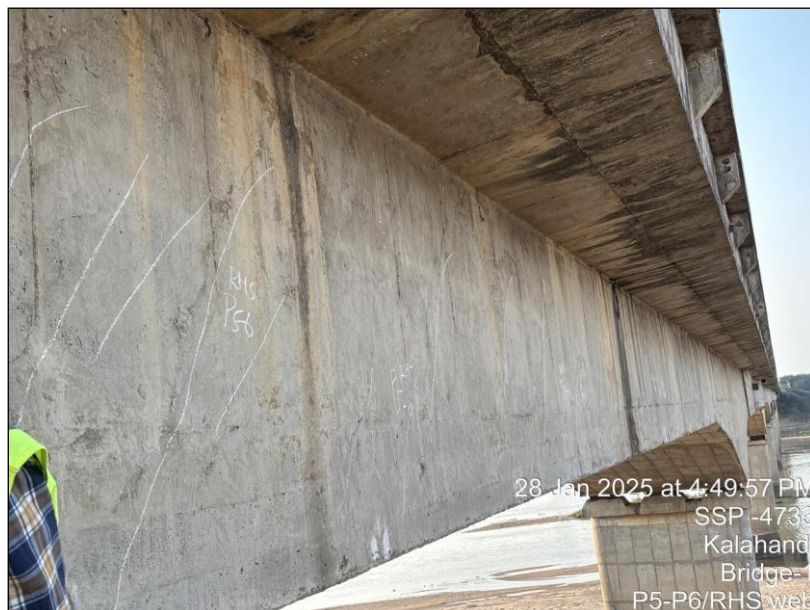
Photo 23: A view of Cracks on RHS web in the span P5-P6 of H L Bridge at 27/500 Km on Bhawanipatna–Khariar Road in the Kalahandi Division.

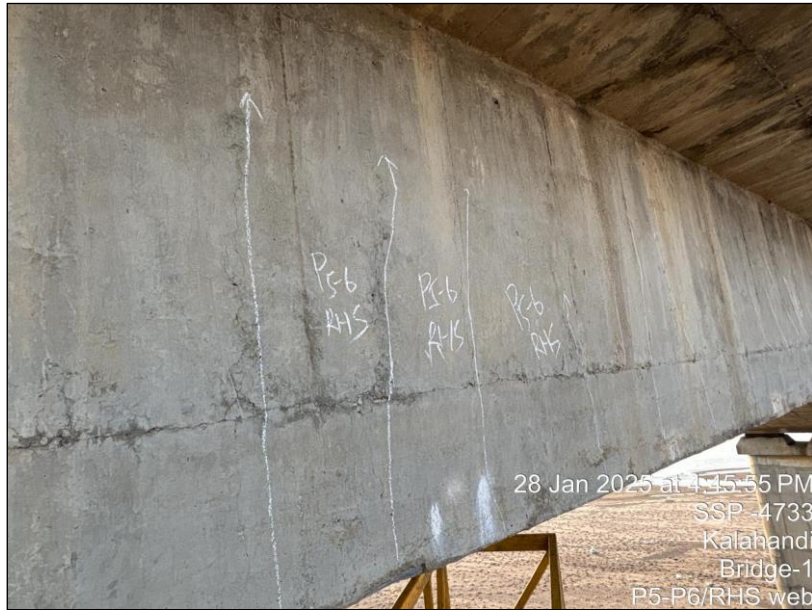
Photo 24: A view of Cracks on RHS web in the span P5-P6 of H L Bridge at 27/500 Km on Bhawanipatna – Khariar Road in the Kalahandi Division

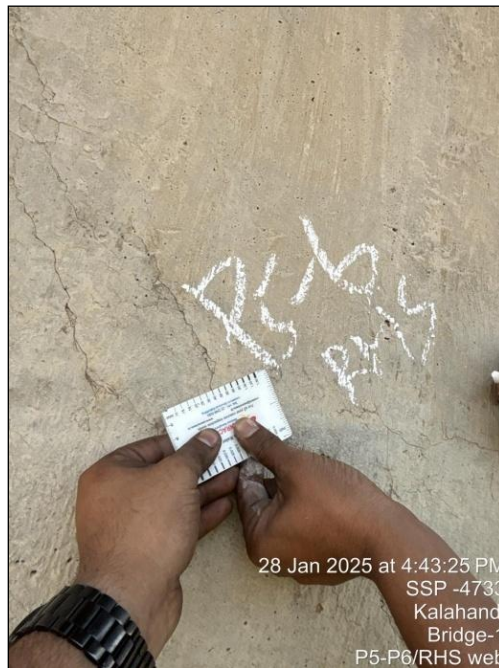
Photo 25: A view of crack width measurement (0.40mm) on RHS web in the span P5-P6 of H.L Bridge at Km 27/500 on Bhawanipatna – Khariar Road in the Kalahandi Division.

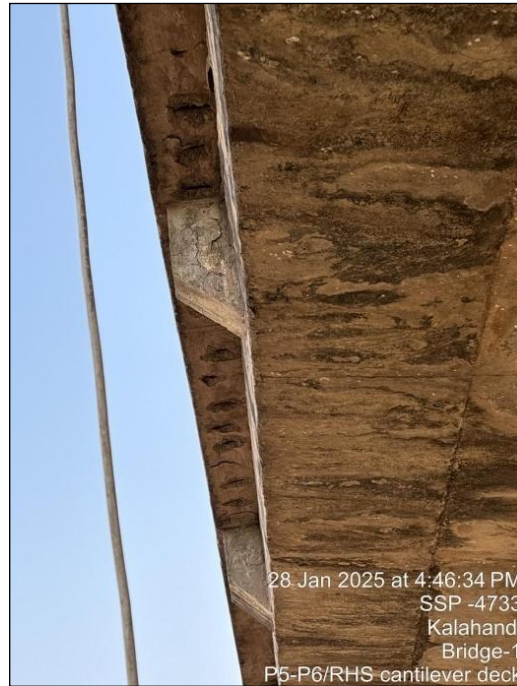
Photo 26: A view of cracks and exposed reinforcement on cantilever deck slab in the Span P5-P6 of H.L Bridge at 27/500 Km on Bhawanipatna – Khariar Road in the Kalahandi Division.

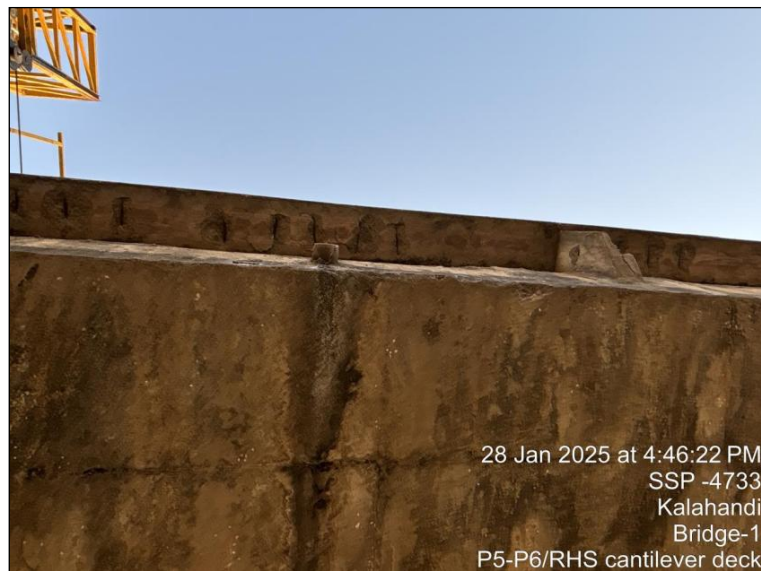
Photo 27: A view of cracks and exposed reinforcement and seepage through drainage spout on cantilever deck slab in the Span P5-P6 of H.L Bridge at 27/500 Km on Bhawanipatna – Khariar Road in the Kalahandi Division.

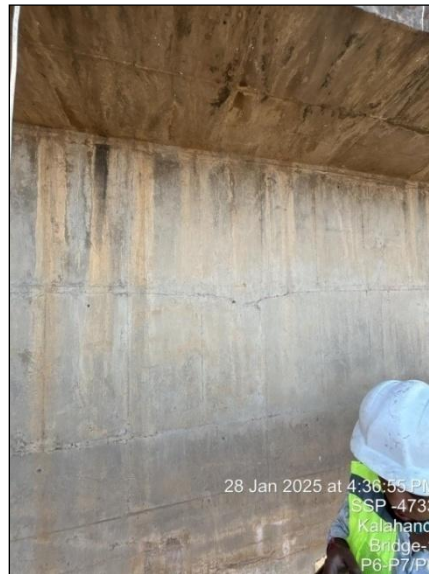
Photo 28: A view of horizontal cracks on Web at Pier P-6 in the Span P6-P7 of H L Bridge at 27/500 Km on Bhawanipatna–Khariar Road in the Kalahandi Division.

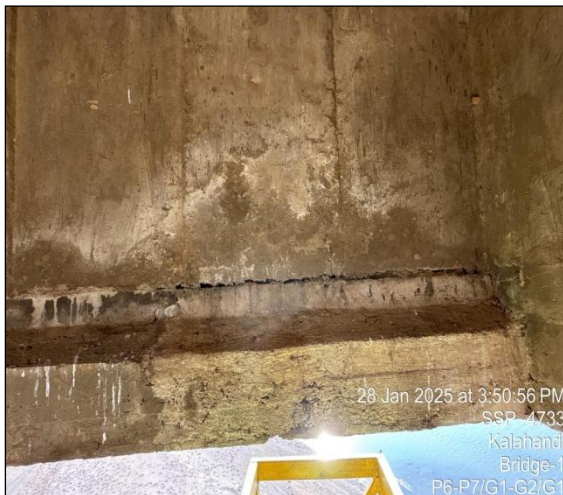
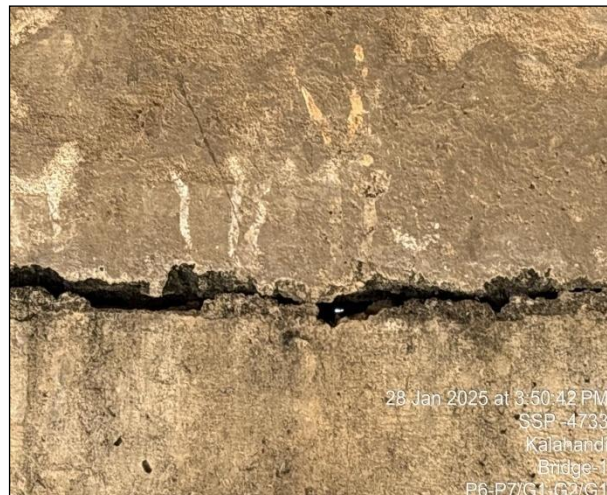
Photo 29: A view of crack on Cross girder Between girders G1-G2 near Pier P-6 in the Span P6-P7 of H.L Bridge at 27/500 Km on the Bhawanipatna–Khariar Road in the Kalahandi Division

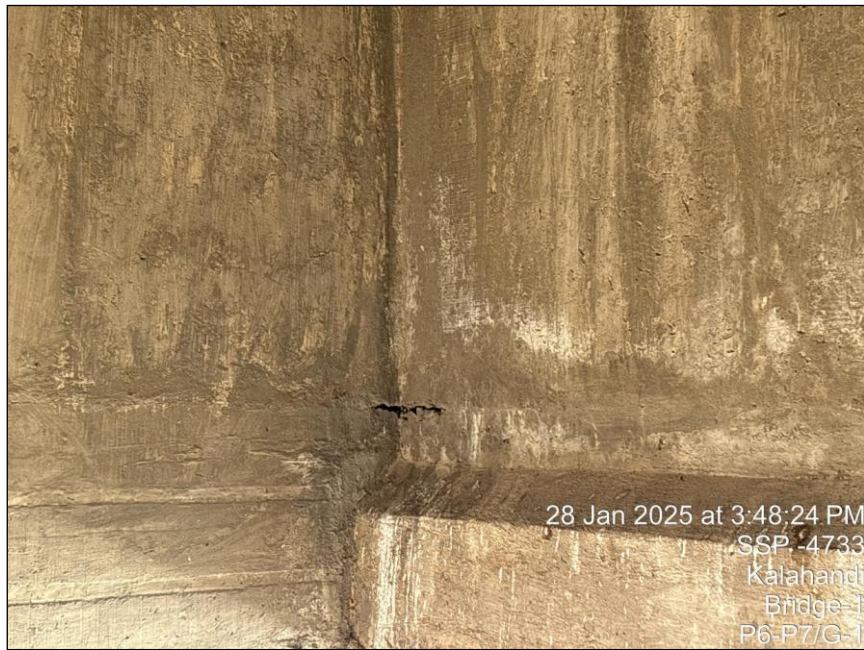
Photo 30: A view of Honeycombing on Girder-1 in the Span P6-P7 of H L Bridge at 27/500 Km on Bhawanipatna – Khariar Road in the Kalahandi Division

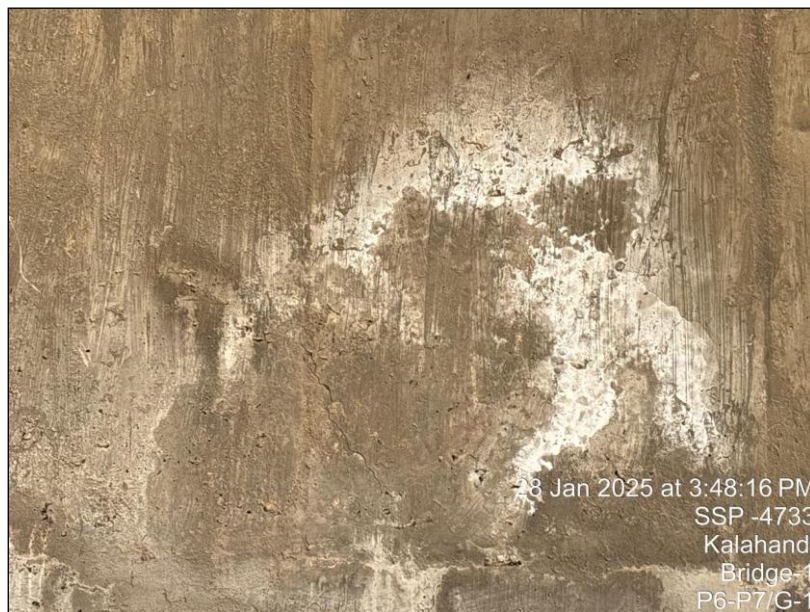
Photo 31: A view of Cracks on Girder-1 in the Span P6-P7 of H.L Bridge at 27/500 Km on Bhawanipatna – Khariar Road in the Kalahandi Division

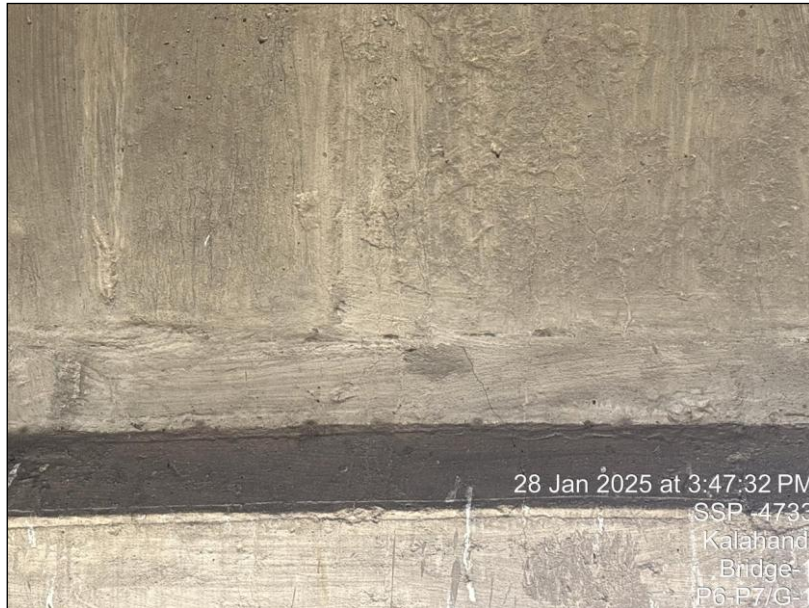
Photo 32: A view of Cracks on the Girder-1 in the Span P6-P7 of H.L Bridge at 27/500 Km on Bhawanipatna – Khariar Road in the Kalahandi Division

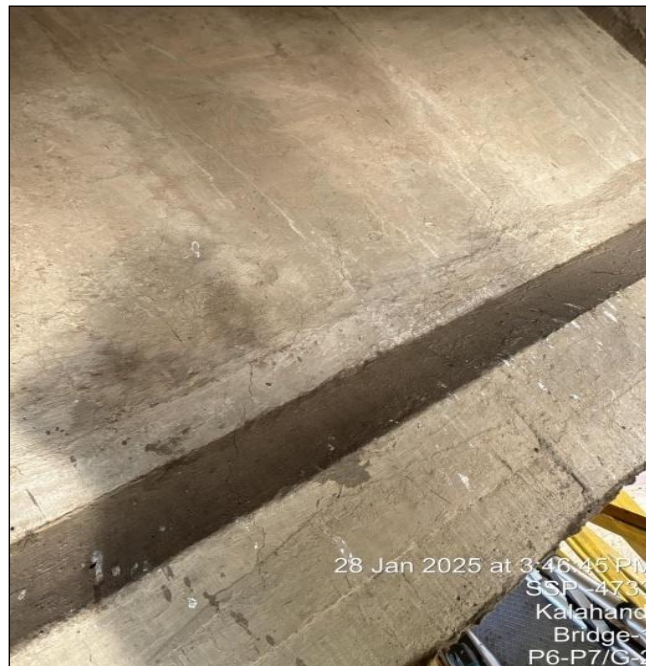
Photo 33: A view of Cracks on Girder-2 in the Span P6-P7 of H.L Bridge at 27/500 Km on Bhawanipatna – Khariar Road in the Kalahandi Division

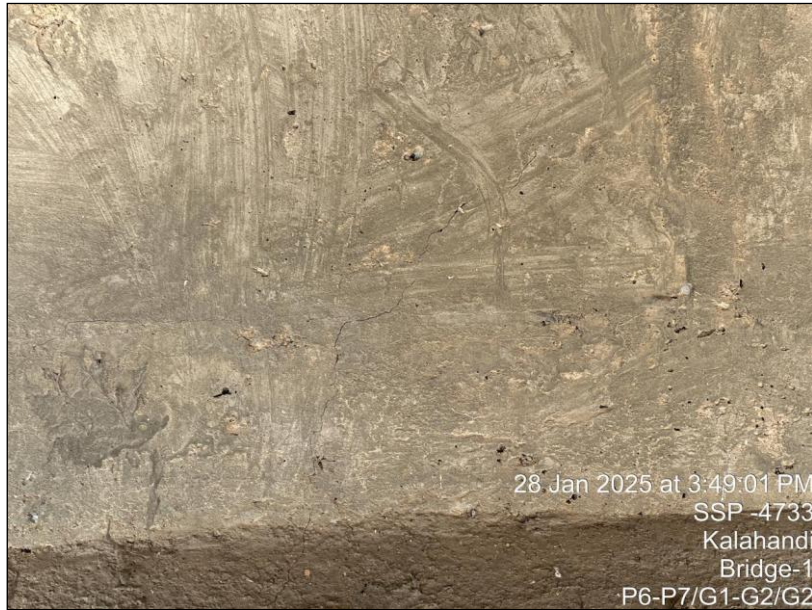
Photo 34: A view of Crack on Girder-2 in the Span P6-P7 of H.L Bridge at 27/500 Km on Bhawanipatna – Khariar Road in the Kalahandi Division

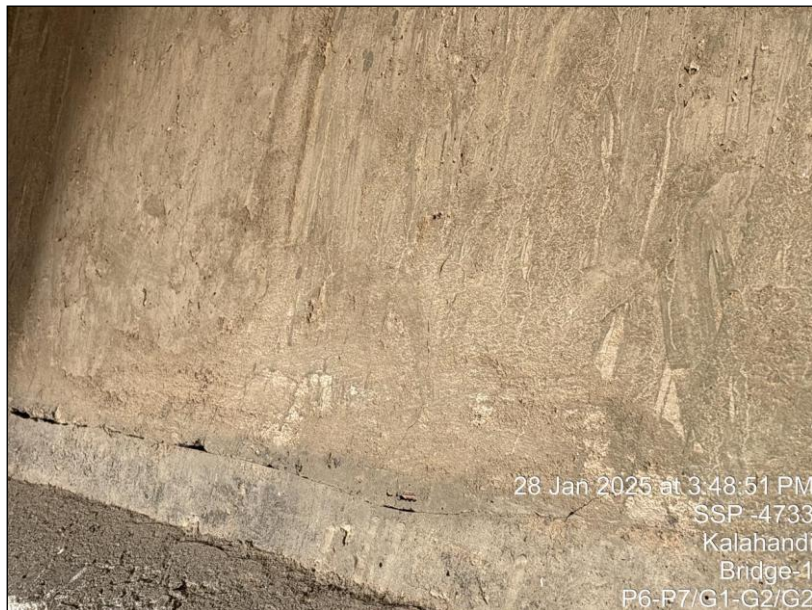
Photo 35: A view of Cracks on Girder-2 in the Span P6-P7 of H.L Bridge at 27/500 Km on Bhawanipatna – Khariar Road in the Kalahandi Division
