लोक निर्माण विभाग, ओडिशा सरकार के अंतर्गत, पुलों की आधुनिक परीक्षण प्रक्रियाओं का उपयोग करते हुए ओडिशा राज्य के रोड नेटवर्क के मेजर और माईनर ब्रिजो के स्थिति का आकलन और उपचारात्मक उपायों के लिए सुझाव

अंतिम रिपोर्ट

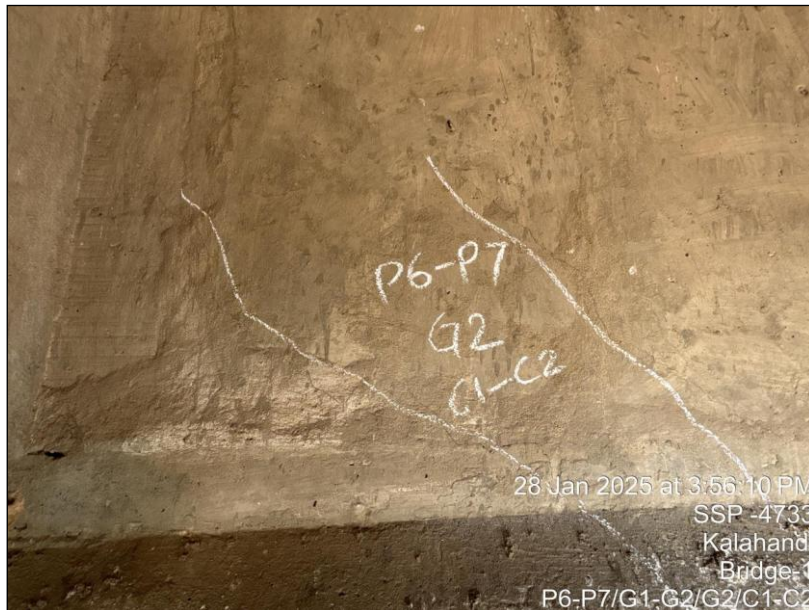
Photo 36: A view of Cracks on Girder G-2 between Cross Girder C1, C2 in the Span P6 P7 of HL Bridge at Km 27/500 on the Bhawanipatna–Khariar Road in the Kalahandi Division

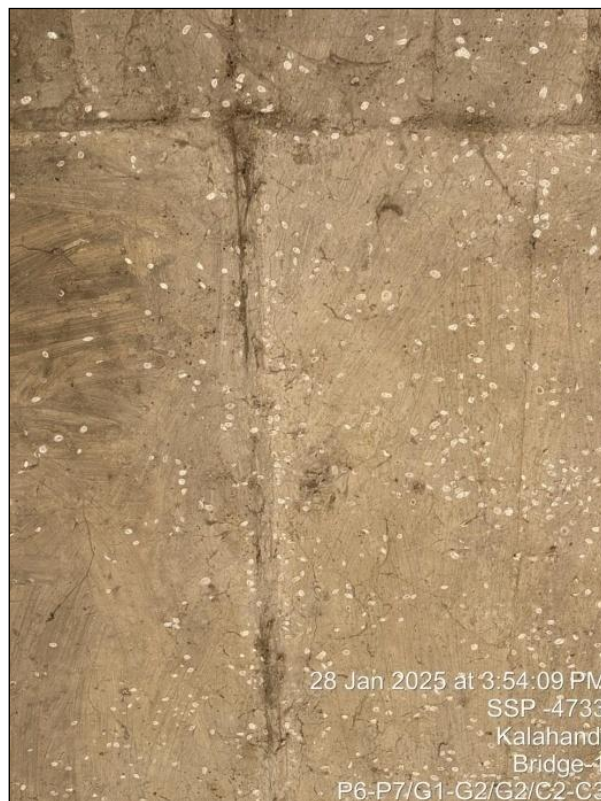
Photo 37: A view of Deck Slab Between girder G1-G2 and Cross girder C2-C3 of H.L Bridge at 27/500 Km on Bhawanipatna–Khariar Road in the Kalahandi Division.

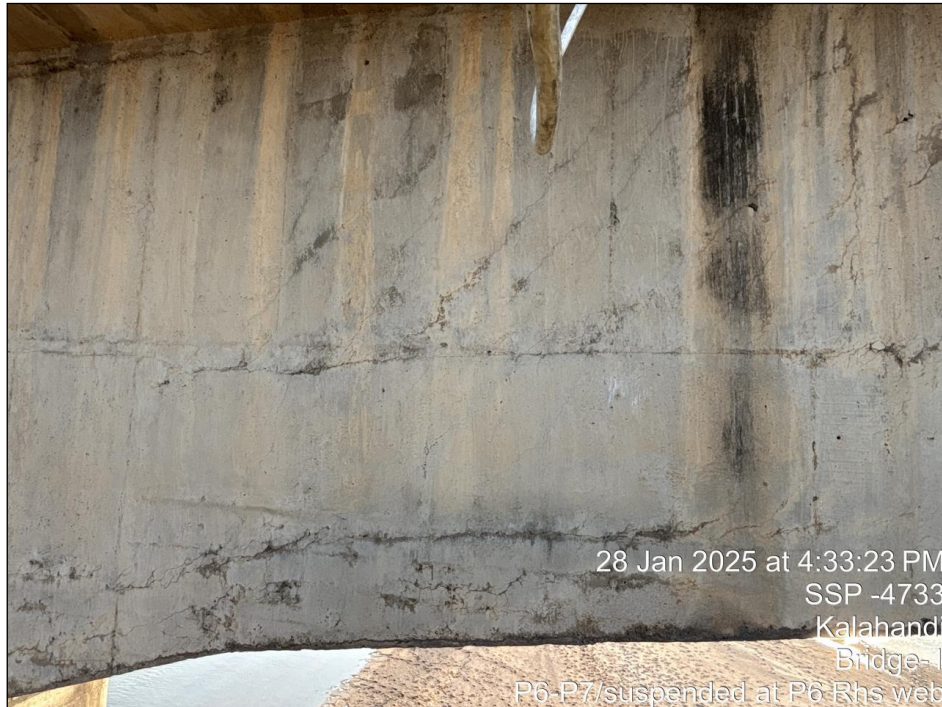
Photo 38: A view of Crack on RHS web near Pier P-6 in the Span P6-P7 of HL Bridge at 27/500 Km on Bhawanipatna–Khariar Road in the Kalahandi Division.

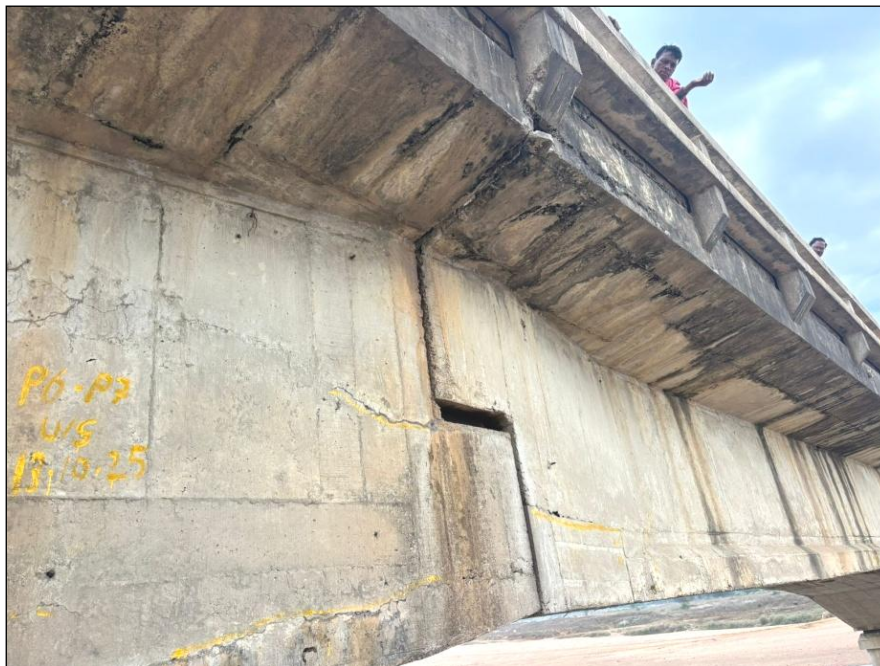
Photo 39: A view of Span P6-P7 of HL Bridge at 27/500 Km on Bhawanipatna–Khariar Road in the Kalahandi Division.

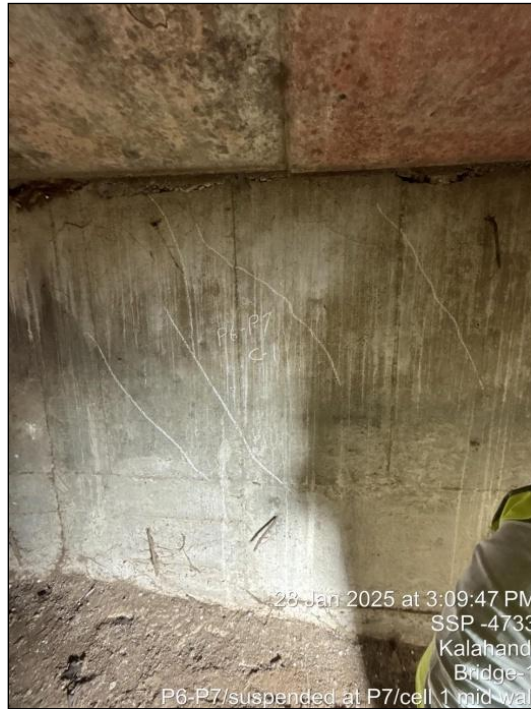
Photo 40: A view of Cracks on middle web in cell-1 near Pier P-7 in the Span P6-P7 of H.L Bridge at 27/500 Km on Bhawanipatna–Khariar Road in the Kalahandi Division

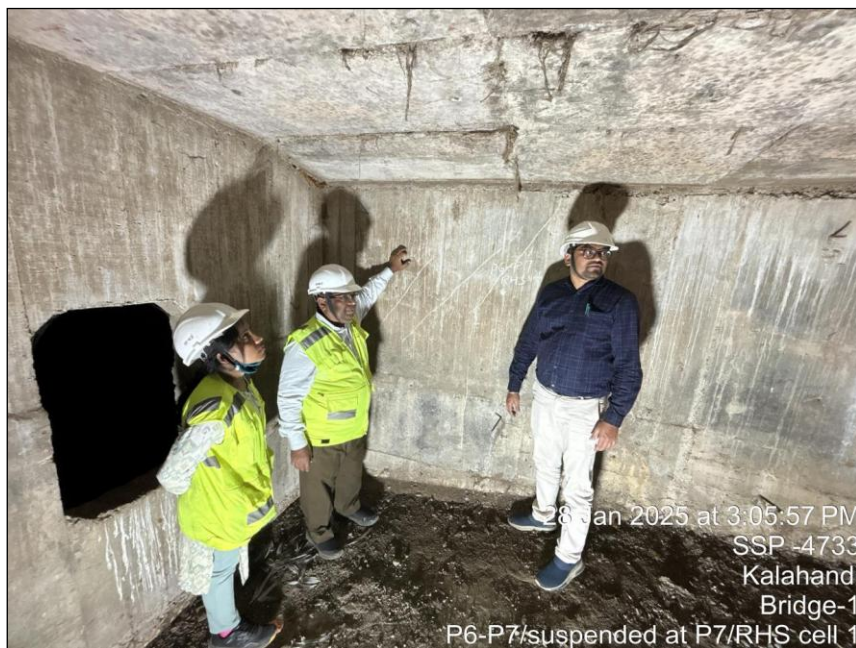
Photo 41: A view of inspection inside RHS cell-1 near Pier P-7 of Box girder in the Suspended Span P6-P7 of HL Bridge at 27/500 Km on Bhawanipatna–Khariar Road in the Kalahandi Division.

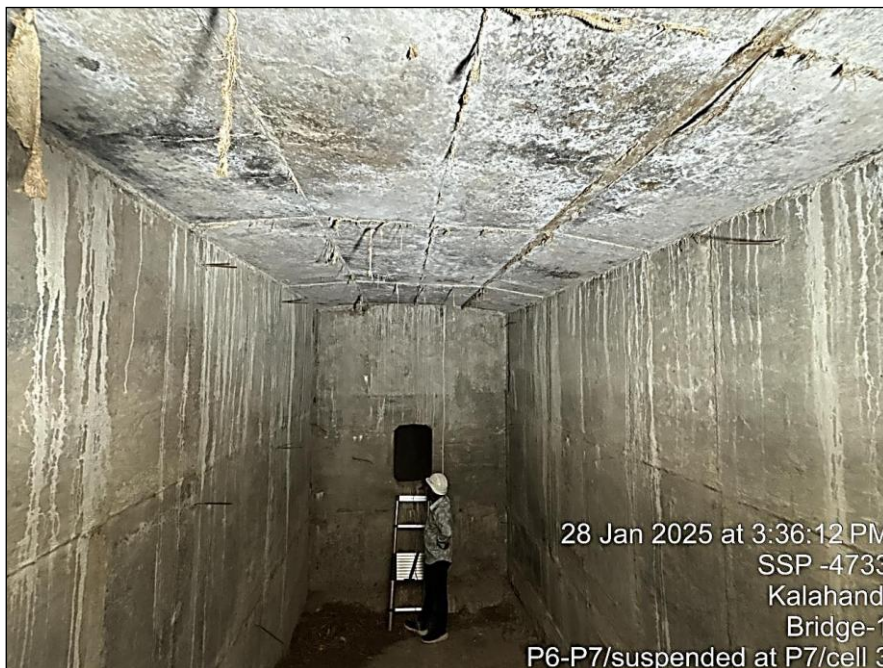
Photo 47: A view of cracks and leaching on Deck Slab in Cell-3 (longitudinal) of Box girder in the suspended Span P6-P7 of H.L Bridge at 27/500 Km on Bhawanipatna–Khariar Road in the Kalahandi Division

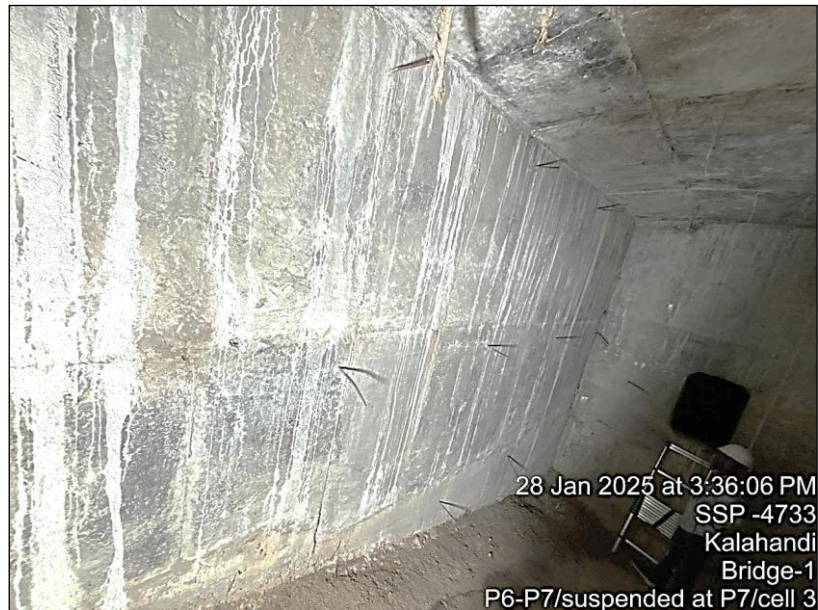
Photo 48: A General view of projected reinforcement on RHS wall of Cell-3 (longitudinal) in the suspended Span P6-P7 of H.L. Bridge at 27/500 Km on Bhawanipatna–Khariar Road in the Kalahandi Division

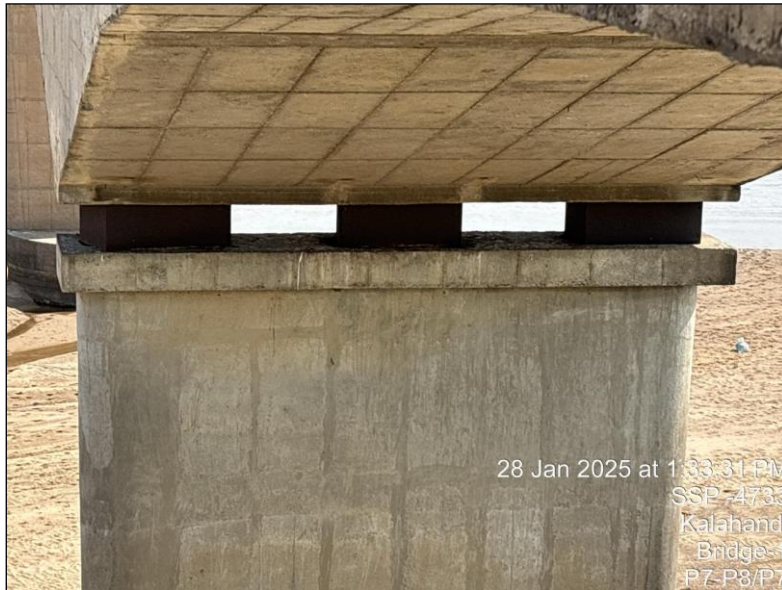
Photo 50: A view of Roller-cum-Rocker bearing at Pier P-7 in the Span P7-P8 of H.L Bridge at 27/500 Km on Bhawanipatna-Khariar Road in the Kalahandi Division.

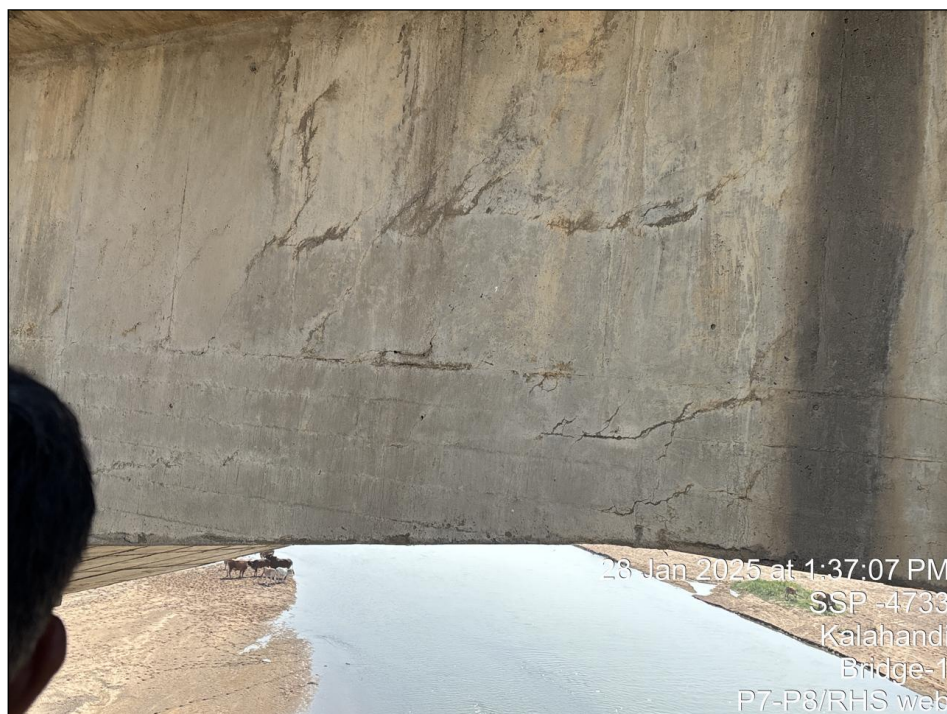
Photo 51: A view of Crack on RHS web in the Span P7-P8 of H.L Bridge at 27/500 Km on Bhawanipatna-Khariar Road in the Kalahandi Division

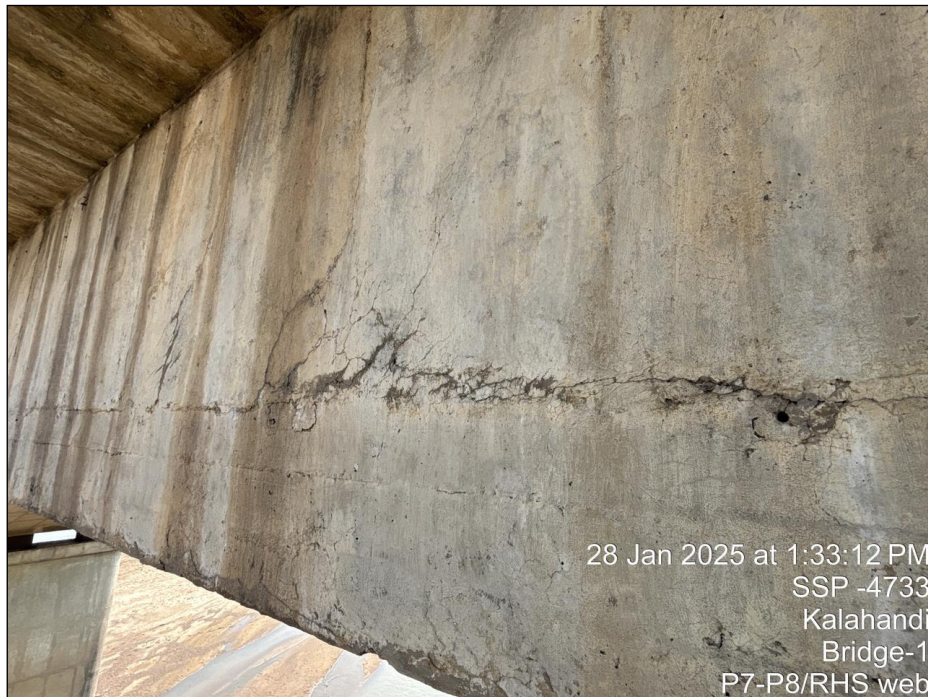
Photo 52: A view of Crack on RHS web in the Span P7-P8 of H.L Bridge at 27/500 Km on Bhawanipatna-Khariar Road in the Kalahandi Division

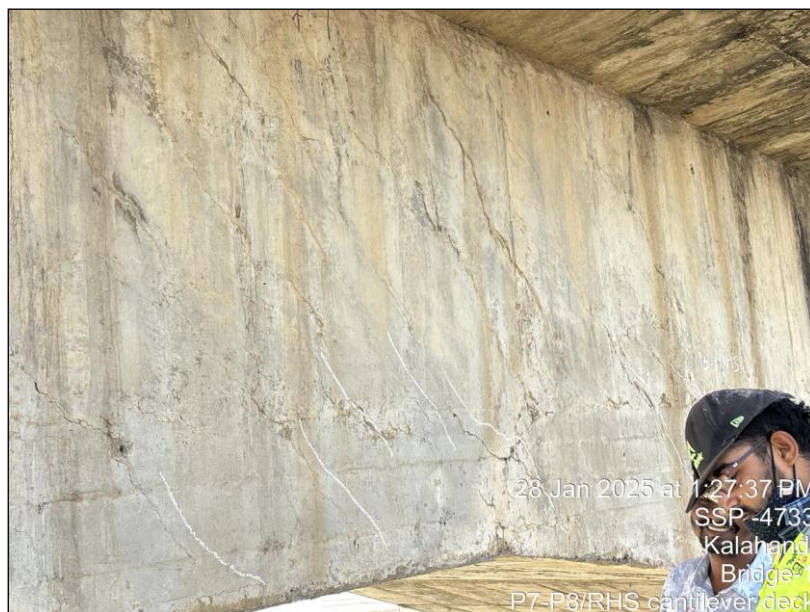
Photo 53: A view of Crack on RHS web in the Span P7-P8 of H.L Bridge at 27/500 Km on Bhawanipatna-Khariar Road in the Kalahandi Division

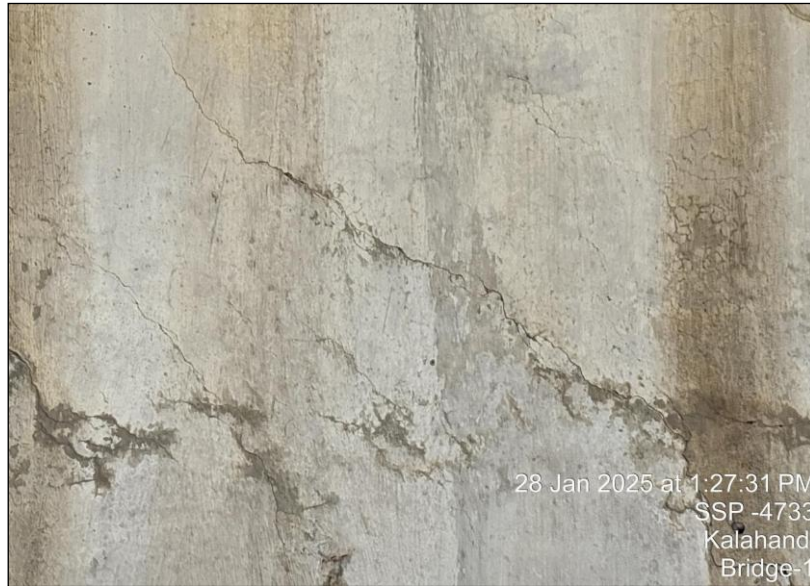
Photo 54: A view of Crack on RHS web in the Span P7-P8 of H.L Bridge at 27/500 Km on Bhawanipatna-Khariar Road in the Kalahandi Division

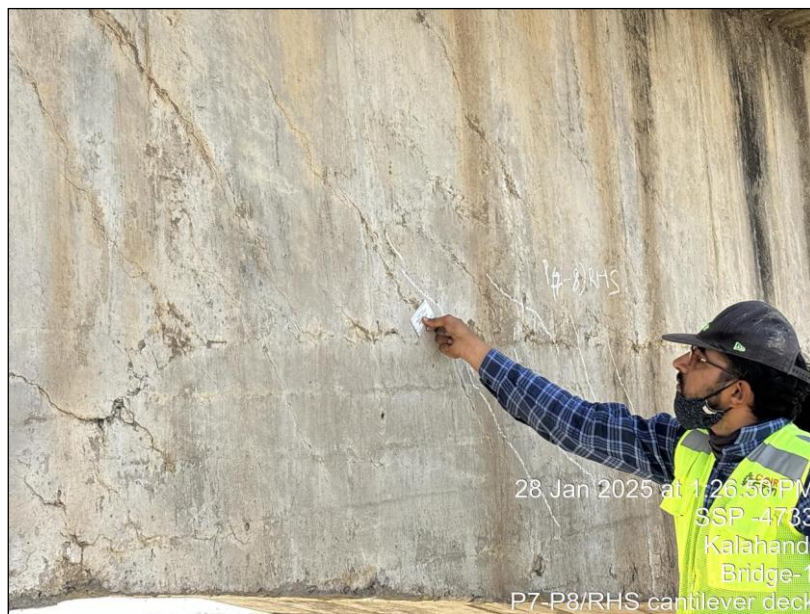
Photo 55: A view of Crack width measurement on RHS web in the Span P7-P8 of HL Bridge at 27/500 Km on Bhawanipatna-Khariar Road in the Kalahandi Division

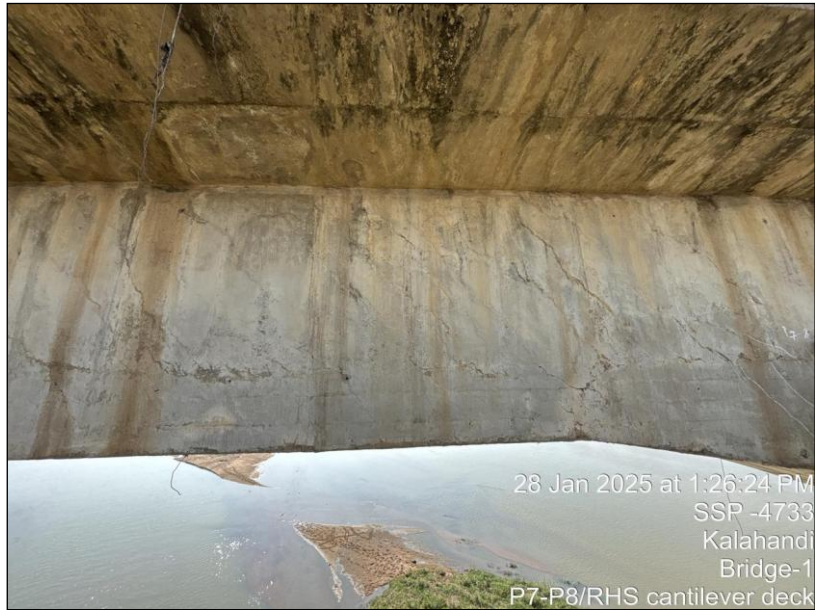
Photo 56: A view of Crack on Web in the Span P7-P8 of H.L Bridge at 27/500 Km on Bhawanipatna-Khariar Road in the Kalahandi Division

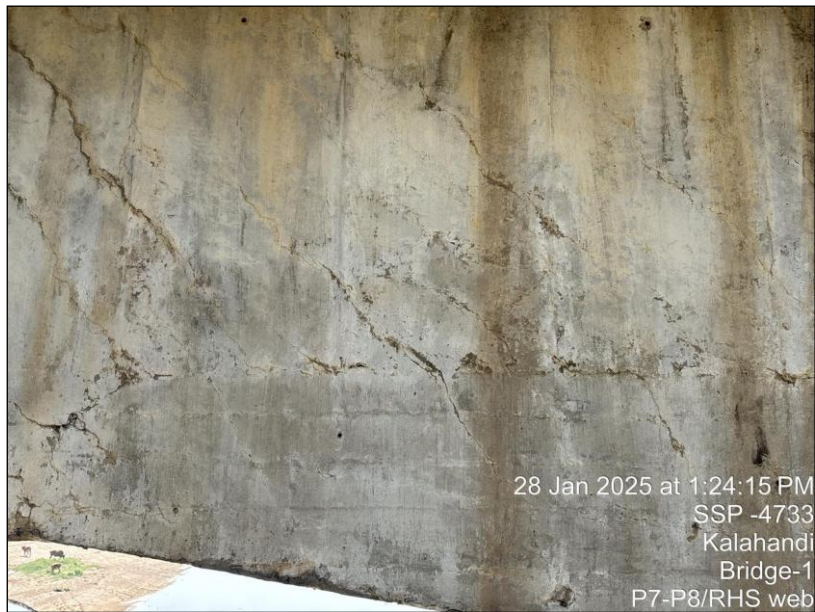
Photo 57: A view of Crack on RHS web in the Span P7-P8 of H.L Bridge at 27/500 Km on Bhawanipatna-Khariar Road in the Kalahandi Division

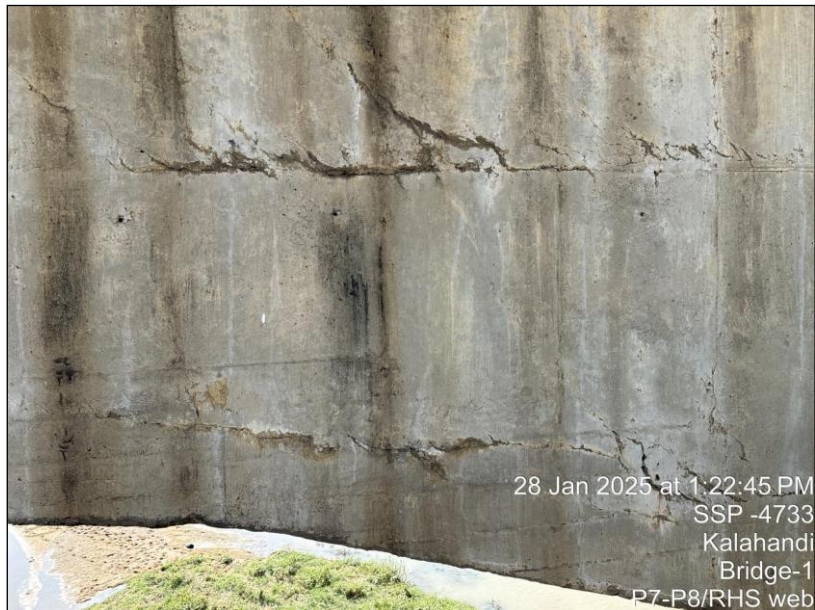
Photo 58: A view of Crack on RHS web in the Span P7-P8 of H.L Bridge at 27/500 Km on Bhawanipatna-Khariar Road in the Kalahandi Division

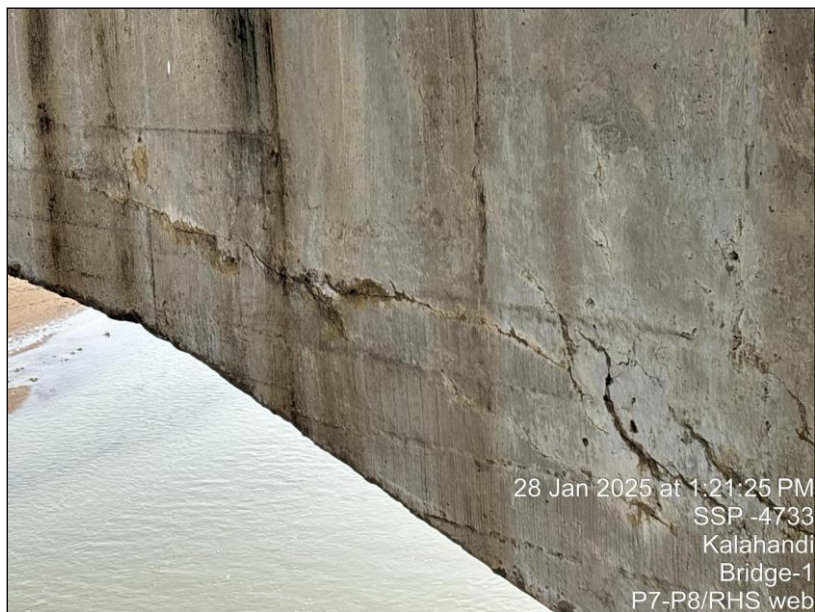
Photo 59: A view of Crack on RHS web in the Span P7-P8 of H.L Bridge at 27/500 Km on Bhawanipatna-Khariar Road in the Kalahandi Division

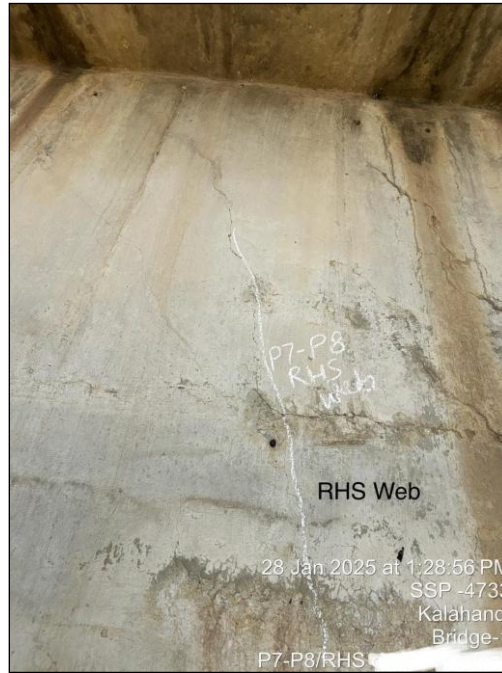
Photo 60: A view of 0.50mm Crack on RHS web in the Span P7-P8 of H L Bridge at 27/500 Km on Bhawanipatna-Khariar Road in the Kalahandi Division

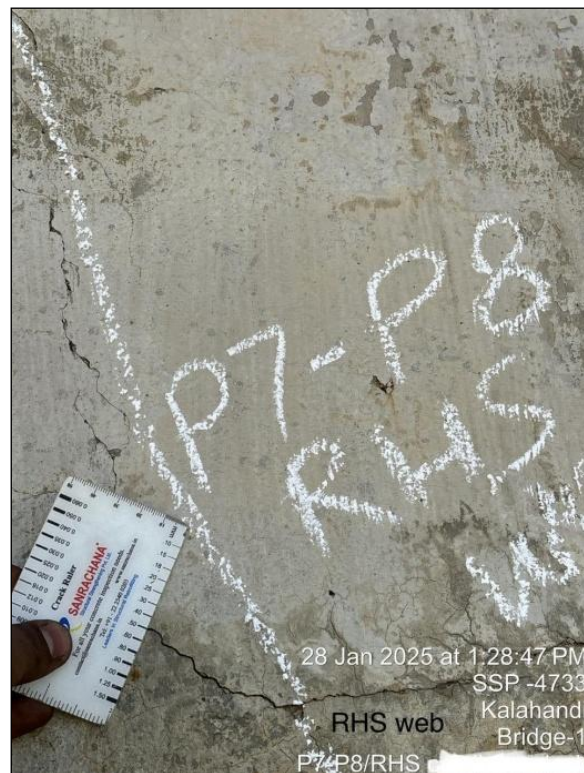
Photo 61: A view of 0.50mm Crack on RHS web in the Span P7-P8 of H.L Bridge at 27/500 Km on Bhawanipatna-Khariar Road in the Kalahandi Division

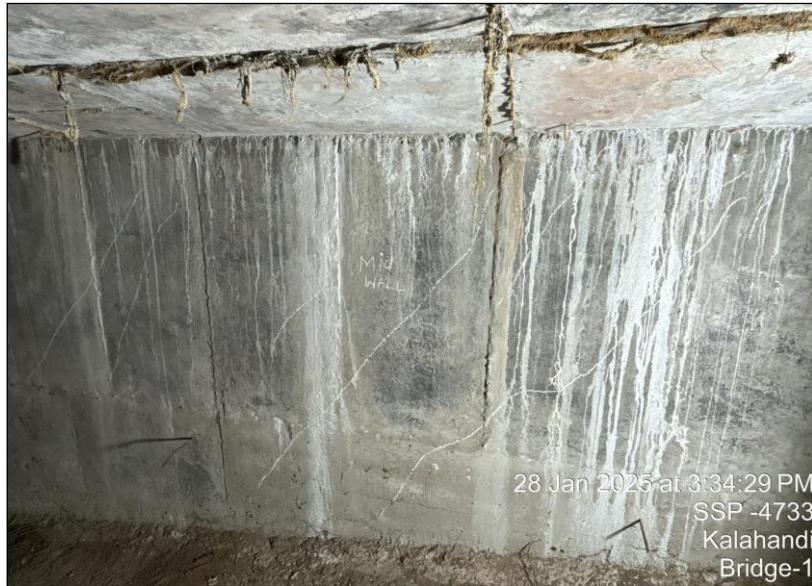
Photo 62: A General view of cracks on Middle wall of Cell-1 near Pier P-7 in the Span P7-P8 of H.L Bridge at 27/500 Km on Bhawanipatna–Khariar Road in the Kalahandi Division

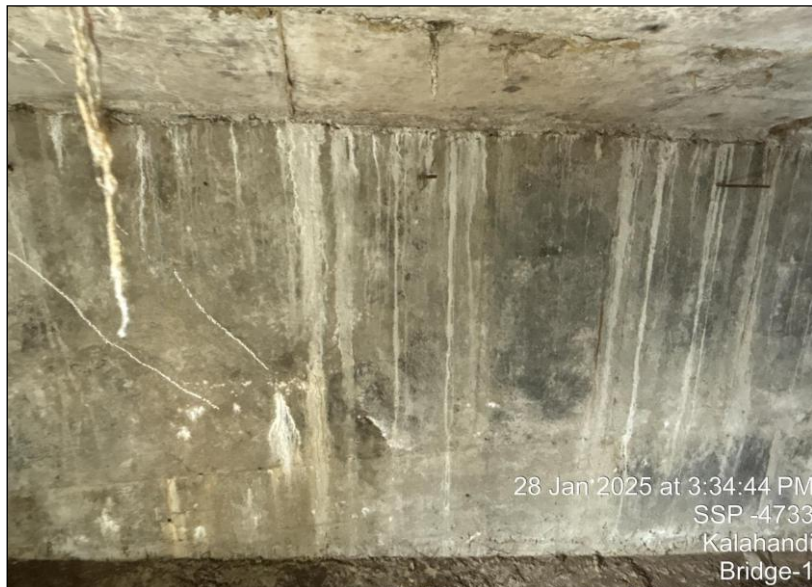
Photo 63: A General view of cracks on RHS web in Cell-1 at Pier P-7 in the Span P7-P8 of H.L Bridge at 27/500 Km on Bhawanipatna–Khariar Road in the Kalahandi Division.

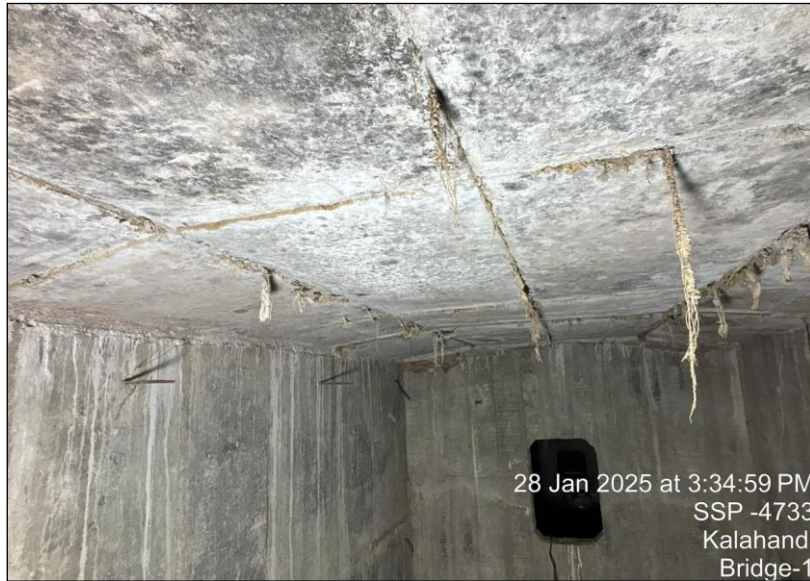
Photo 64: A view of crack on Deck Slab in Cell-1 of Box Girder near Pier P-7 in the Span P7-P8 of H.L Bridge at 27/500 Km on Bhawanipatna-Khariar Road in the Kalahandi Division

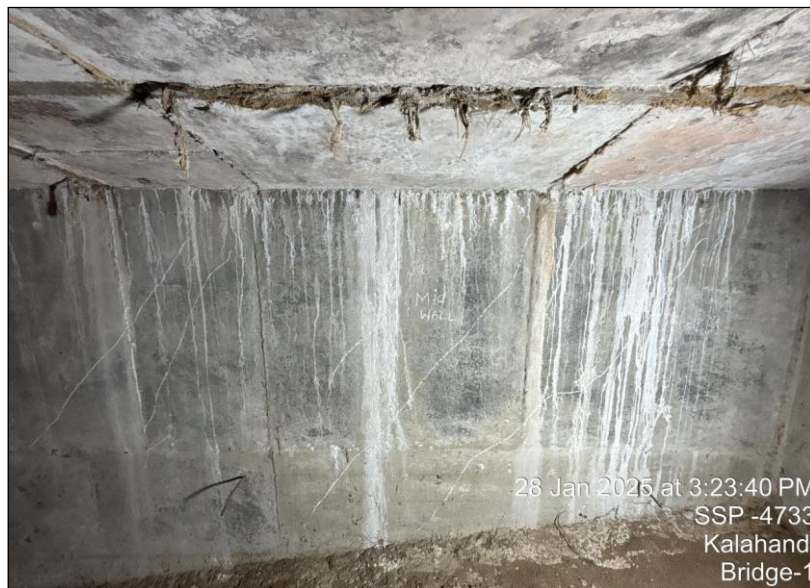
Photo 65: A view of Cracks on Middle web of Cell-1 near Pier P-7 in the Span P7-P8 of H L Bridge at 27/500 Km on Bhawanipatna-Khariar Road in the Kalahandi Division

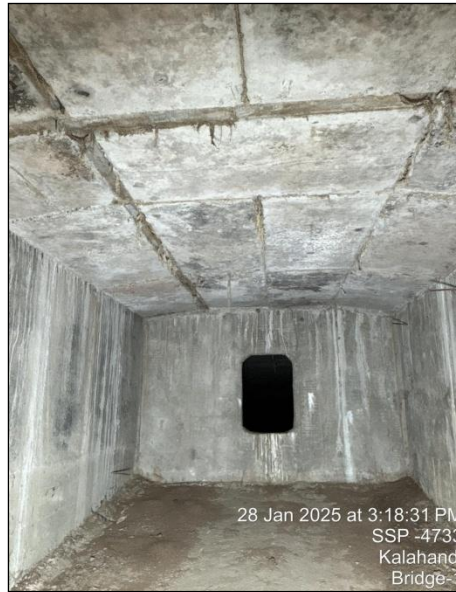
Photo 66: A view of Deck Slab in Cell-1 near pier P-7 in the Span P7-P8 of H L Bridge at 27/500 Km on Bhawanipatna-Khariar Road in the Kalahandi Division.

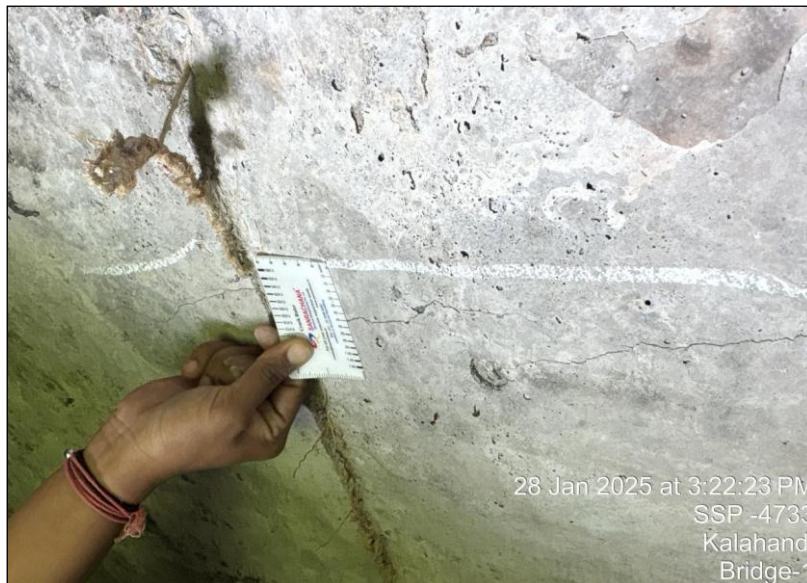
Photo 67: A view of crack width measurement (0.40 mm) on Deck Slab of Cell-1 near Pier P-7 in the Span P7-P8 of H.L Bridge at 27/500 Km on Bhawanipatna-Khariar Road in the Kalahandi Division

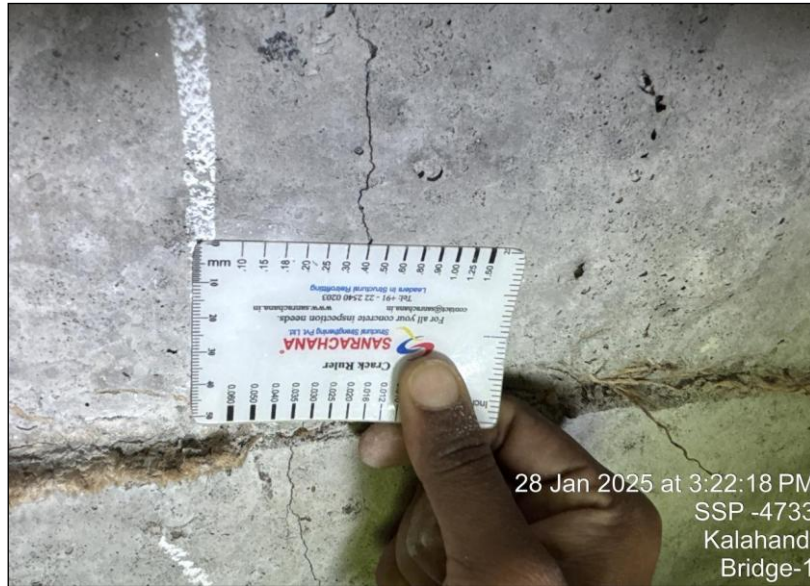
Photo 68: A view of crack width measurement (0.40 mm) on Deck Slab in Cell-1 in the Span P7-P8 of H L Bridge at 27/500 Km on Bhawanipatna-Khariar Road in the Kalahandi Division

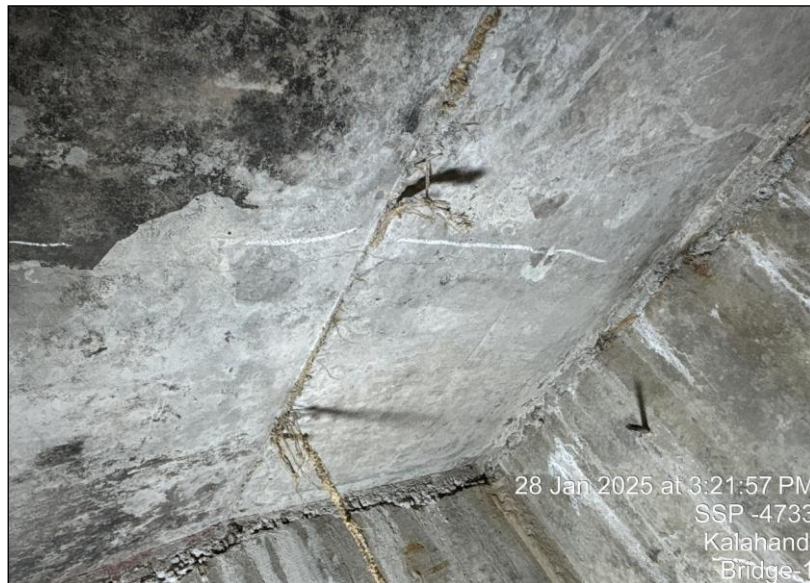
Photo 69: A view of Cracks on Deck Slab in Cell-1 in the suspended Span P7-P8 of H.L Bridge at 27/500 Km on Bhawanipatna-Khariar Road in the Kalahandi Division

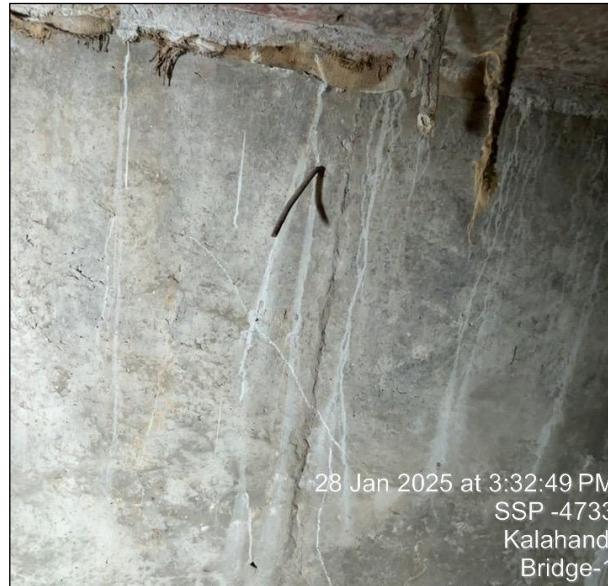
Photo 70: A view of Crack on RHS web of Cell-2 near Pier P-7 in the Span P7-P8 of H.L Bridge at 27/500 Km on Bhawanipatna-Khariar Road in the Kalahandi Division

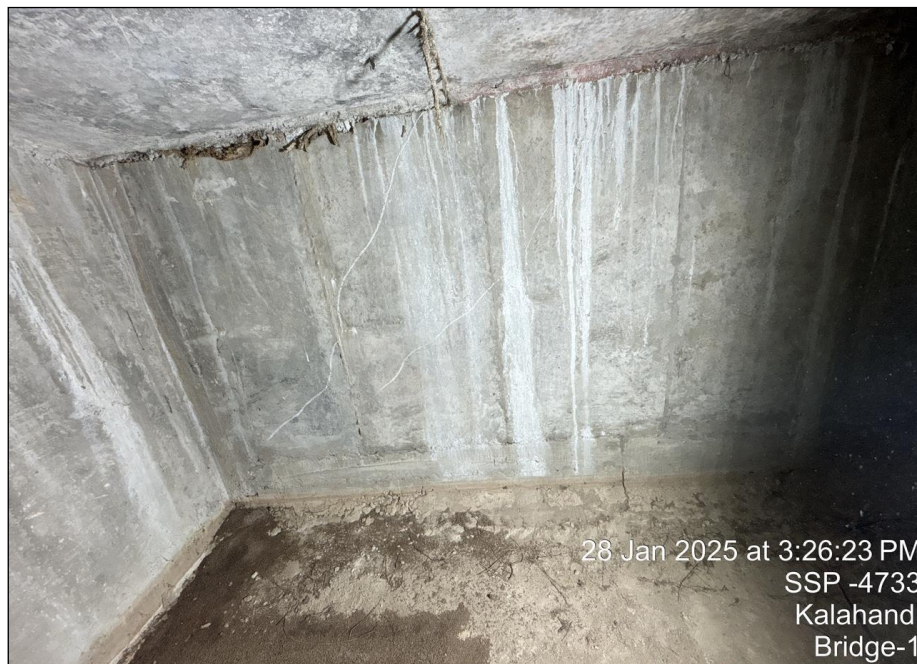
Photo 71: A view of Cracks on mid wall in Cell-2 near Pier P-7 in the Span P7-P8 of H.L Bridge at 27/500 Km on Bhawanipatna-Khariar Road in the Kalahandi Division

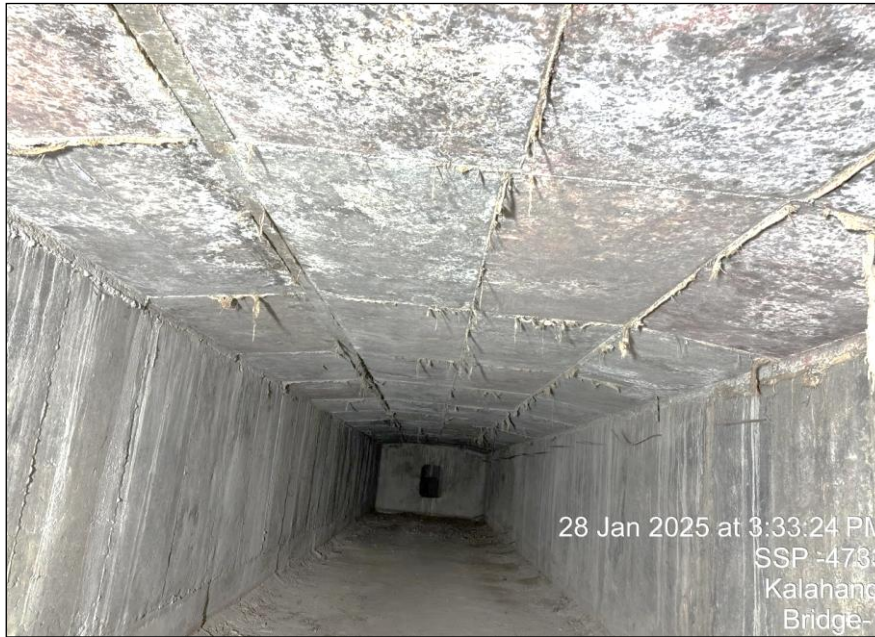
Photo 72: A view of deck slab in Cell-2 near Pier P-7 in the Suspended Span P7-P8 of HL Bridge at 27/500 Km on Bhawanipatna-Khariar Road in the Kalahandi Division.

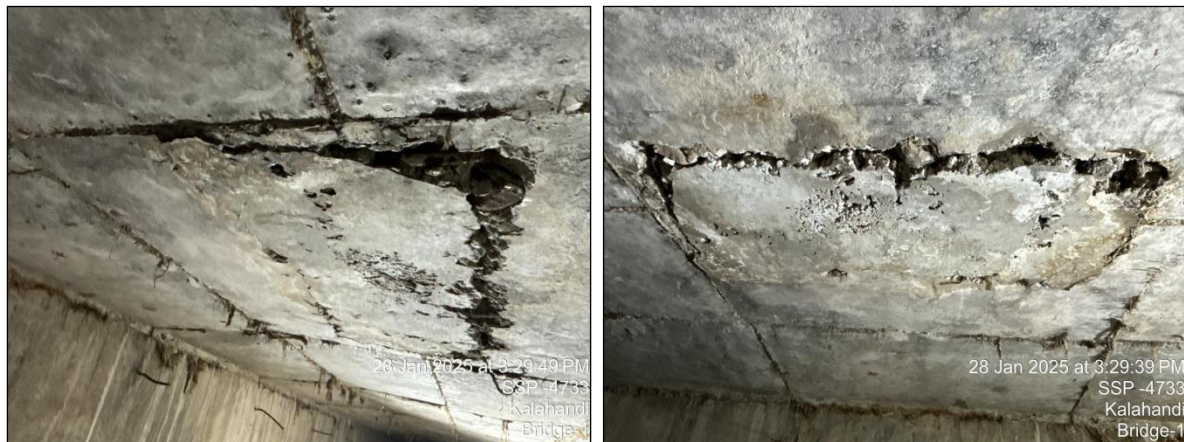
Photo 77: A view of repaired shear punching patch work on Deck Slab in cell-2 near Pier P-7 In the suspended Span P7-P8 of H L Bridge at 27/500 Km on Bhawanipatna-Khariar Road in the Kalahandi Division

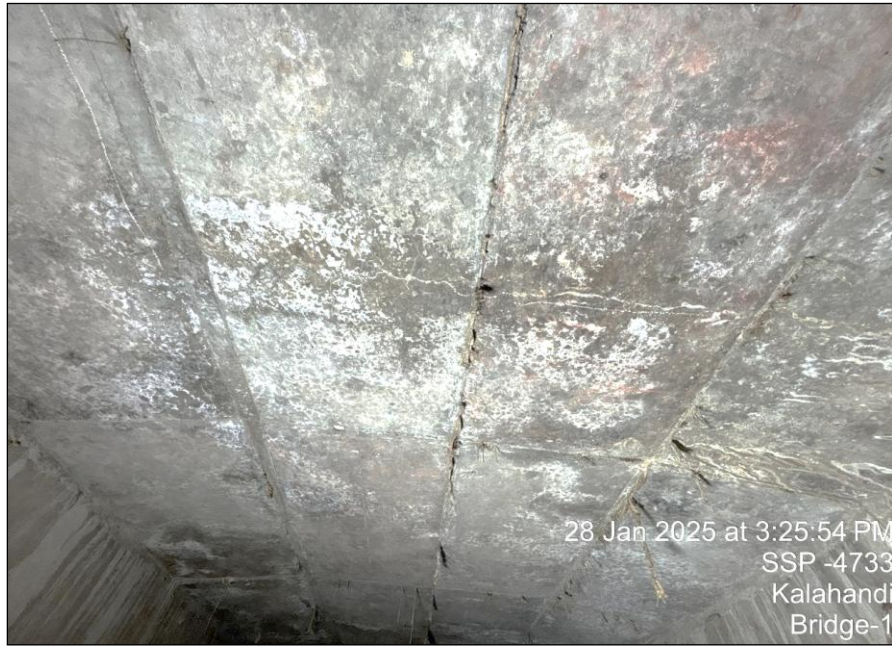
Photo 78: A view of crack on Deck Slab in cell-2 near Pier P-7 in the Span P6-P7 of H.L Bridge at 27/500 Km on Bhawanipatna-Khariar Road in the Kalahandi Division

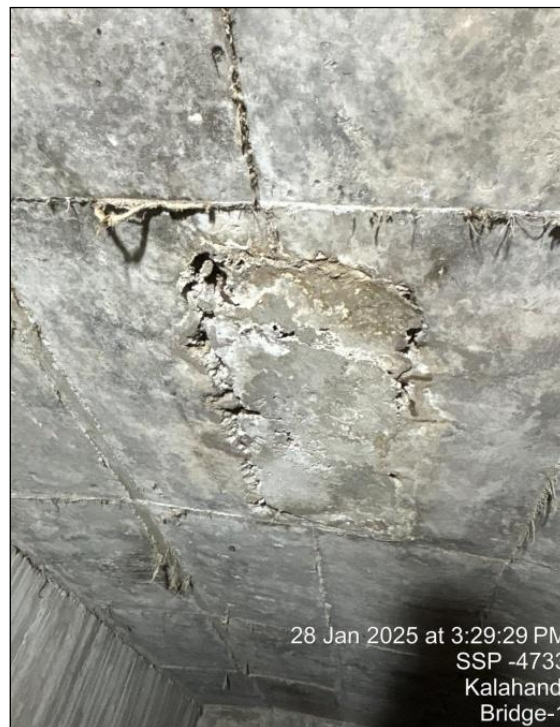
Photo 79: A view of repaired shear punching of Deck Slab in cell-2 near Pier P-7 in the Span P7-P8 of H.L Bridge at 27/500 Km on Bhawanipatna-Khariar Road in the Kalahandi Division

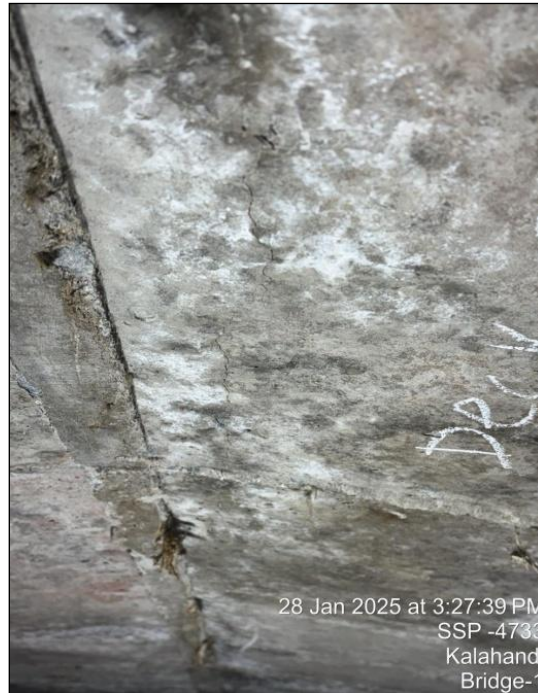
Photo 80: A view of seepage and cracks at deck Slab in cell -2 near Pier P-7 in the Span P7-P8 of H L Bridge at 27/500 Km on Bhawanipatna-Khariar Road in the Kalahandi Division .

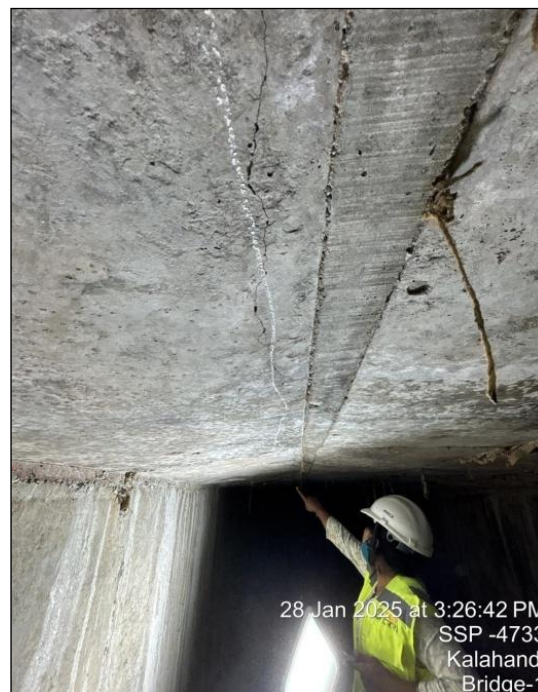
Photo 81: A view of Crack on Deck Slab in cell-2 near Pier P-7 in the Span P7-P8 of H L Bridge at 27/500 Km on Bhawanipatna-Khariar Road in the Kalahandi Division .

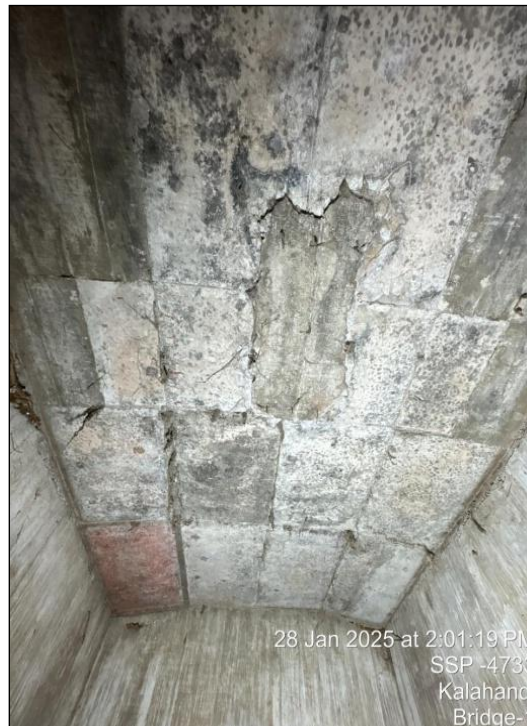
Photo 82: A view of repaired patch work on Deck Slab near Pier P-7 in the Span P7-P8 of H.L Bridge at Km 27/500 Km on Bhawanipatna-Khariar Road in the Kalahandi Division.

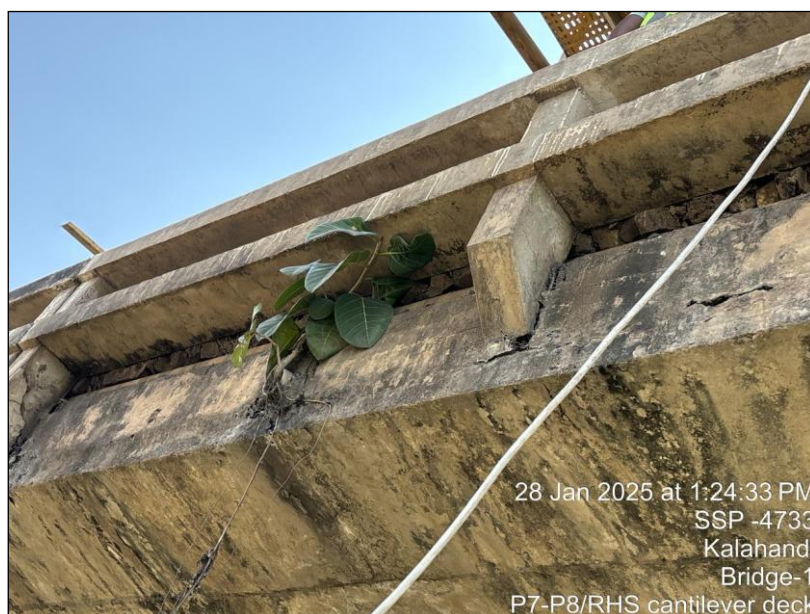
Photo 83: A view of vegetation growth on the Cantilever portion in the Span P7-P8 of H L Bridge at 27/500 Km on Bhawanipatna-Khariar Road in the Kalahandi Division.

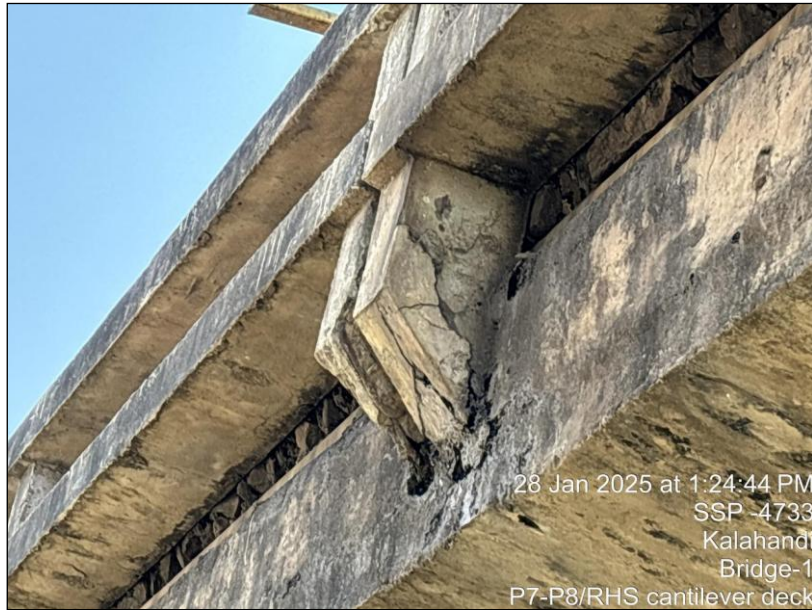
Photo 84: A view of cracks and damaged bracket of supporting railing in the RHS cantilever in the span P7-P8 of H L Bridge at 27/500 Km on Bhawanipatna-Khariar Road in the Kalahandi Division.

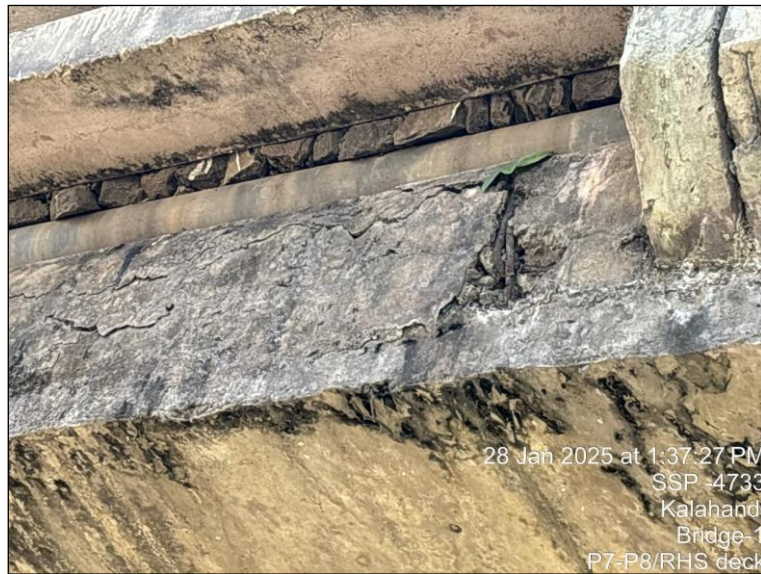
Photo 85: A view of cracks and exposed reinforcement on RHS cantilever deck Slab in the span P7-P8 of HL Bridge at 27/500 Km on Bhawanipatna-Khariar Road in the Kalahandi Division

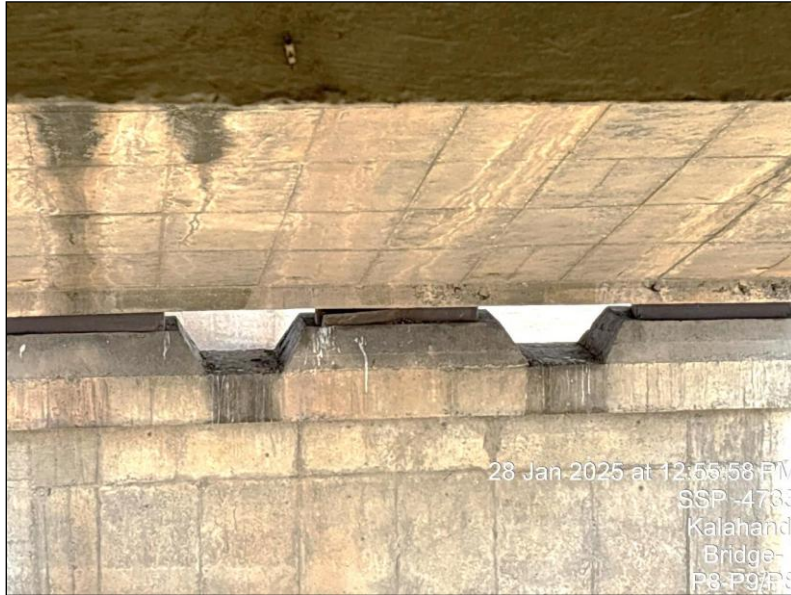
Photo 86: A view of bearing at Pier P-8 in the Span P8-P9 of H.L Bridge at 27/500 Km on Bhawanipatna-Khariar Road in the Kalahandi Division

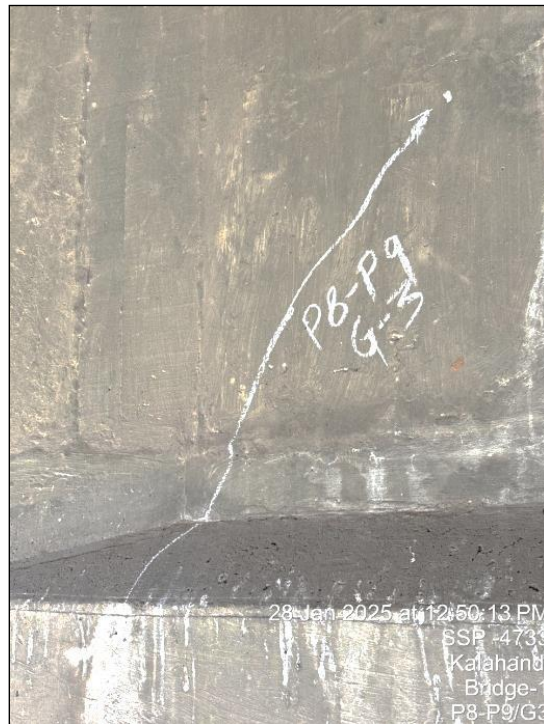
Photo 88: A view of Crack on Girder G-3 at Pier P-8 in the Suspended Span P8-P9 of H L Bridge at 27/500 Km on Bhawanipatna-Khariar Road in the Kalahandi Division.

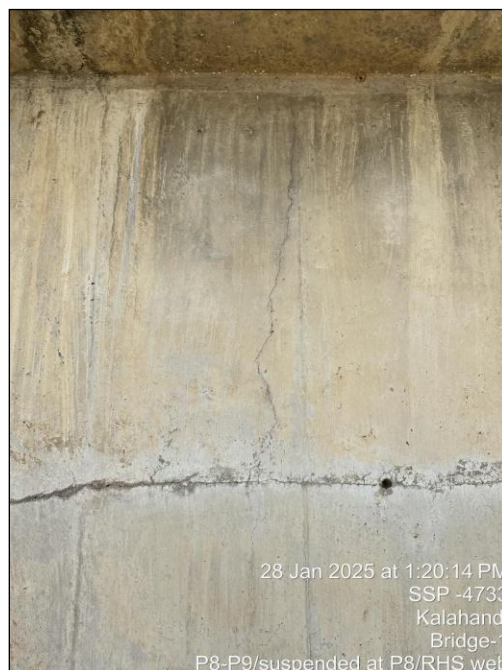
Photo 89: A view of Crack on RHS web near Pier P-8 in the Suspended Span P8-P9 of H.L Bridge at 27/500 Km on Bhawanipatna-Khariar Road in the Kalahandi Division

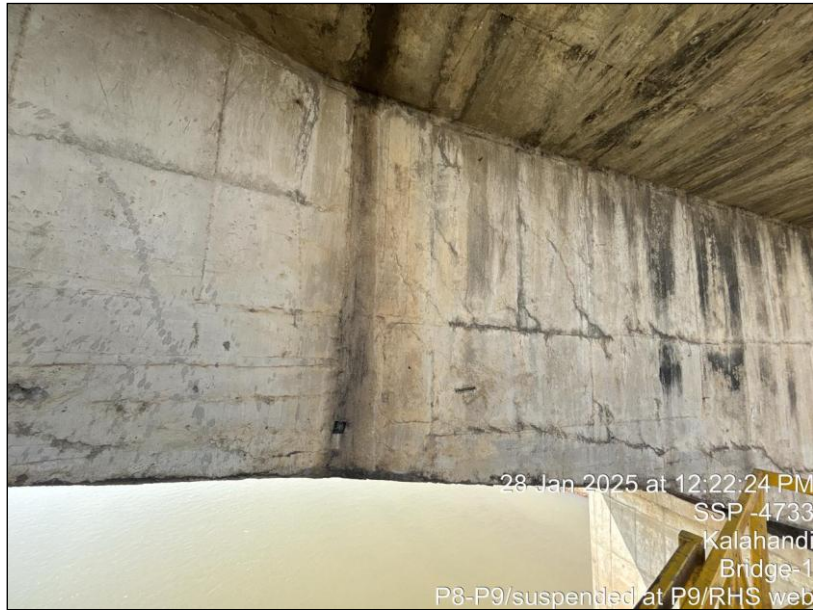
Photo 90: A view of Crack on RHS web near Pier P-9 in the Suspended Span P8-P9 of H.L Bridge at 27/500 Km on Bhawanipatna-Khariar Road in the Kalahandi Division
