लोक निर्माण विभाग, ओडिशा सरकार के अंतर्गत, पुलों की आधुनिक परीक्षण प्रक्रियाओं का उपयोग करते हुए ओडिशा राज्य के रोड नेटवर्क के मेजर और माईनर ब्रिजो के स्थिति का आकलन और उपचारात्मक उपायों के लिए सुझाव

अंतिम रिपोर्ट

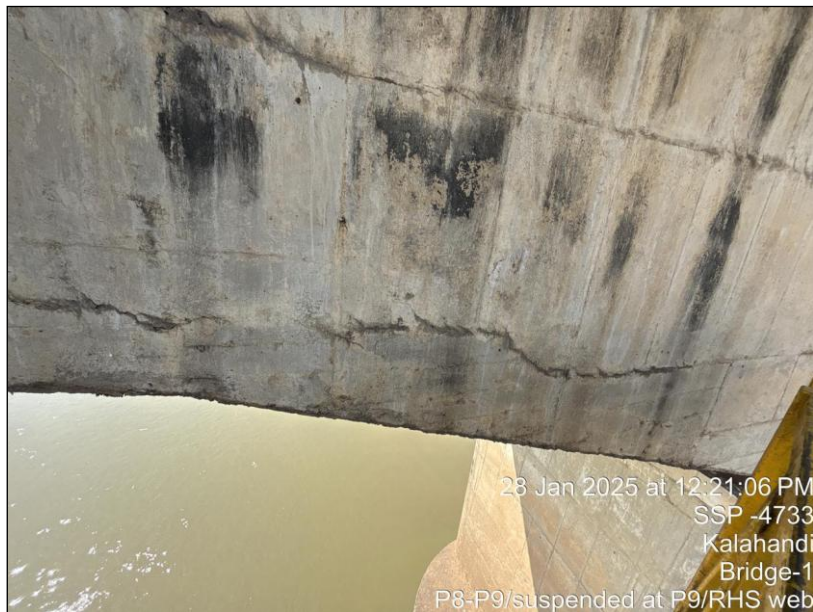
Photo 91: A view of Crack on RHS web at Pier P-9 in the Suspended Span P8-P9 of H.L Bridge at 27/500 Km on Bhawanipatna-Khariar Road in the Kalahandi Division

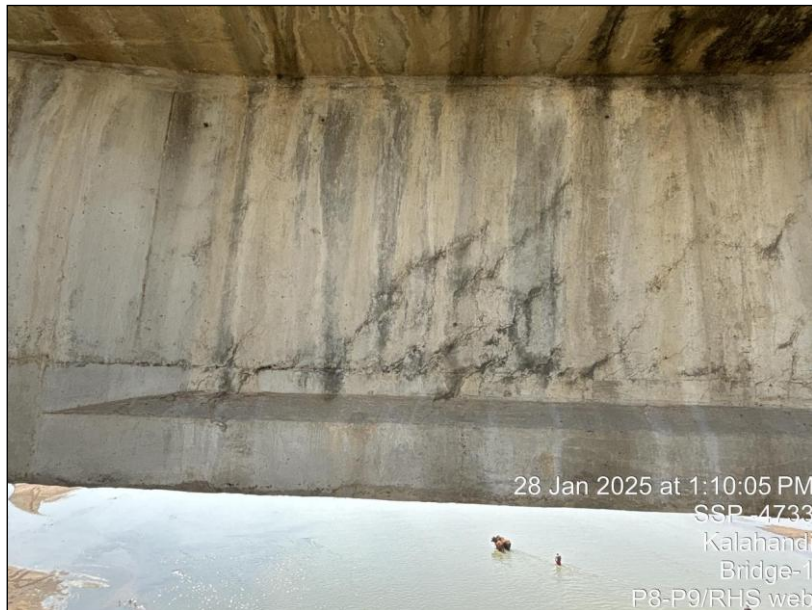
Photo 92: A view of Crack on RHS web near Pier P-8 in the Suspended Span P8-P9 of H.L Bridge at 27/500 Km on Bhawanipatna-Khariar Road in the Kalahandi Division

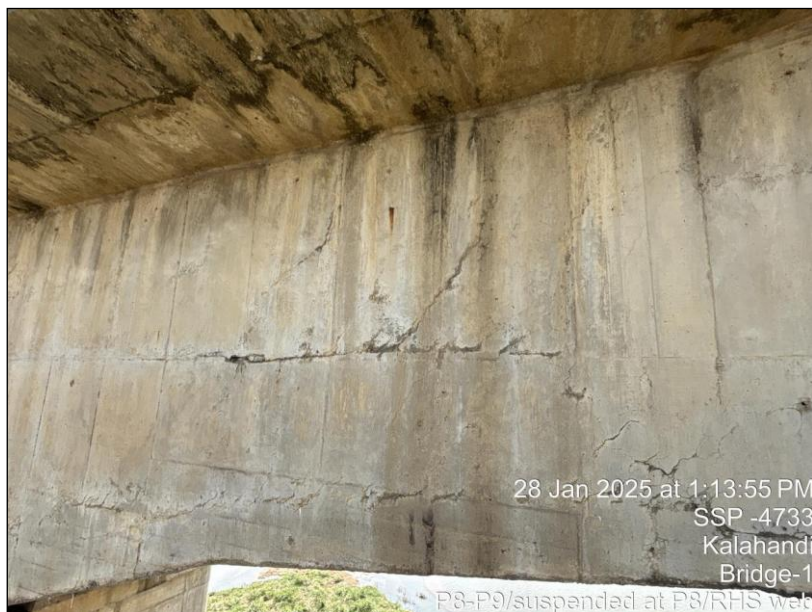
Photo 93: A view of Crack on RHS web near Pier P-8 in the Suspended Span P8-P9 of H.L Bridge at 27/500 Km on Bhawanipatna-Khariar Road in the Kalahandi Division

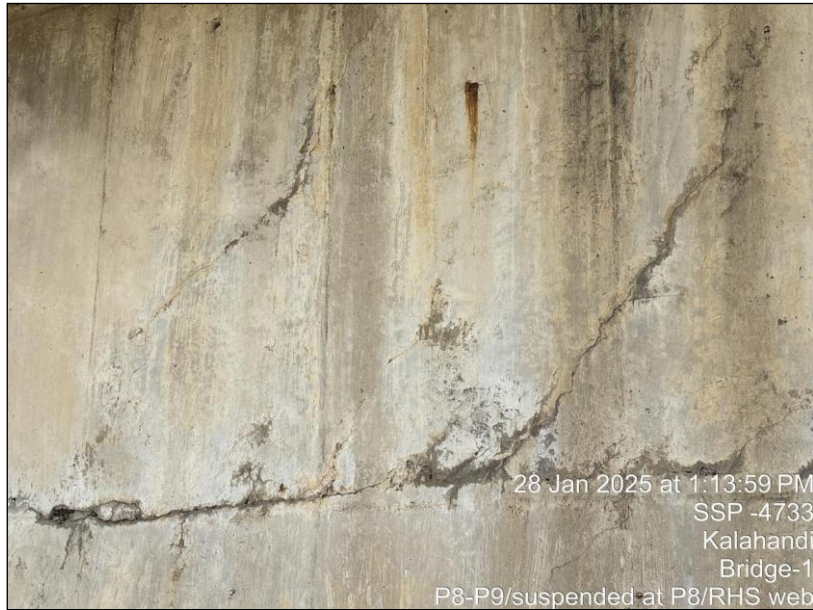
Photo 94: A view of Crack on RHS web near Pier P-8 in the Suspended Span P8-P9 of H.L Bridge at 27/500 Km on Bhawanipatna-Khariar Road in the Kalahandi Division

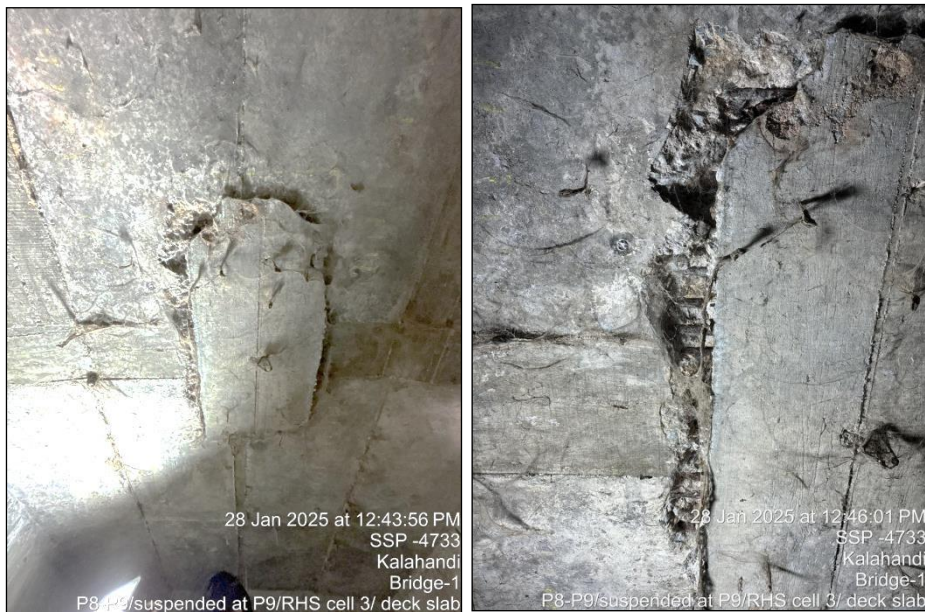
Photo 95: A view of Patch repair and exposed reinforcement on Deck Slab in RHS cell-3 near Pier P-9 in the Span P8-P9 of H.L Bridge at 27/500 Km on Bhawanipatna-Khariar Road in the Kalahandi Division.

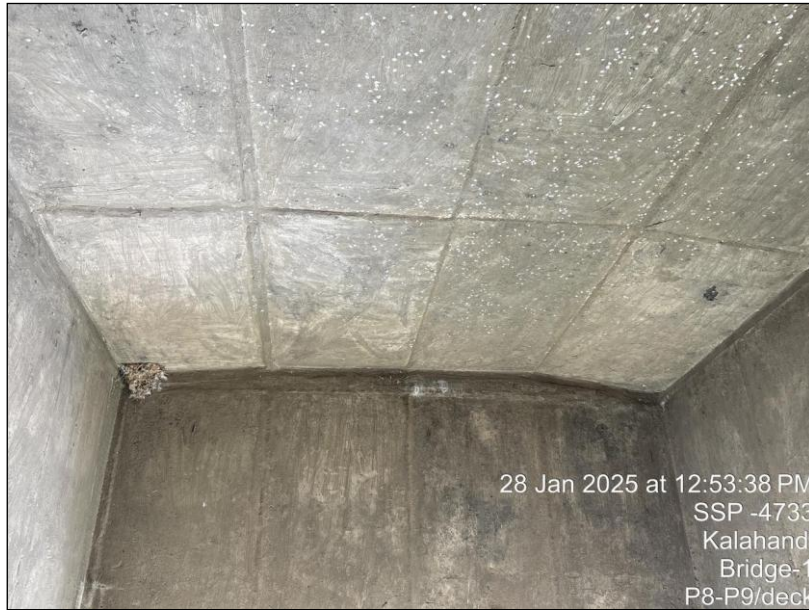
Photo 96: A view of deck slab in the Span P8-P9 of H.L Bridge at 27/500 Km on Bhawanipatna-Khariar Road in the Kalahandi Division.

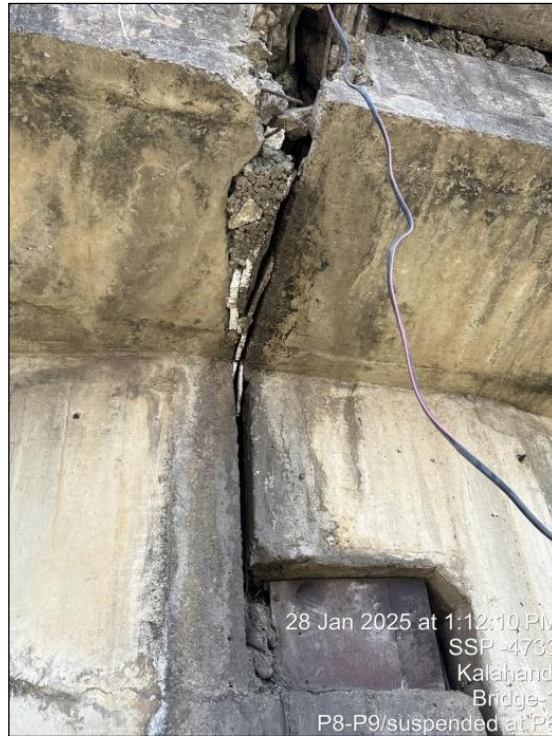
Photo 100: A view of leakage through expansion joint in the span P8-P9 of H.L Bridge at Km 27/500 on Bhawanipatna-Khariar Road in the Kalahandi Division.

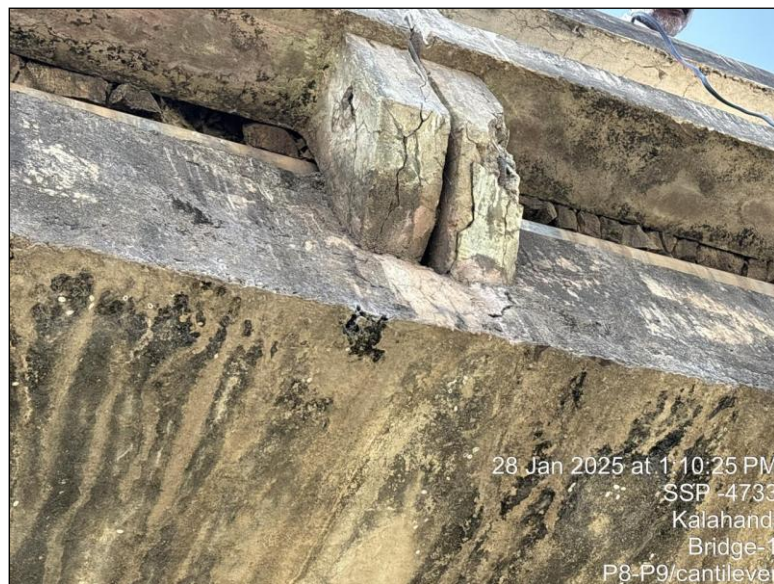
Photo 101: A view of Cracks on supporting bracket of railing in the span P8-P9 of H.L Bridge at 27/500 Km on Bhawanipatna-Khariar Road in the Kalahandi Division.

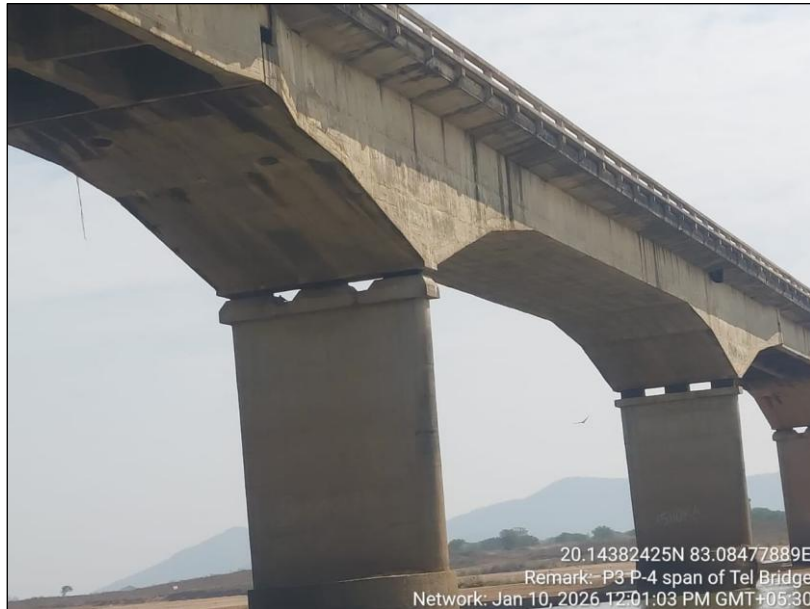
Photo 102: A view of Span P9-P10 of H.L Bridge at 27/500 Km on Bhawanipatna-Khariar Road in the Kalahandi Division.

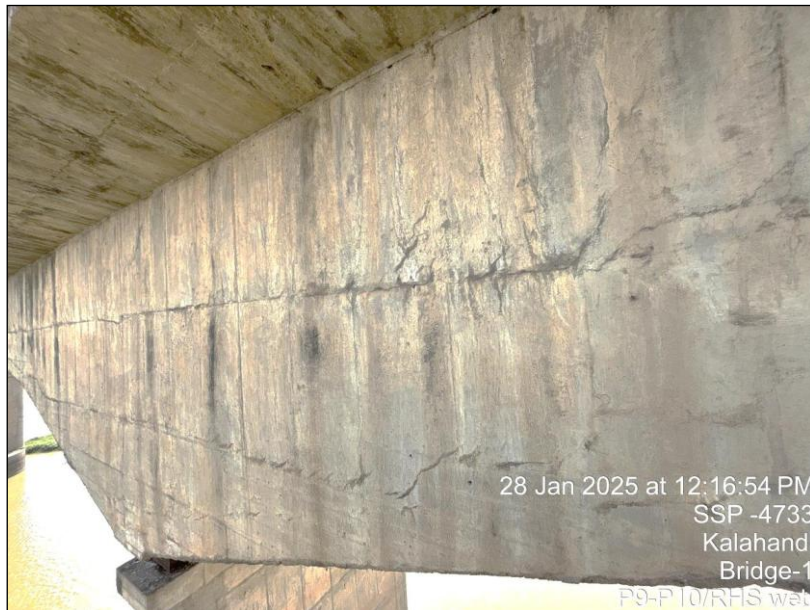
Photo 104: A view of crack on RHS web in the Span P9-P10 of H.L Bridge at 27/500 Km on Bhawanipatna-Khariar Road in the Kalahandi Division.

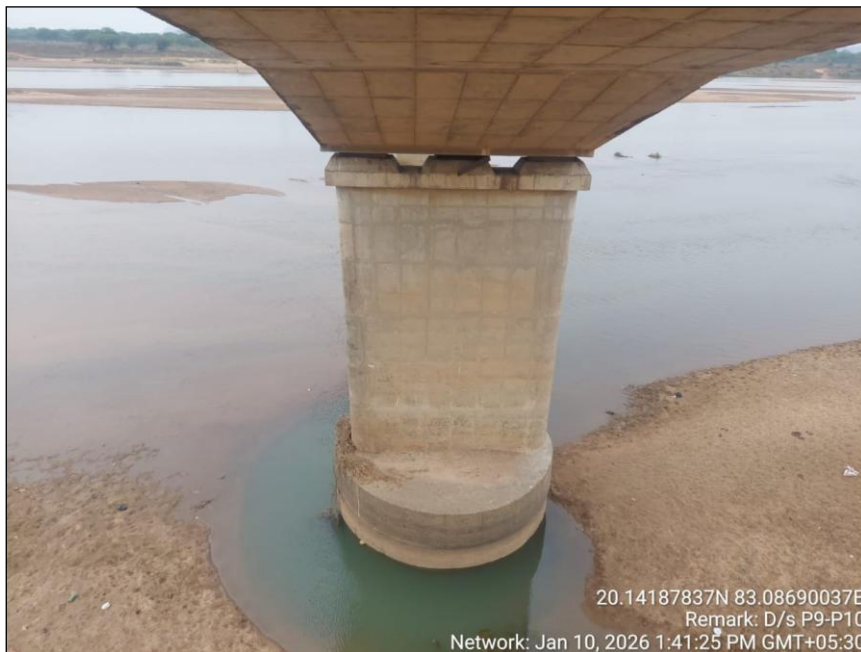
Photo 105: A view of scouring at Pier P-8 in the Span P9-P10 of H.L Bridge at 27/500 Km on Bhawanipatna-Khariar Road in the Kalahandi Division.

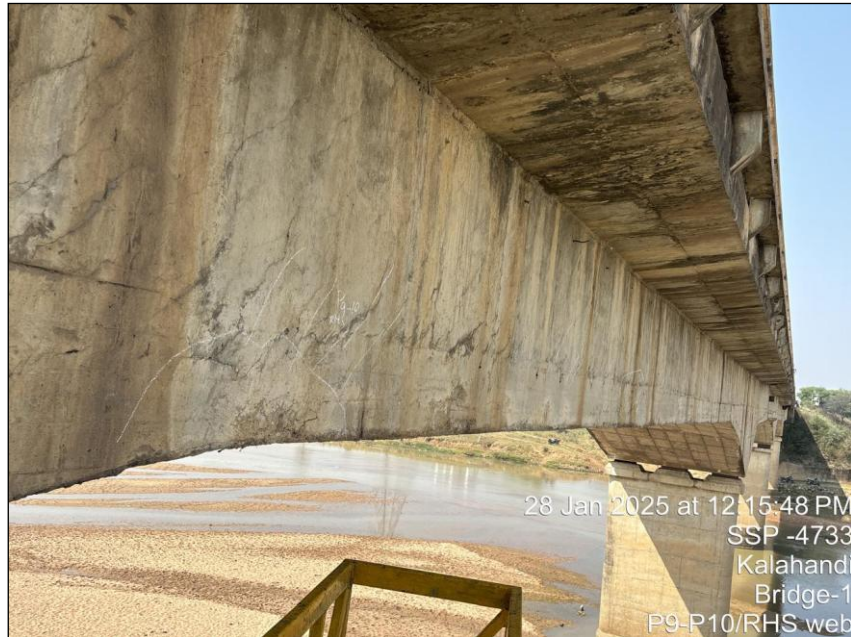
Photo 106: A view of crack on RHS web in the Span P9-P10 of H.L Bridge at 27/500 Km on Bhawanipatna-Khariar Road in the Kalahandi Division.

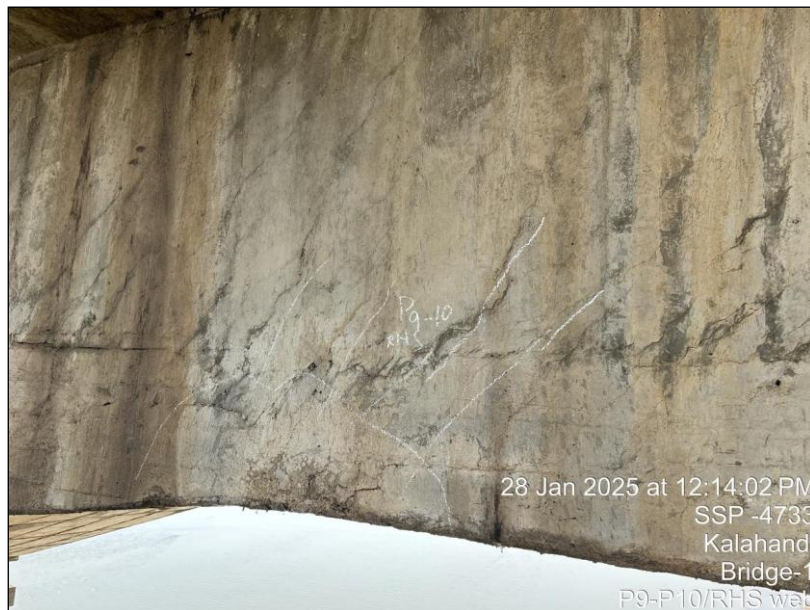
Photo 107: A view of crack on RHS web in the Span P9-P10 of H.L Bridge at 27/500 Km on Bhawanipatna-Khariar Road in the Kalahandi Division

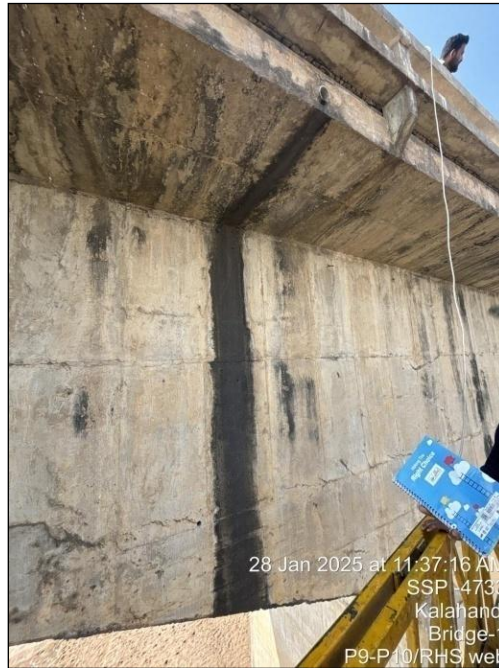
Photo 108: A view of Seepage through drainage spout on RHS web in the Span P9-P10 of H.L Bridge at 27/500 Km on Bhawanipatna-Khariar Road in the Kalahandi Division.

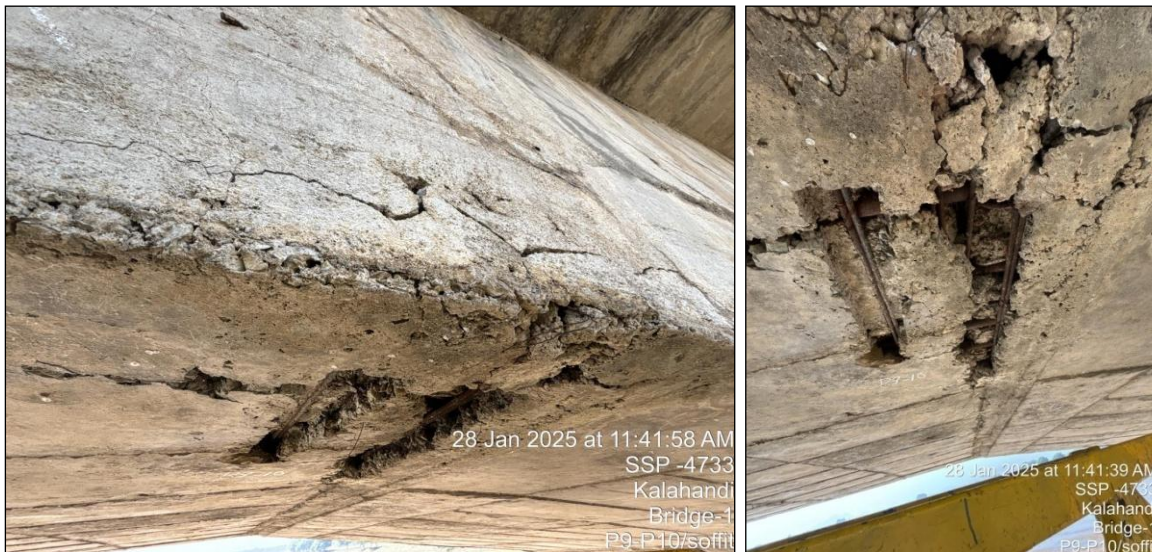
Photo 111: A view of cracks and Exposed Reinforcement on soffit slab in the Span P9-P10 of H.L Bridge at 27/500 Km on Bhawanipatna-Khariar Road in the Kalahandi Division

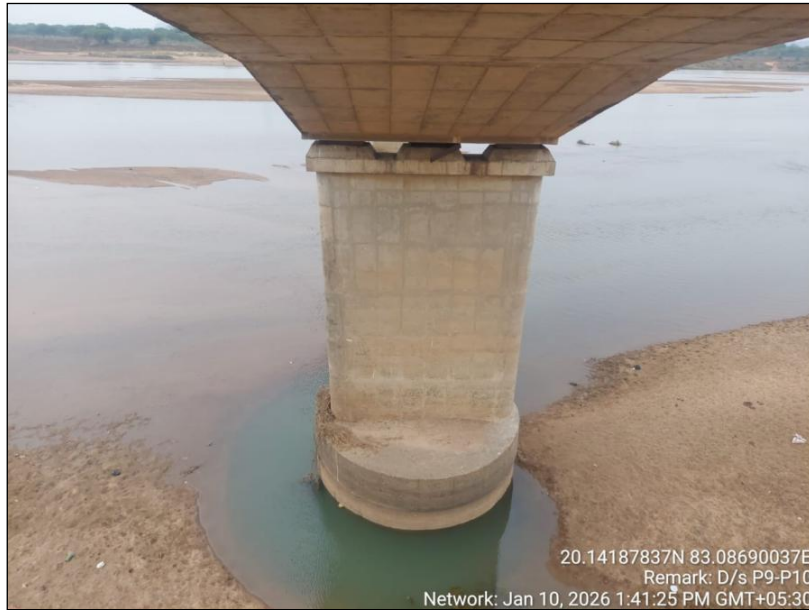
Photo 112: A view of scouring at pier P-10 in the Span P9-P10 of H.L Bridge at 27/500 Km on Bhawanipatna-Khariar Road in the Kalahandi Division

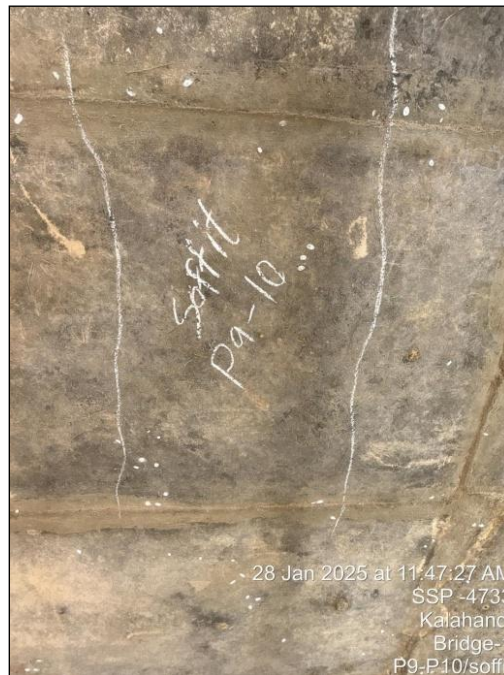
Photo 113: A view of Crack on Soffit in the span P9-P10 of H.L Bridge at 27/500 Km on Bhawanipatna-Khariar Road in the Kalahandi Division

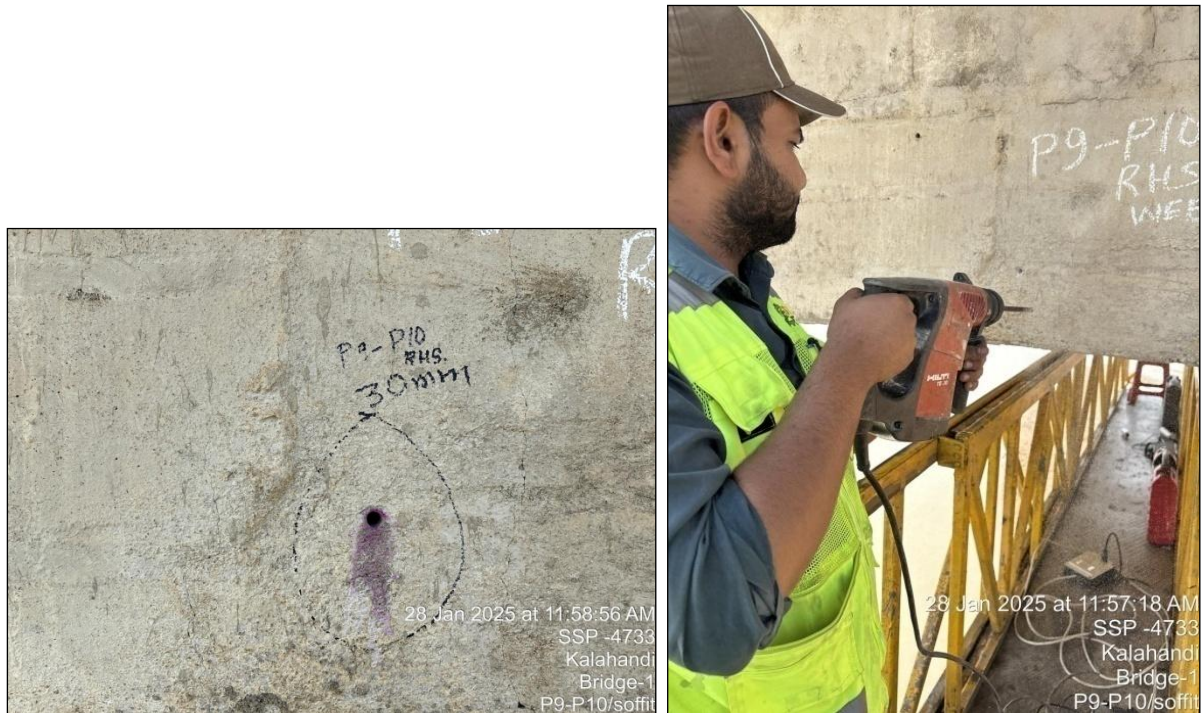
Photo 114: A view of carbonation depth measurement (30mm) on RHS Soffit in the Span P9-P10 of H L Bridge at 27/500 Km on Bhawanipatna-Khariar Road in the Kalahandi Division

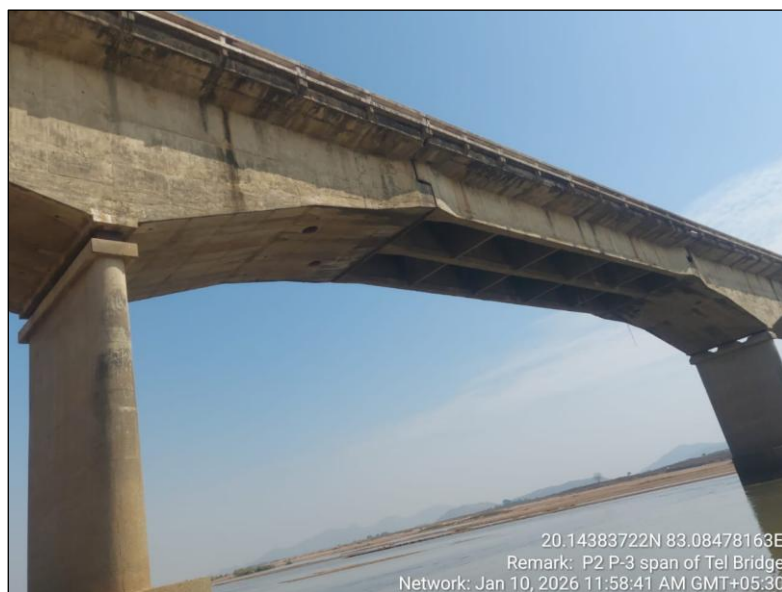
Photo 119: A LHS view of suspended span in the Span P10-P11 of H.L Bridge at 27/500 Km on Bhawanipatna-Khariar Road in the Kalahandi Division.

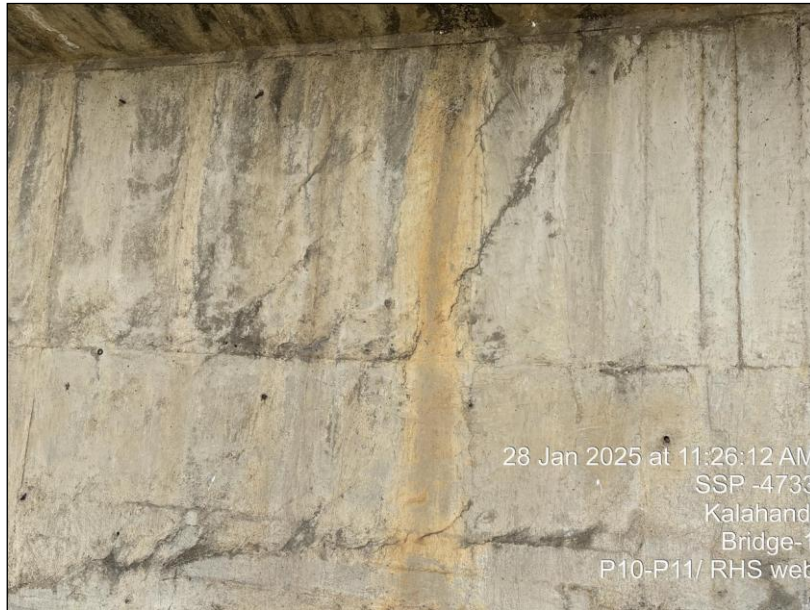
Photo 122: A view of cracks on RHS web in the Span P10-P11 of H.L Bridge at 27/500 Km on Bhawanipatna-Khariar Road in the Kalahandi Division.

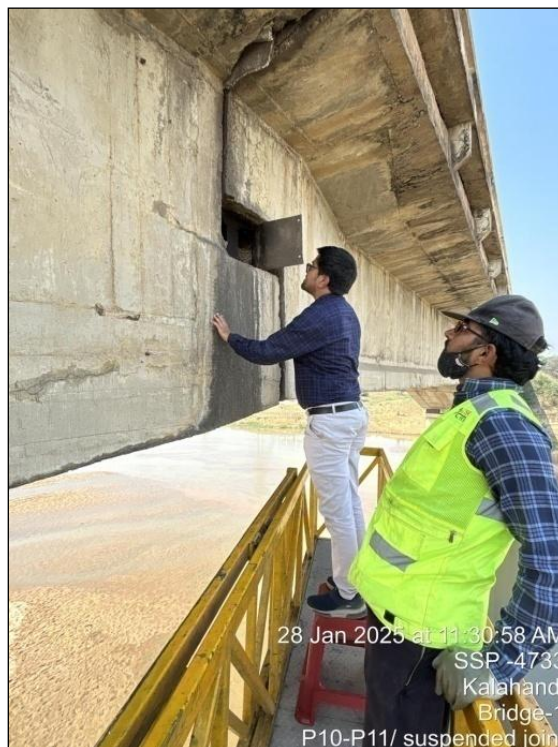
Photo 123: A view of Inspection of Roller bearing of Suspended span in the span P10-P11 of H.L Bridge at 27/500 Km on Bhawanipatna-Khariar Road in the Kalahandi Division

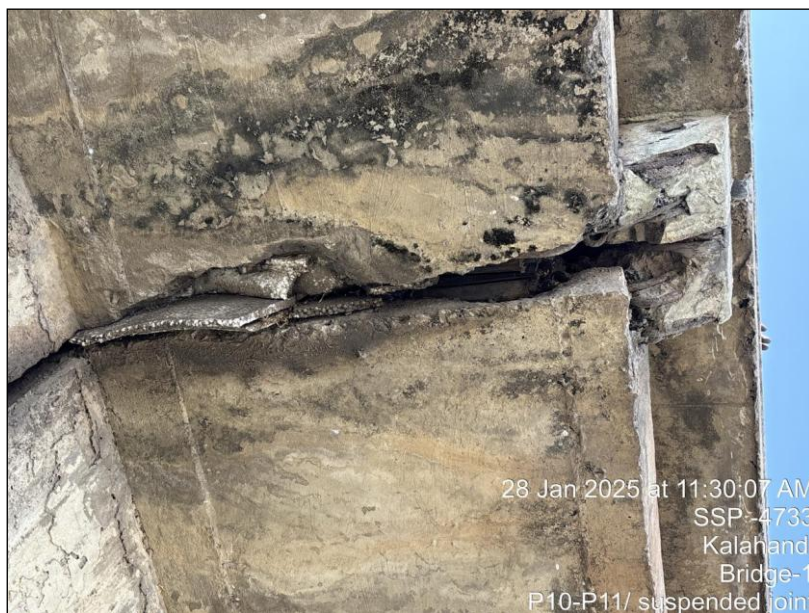
Photo 133: A view of leakage on cantilever deck Slab through Expansion joint in the Span P10-P11 of H.L Bridge at 27/500 Km on Bhawanipatna-Khariar Road in the Kalahandi Division

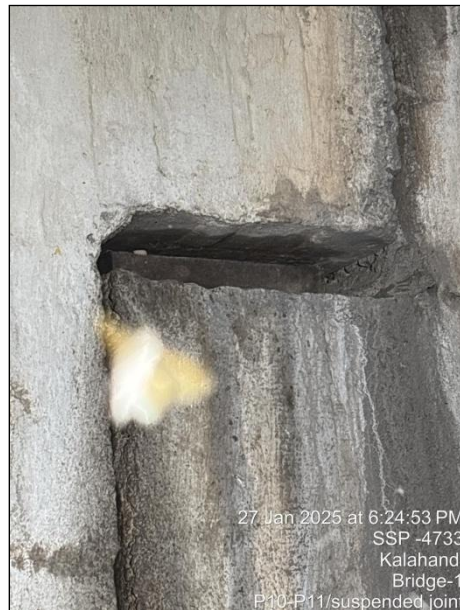
Photo 134: A view of Rocker Bearing on Suspended Span P10-P11 of H.L Bridge at 27/500 Km on Bhawanipatna-Khariar Road in the Kalahandi Division

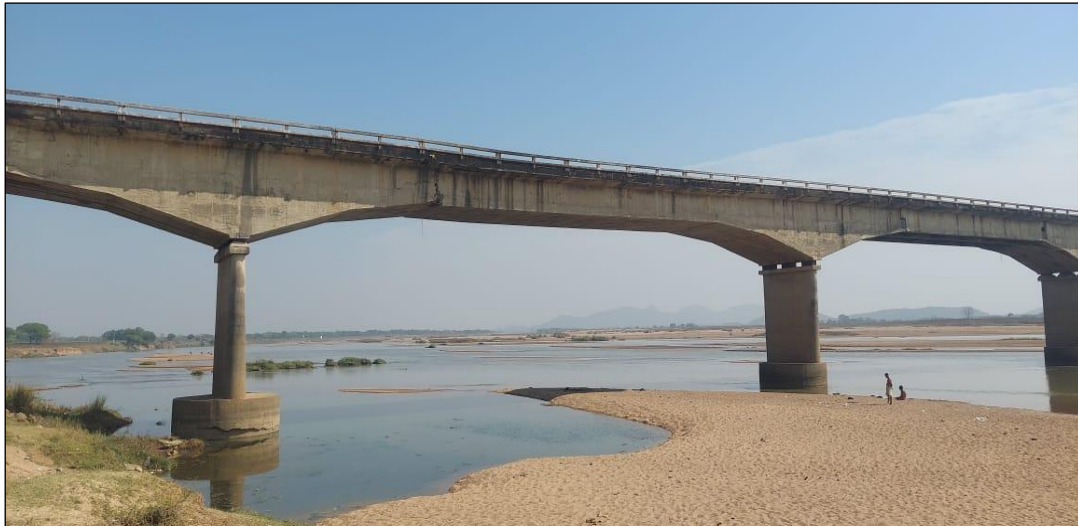
(Severe distressed Span P1-P2 as per OWD)

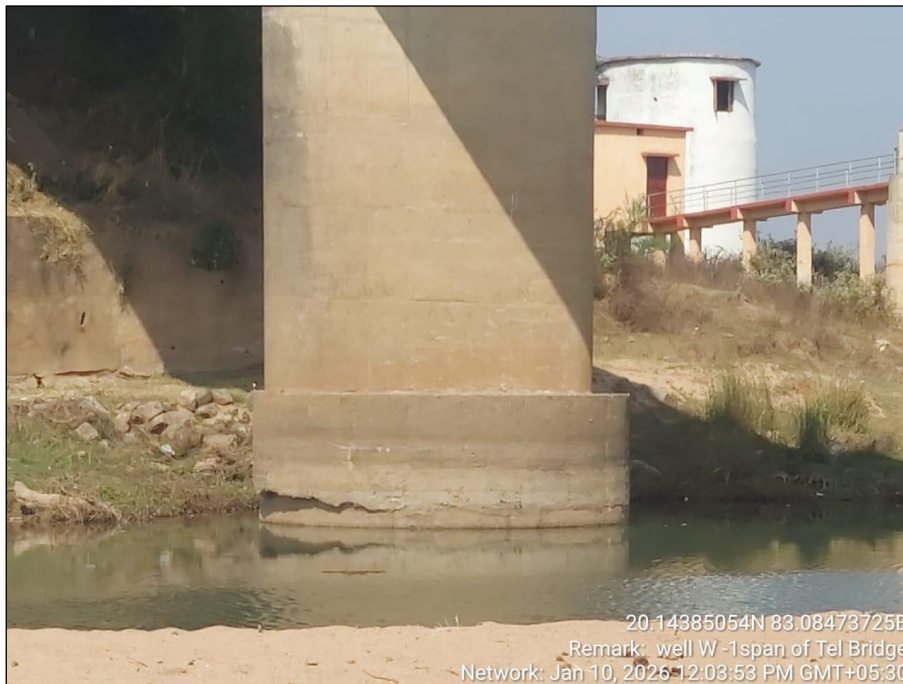
Photo 141: A LHS (u/s) view of Severe distressed web in Span P11-P12 of H.L Bridge at 27/500 Km on Bhawanipatna-Khariar Road in the Kalahandi Division.

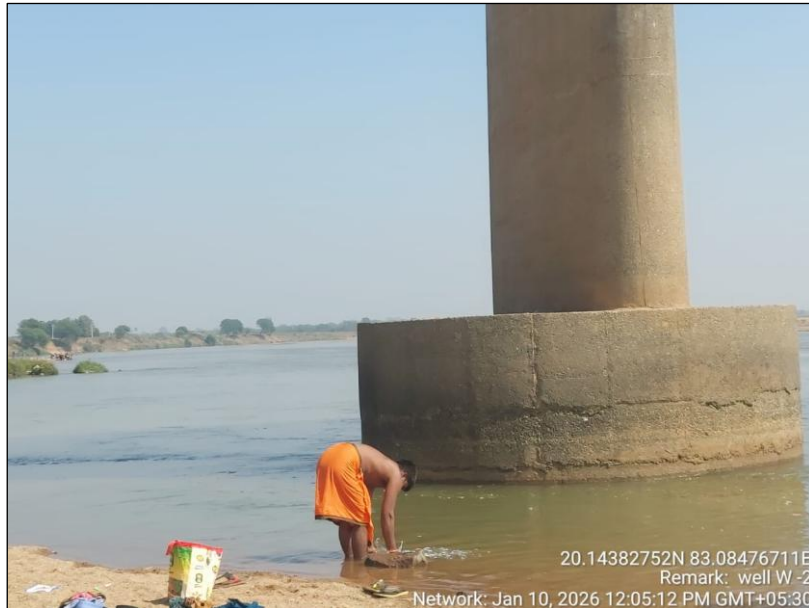
Photo 142: A view of well foundation at Pier P12 of H.L Bridge at 27/500 Km on Bhawanipatna-Khariar Road in the Kalahandi Division.

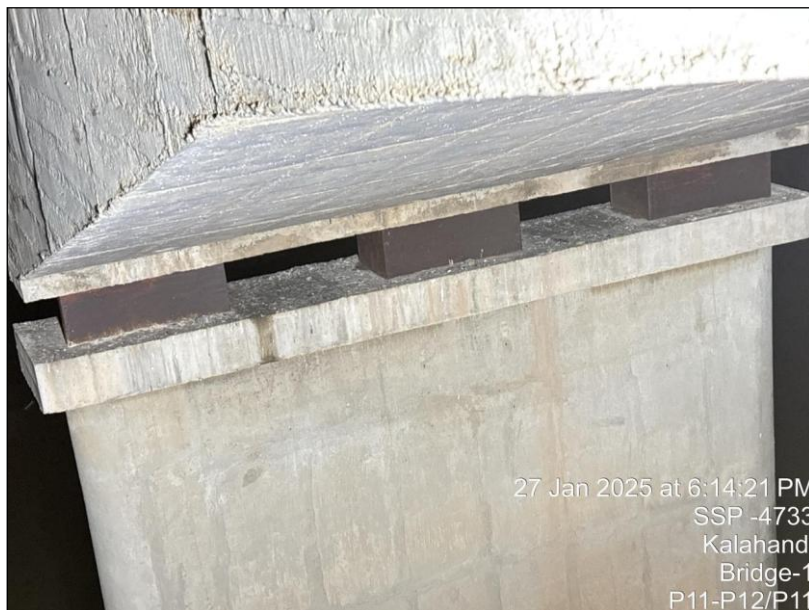
Photo 143: A view of well foundation at Pier P11 of H.L Bridge at 27/500 Km on Bhawanipatna-Khariar Road in the Kalahandi Division.

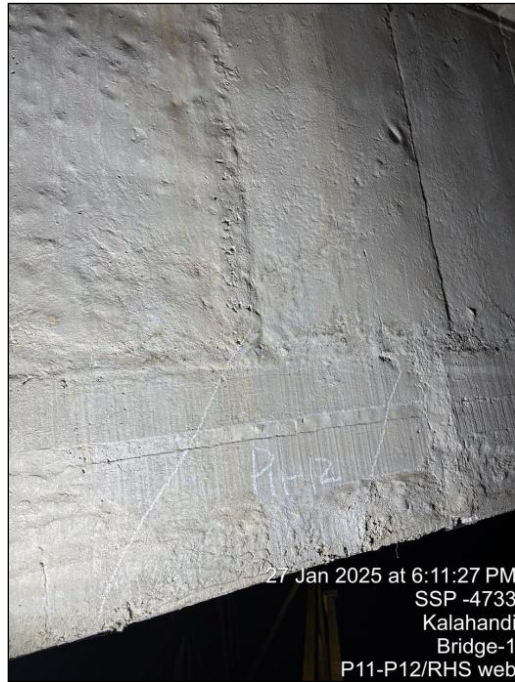
Before distress 27th Jan, 2025

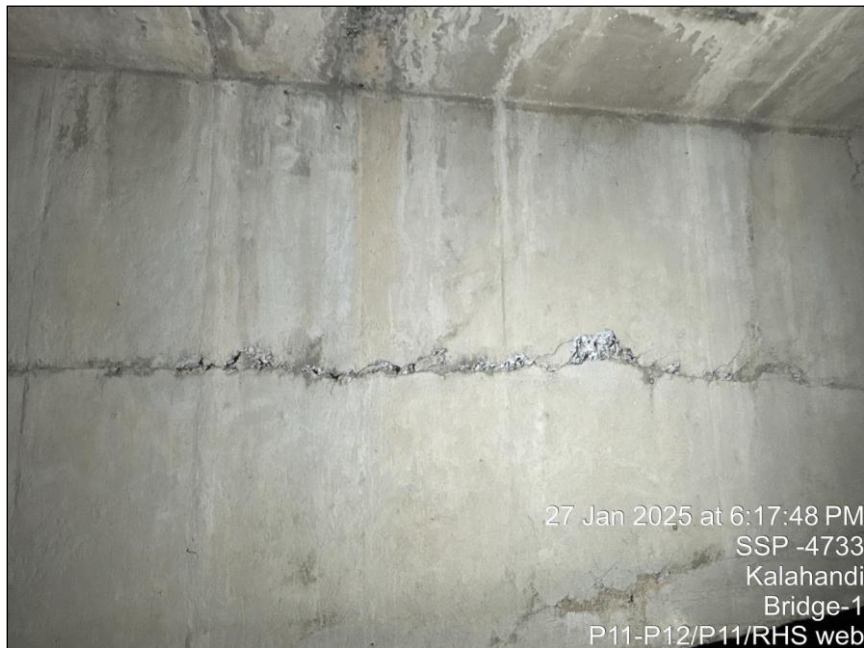
Before distress 27th Jan, 2025

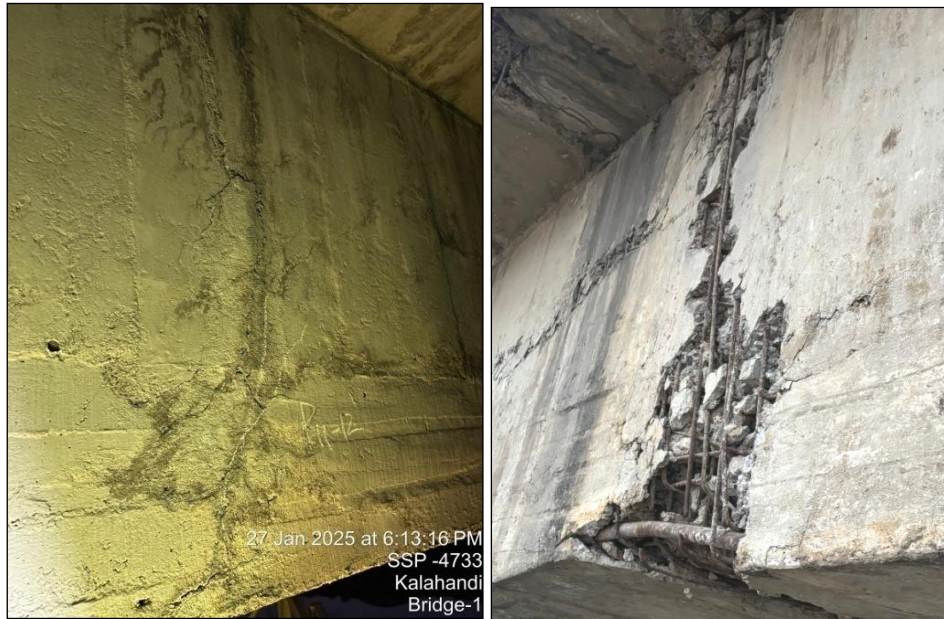
Before distress 27th Jan, 2025 After distressed 10th January, 2026

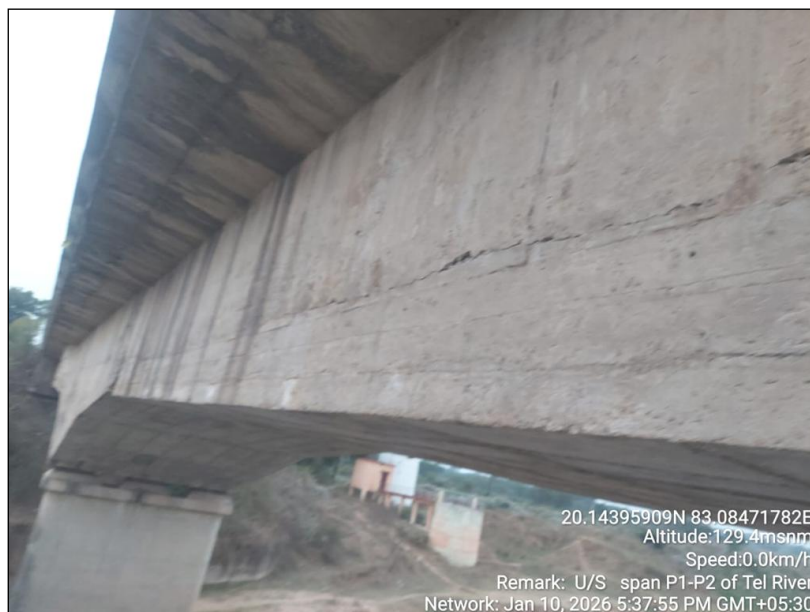
Photo 154: A view of Crack on the distressed LHS web in the Span P11-P12 of H.L Bridge at 27/500 Km on Bhawanipatna-Khariar Road in the Kalahandi Division.

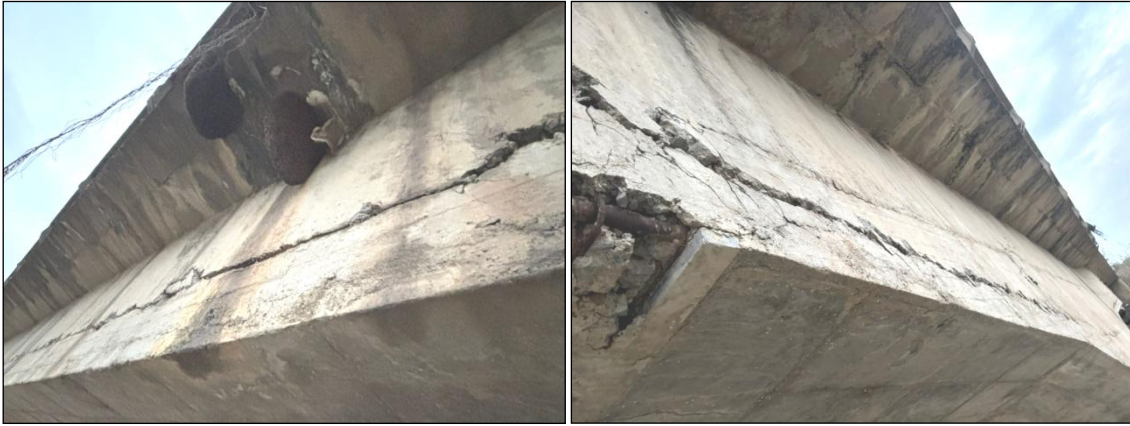
Photo 155: A view of Cracks on the distressed RHS web in the Span P11-P12 of H.L Bridge at 27/500 Km on Bhawanipatna-Khariar Road in the Kalahandi Division.

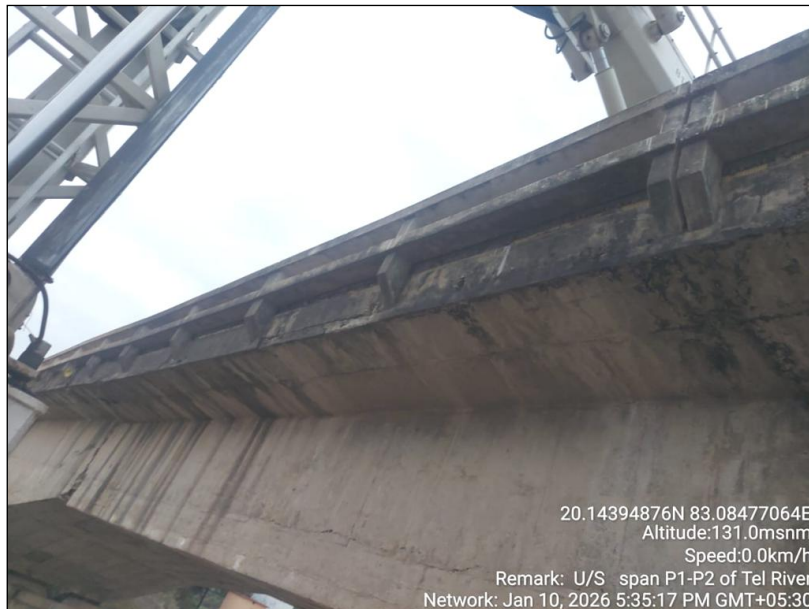
Photo 156: A LHS (u/s) view of cantilever deck slab of distressed Span P11-P12 of H.L Bridge at 27/500 Km on Bhawanipatna-Khariar Road in the Kalahandi Division

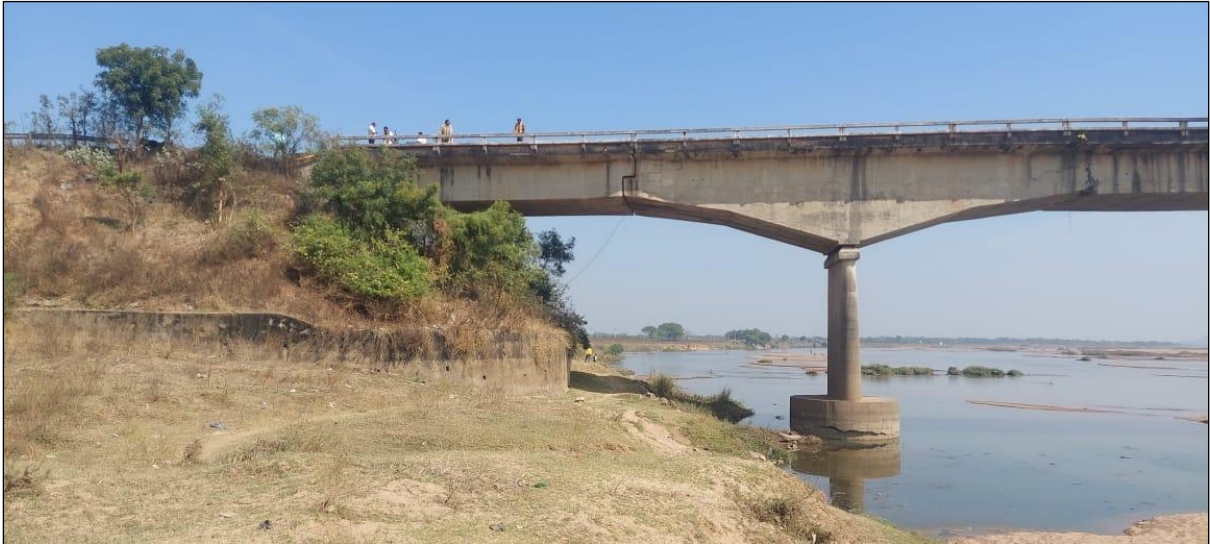
Photo 163: A view of Span P12-A2 of H.L Bridge at 27/500 Km on Bhawanipatna-Khariar Road in the Kalahandi Division

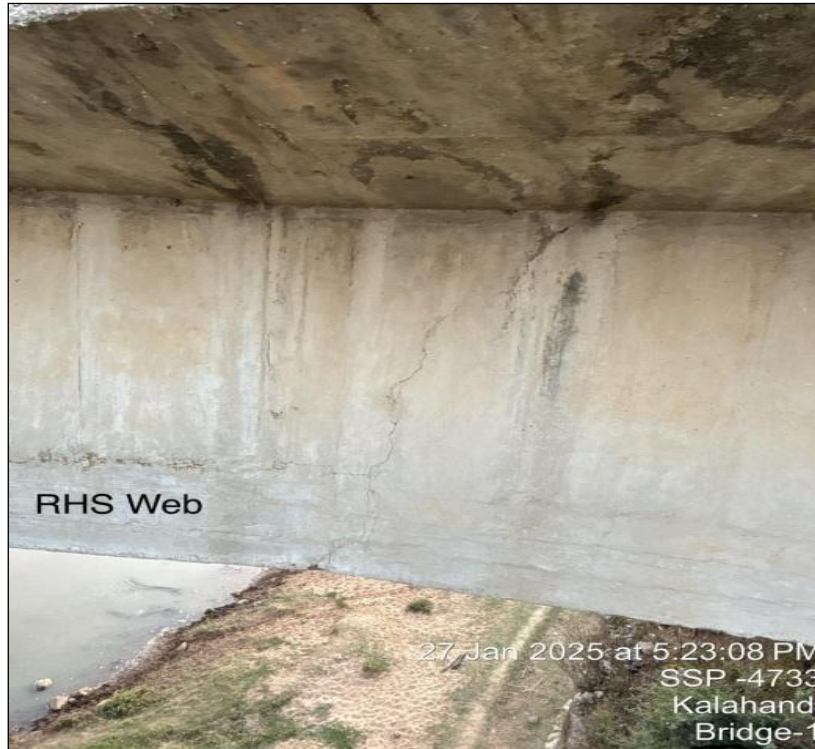
Photo 171: A view of Crack on RHS web in the Span P12-A2 of H.L Bridge at 27/500 Km on Bhawanipatna – Khariar Road in the Kalahandi Division.

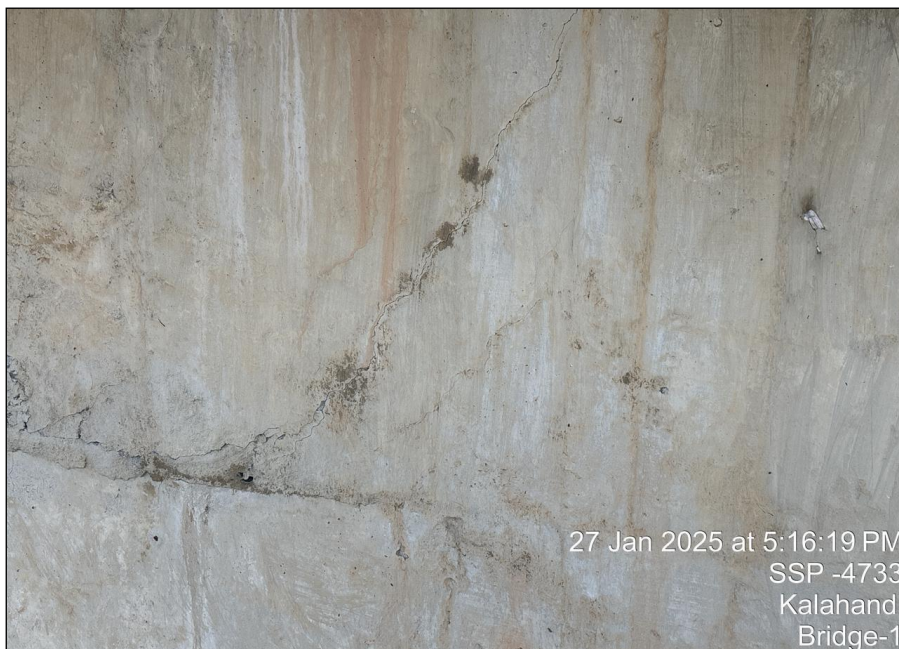
Photo 172: A view of Crack on RHS web in the Span P12-A2 of H.L Bridge at 27/500 Km on Bhawanipatna – Khariar Road in the Kalahandi Division.

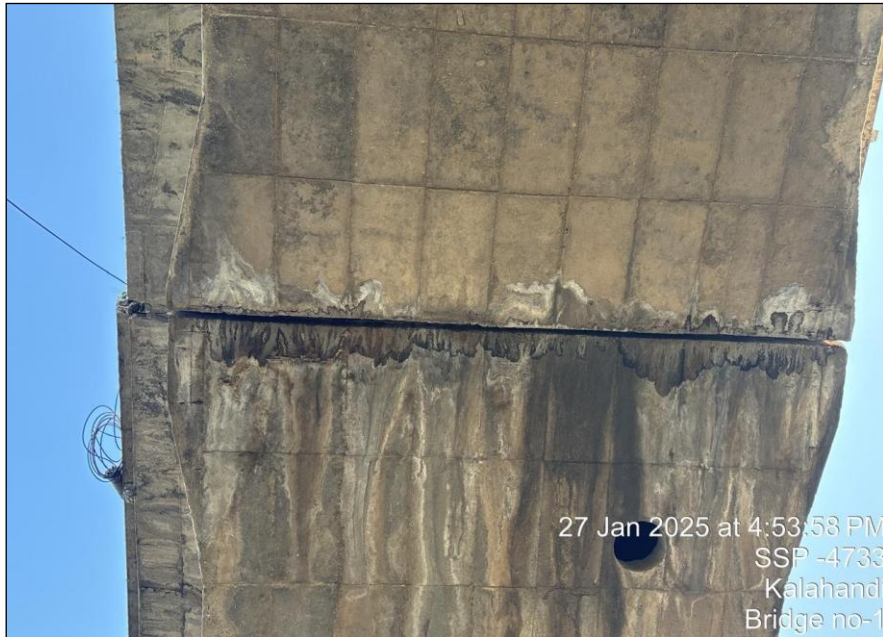
Photo 173: A view of from Expansion Joint at the articulation in the Span P12-A2 of H.L Bridge at 27/500 Km on Bhawanipatna–Khariar Road in the Kalahandi Division.

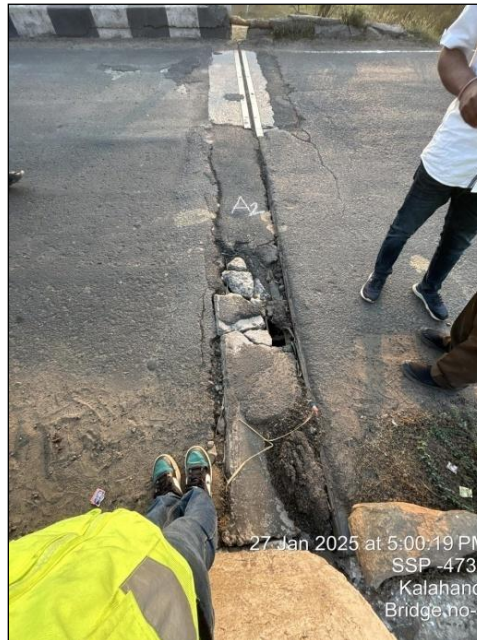
Photo 183: A view of damage Expansion joint at abutment A2 of H.L Bridge at 27/500 Km on Bhawanipatna-Khariar Road in the Kalahandi Division

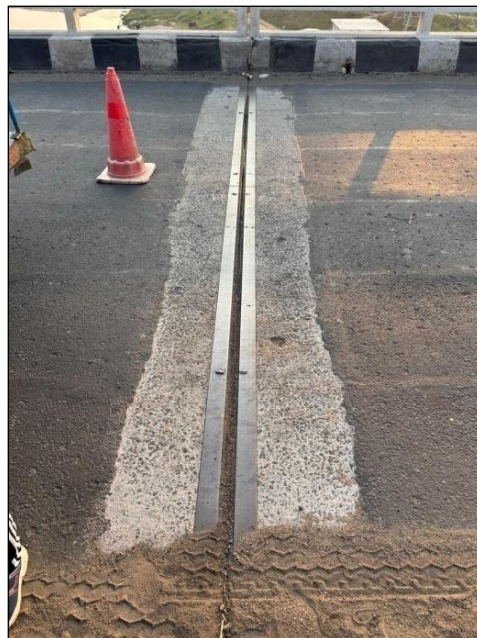
Photo 184: A view of Expansion joint fill with dust of H.L Bridge at 27/500 Km on Bhawanipatna-Khariar Road in the Kalahandi Division

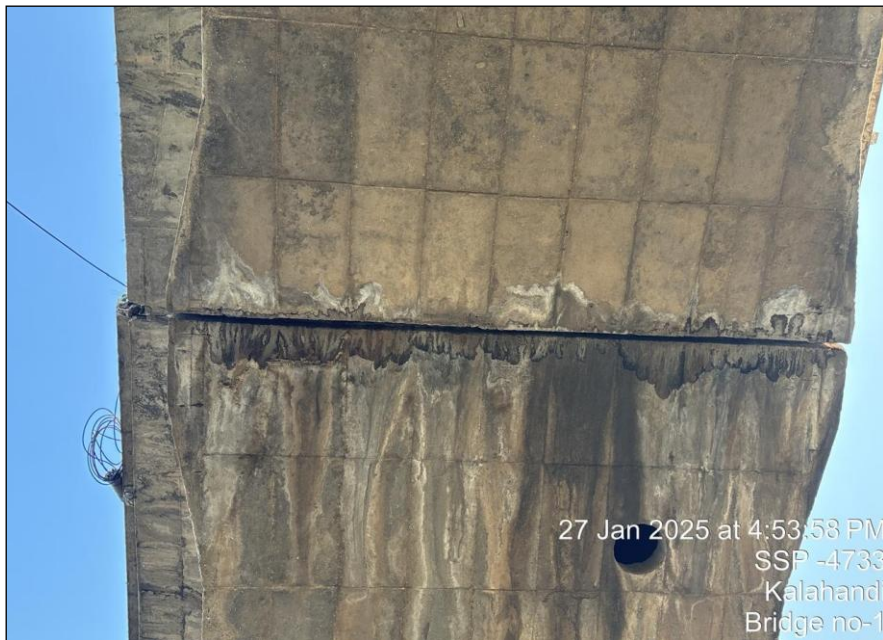
Photo 186: A typical view of leakage through Expansion joint of H.L Bridge at Km 27/500 on Bhawanipatna-Khariar Road in the Kalahandi Division

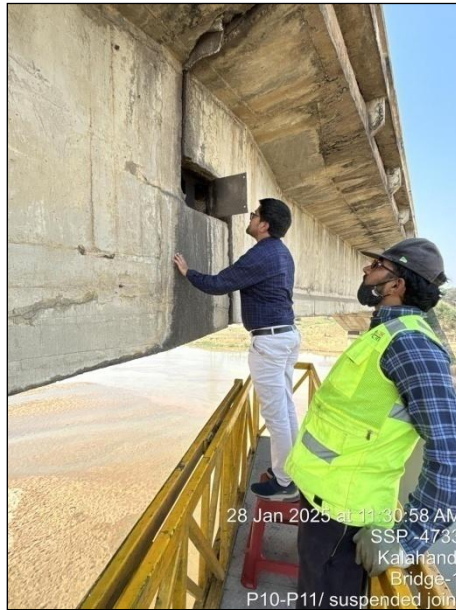
Photo 187: A typical view of leakage through Expansion joint of H.L Bridge at Km 27/500 on Bhawanipatna-Khariar Road in the Kalahandi Division

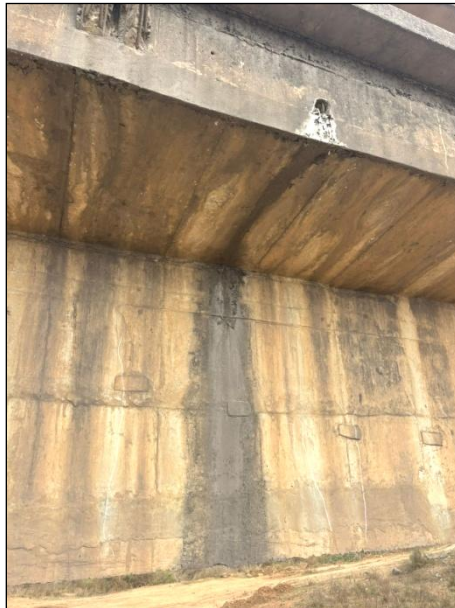
Photo 189: A typical view of drainage spout of H.L Bridge at 27/500 Km on Bhawanipatna-Khariar Road in the Kalahandi Division

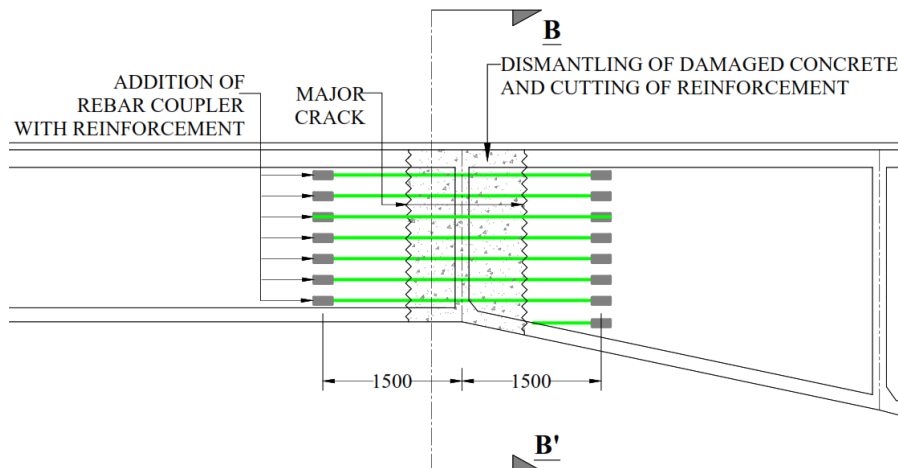
Photo 191 Details of repair methodology for major crack at highly distressed section between span P11–P12.

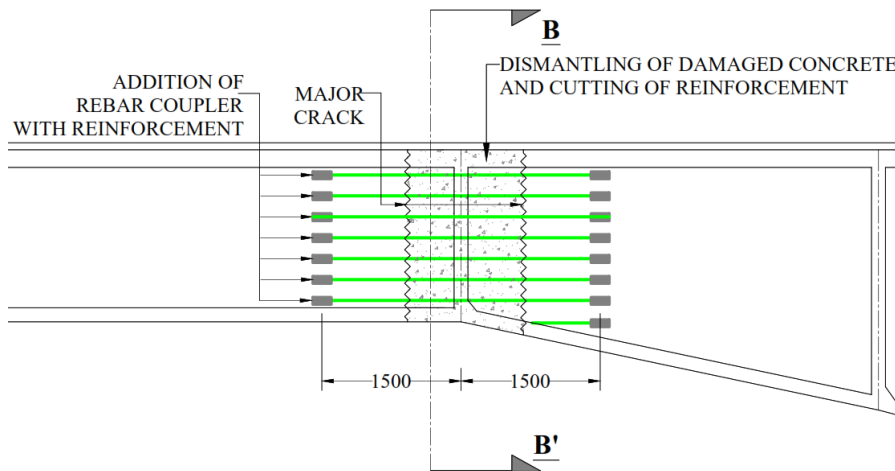
Figure 6 Details of repair methodology for major crack at highly distressed section between span P11-P12.
