लोक निर्माण विभाग, ओडिशा सरकार के अंतर्गत, पुलों की आधुनिक परीक्षण प्रक्रियाओं का उपयोग करते हुए ओडिशा राज्य के रोड नेटवर्क के मेजर और माईनर ब्रिजो के स्थिति का आकलन और उपचारात्मक उपायों के लिए सुझाव

अंतिम रिपोर्ट

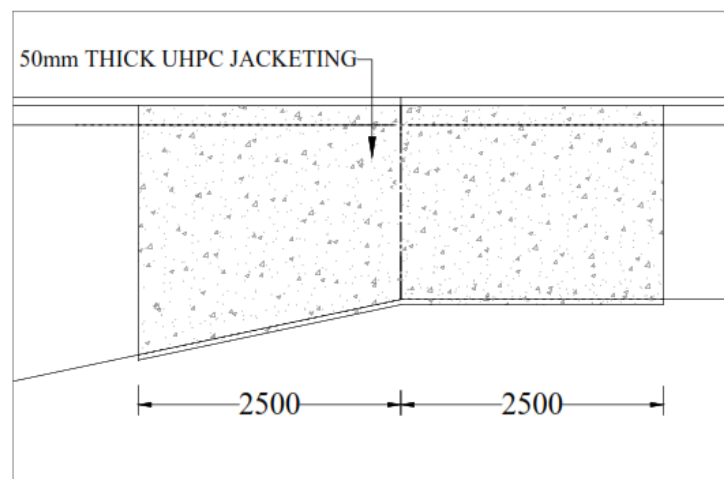
Figure 7 Detail of UHPC strengthening where cross section/geometry of box girder is changing in continuous span.

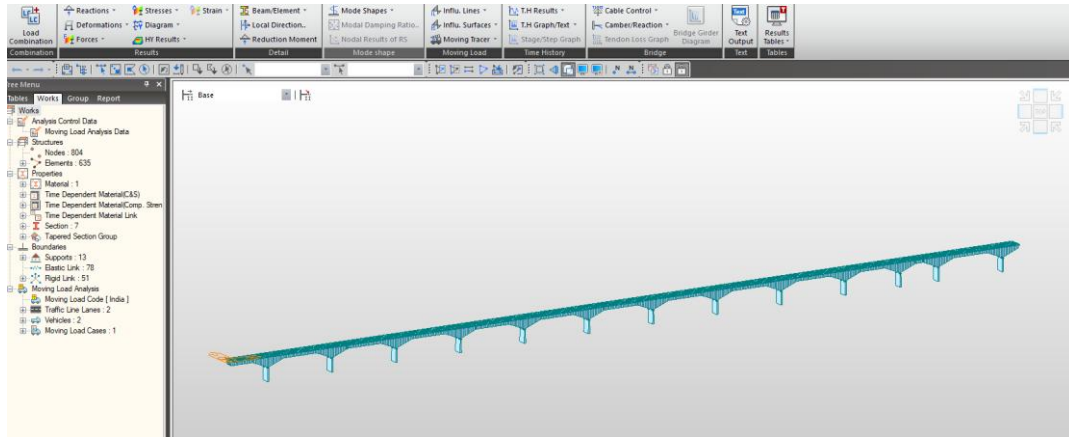
In order to investigate the possible cause of failure of bridge, numerical modelling was performed using finite element (FE) software MIDAS Civil. A typical view of the FE model is shown in Fig. 1.

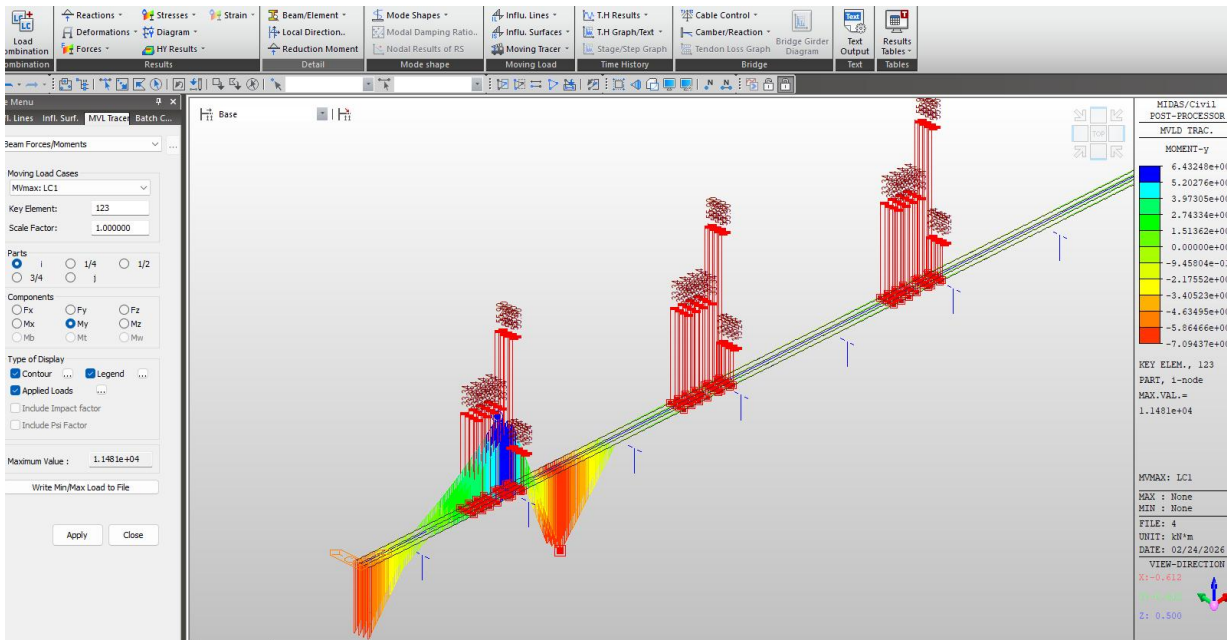
Fig. 3 Position of live load for the maximum bending moment at the critical section (Span P11-P12) obtained through moving load tracer for element at critical location.

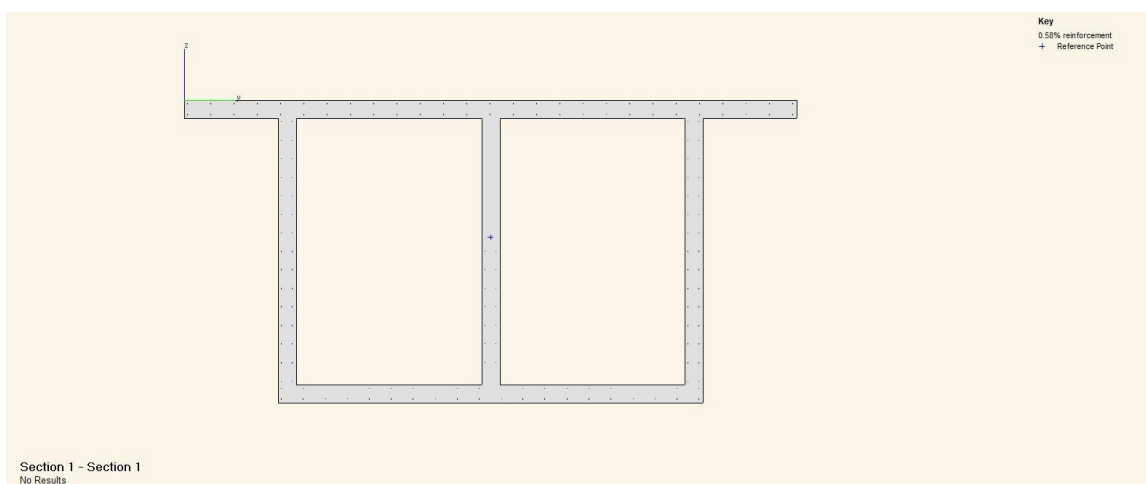
It is to be noted that the calculations are part of the preliminary analysis for finalizing the qualitative strengthening measures. The exact details can be obtained by detailed analysis where exact mapping of the current geometry of the bridge and reinforcement details are required. It is also to be noted that this work is not currently in the scope of work of CRRI.
